### **EXECUTIVE SUMMARY**

An initial baseline industrial hygiene survey was conducted at the Conway Armory on 3 May 2005 as part of the South Carolina Army National Guard Occupational Health Program to identify potential health hazards in the workplace. The survey consisted of collecting lead wipe samples and bulk asbestos samples as needed, conducting a noise and illumination survey and an evaluation of the condition of the building as it related to indoor air quality. A review of the Hazard communication program, ergonomics, and personal protective equipment was also performed.

Initial Baseline Industrial Hygiene Survey of the Conway Armory performed 3 May 2005 in Conway, South Carolina.

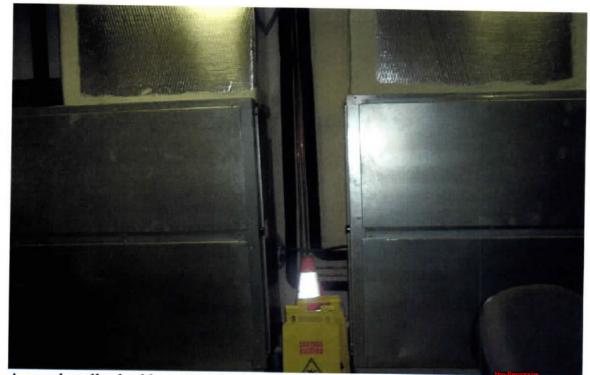
A new handler had been installed in the armory. It constantly runs.

does not have the ability to shut it down. It was 80 degrees in some of the offices. There was no way to access controls to lower the temperature. They run over the weekend as well it was stated.

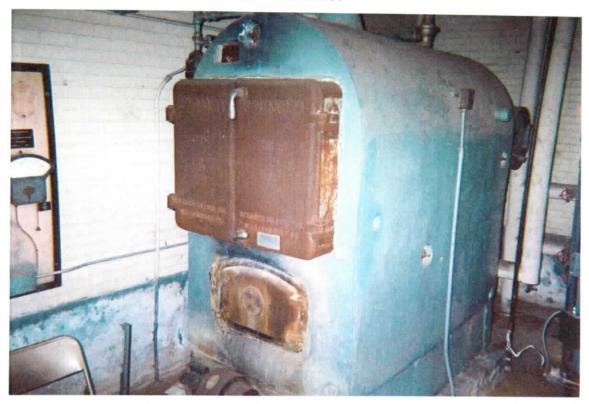
# BOILER, BROKEN SECTION

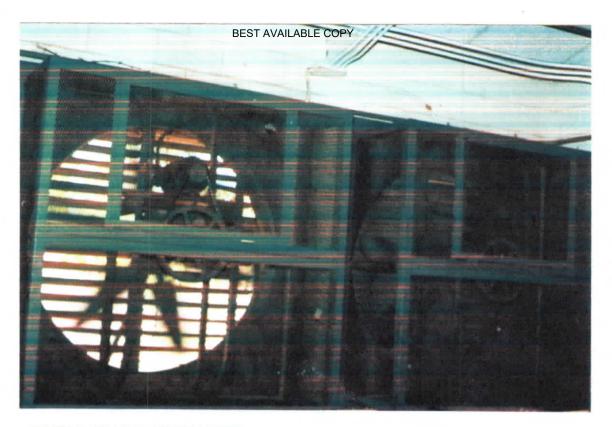
DRILL HALL EXHAUST FANS, IN ADJACENT ROOM AT FLOOR LEVEL
