In accordance to the JFTX-H-OH Industrial Hygiene Implementation Plan of 2009, a follow-up industrial hygiene survey was performed at the Irving Armory located at 1007 O'Connor Road Irving, Texas 75061. The purpose of the survey was to evaluate potential health hazards present in the building

**DEPARTMENT OF THE ARMY AND THE AIR FORCE
NATIONAL GUARD BUREAU
REGIONAL INDUSTRIAL HYGIENE OFFICE
AIRPORT PLAZA SUITE 1530
510 PLAZA DRIVE
COLLEGE PARK, GA 30349**

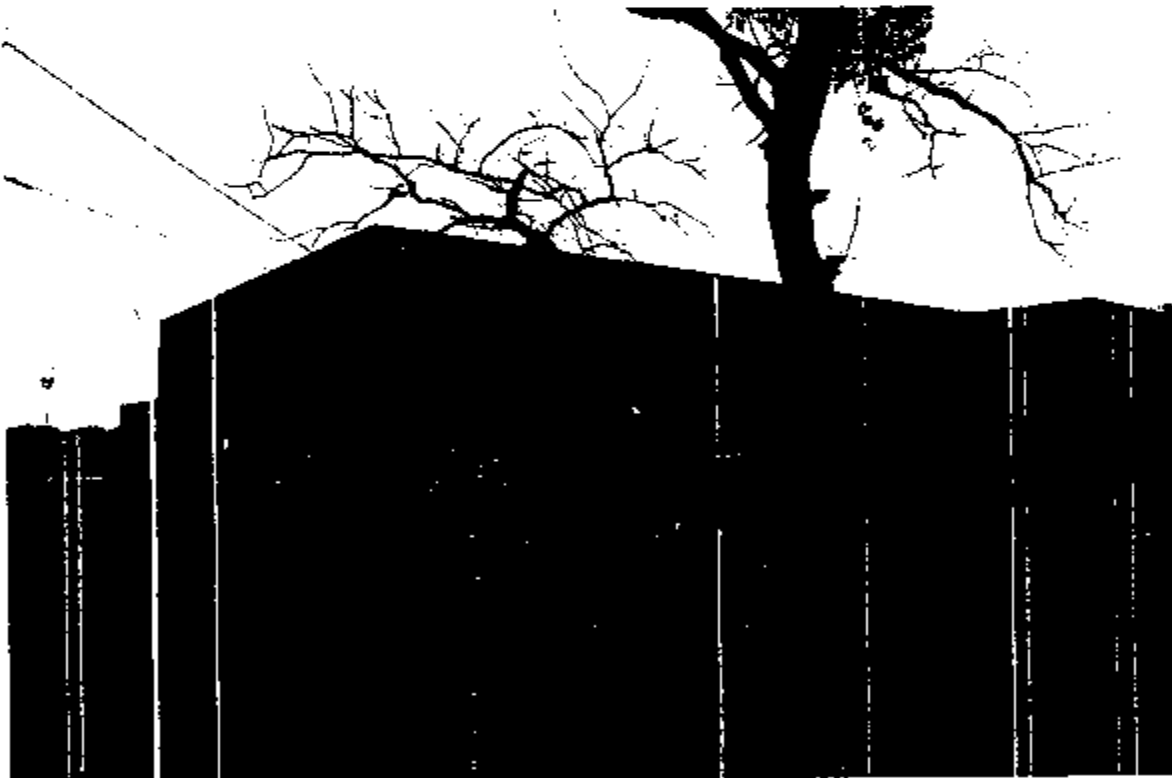
Photo 2: Irving Armory South Side.

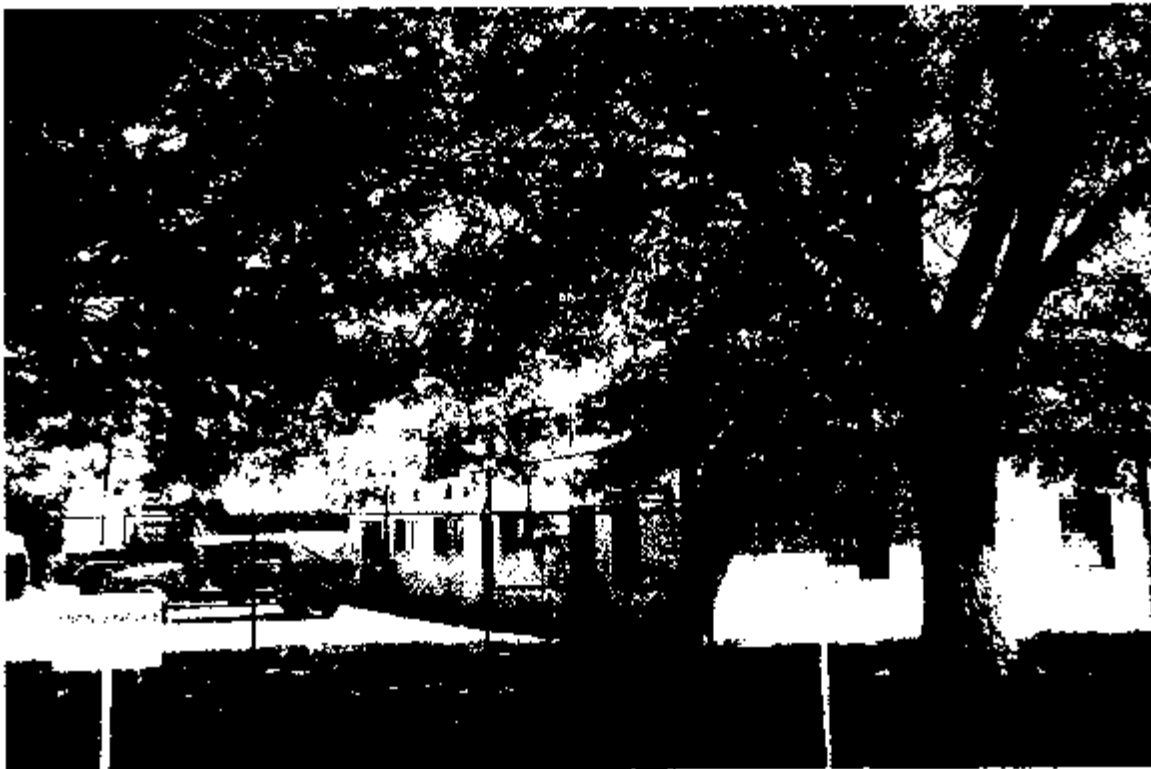
Photo #2: North side of the armory.

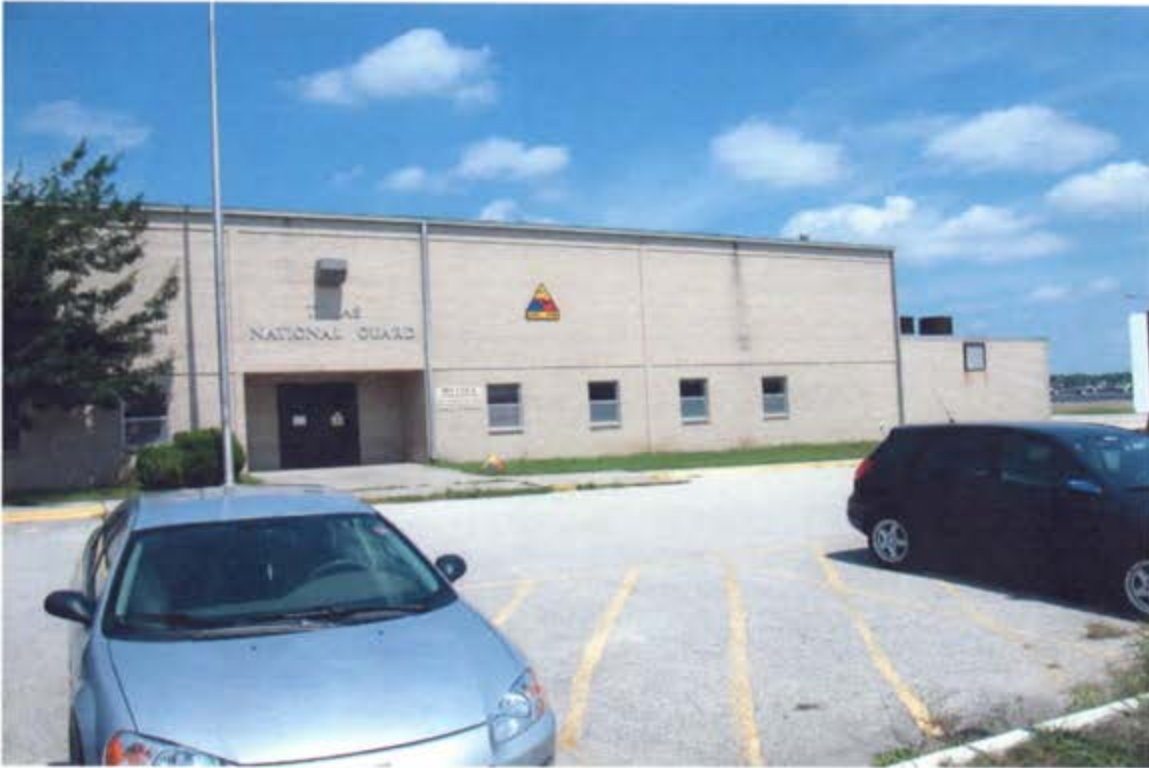
Photo #1: Armory front entrance.

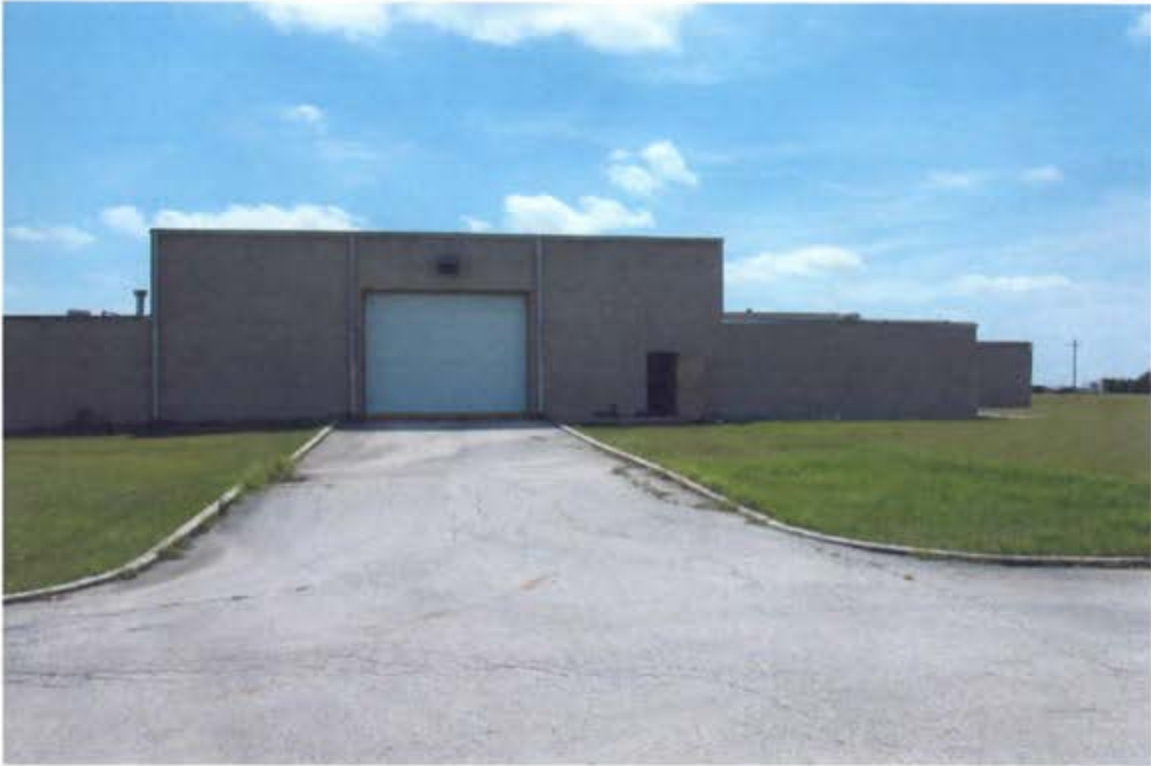
Photo #3: West side of the armory.

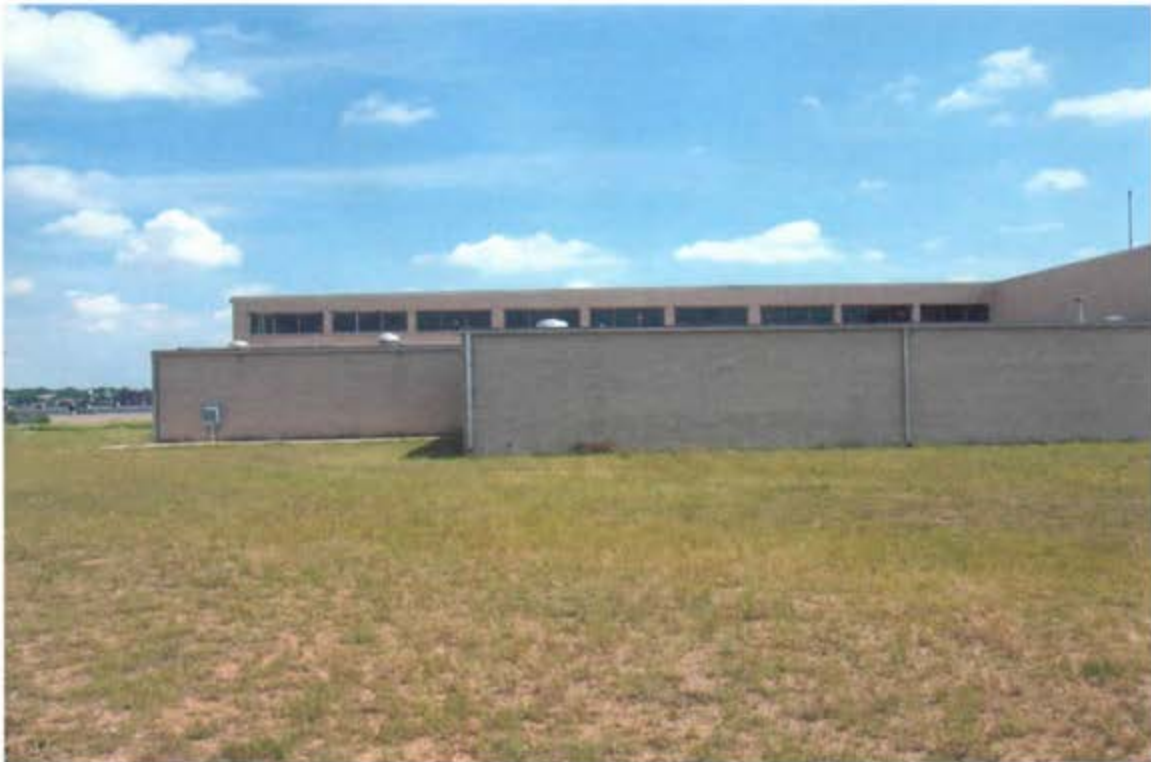
Photo #4: South side of the armory.

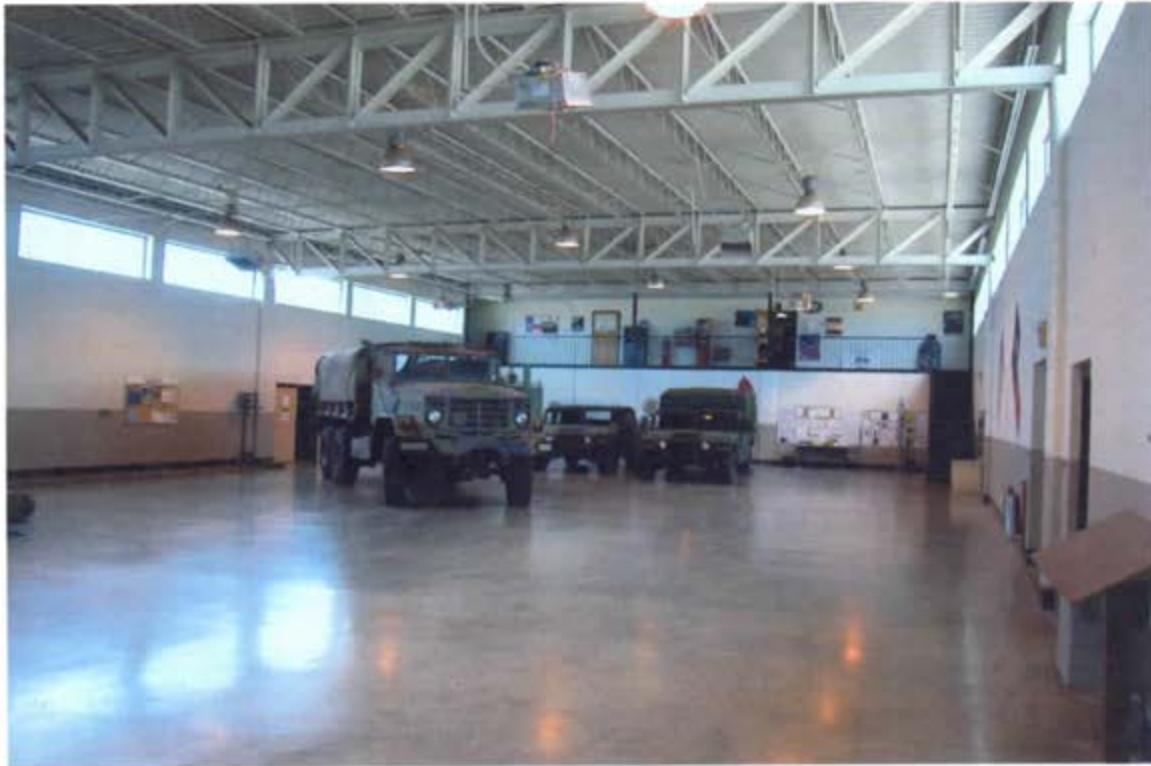
Photo #5: Drill hall facing east.

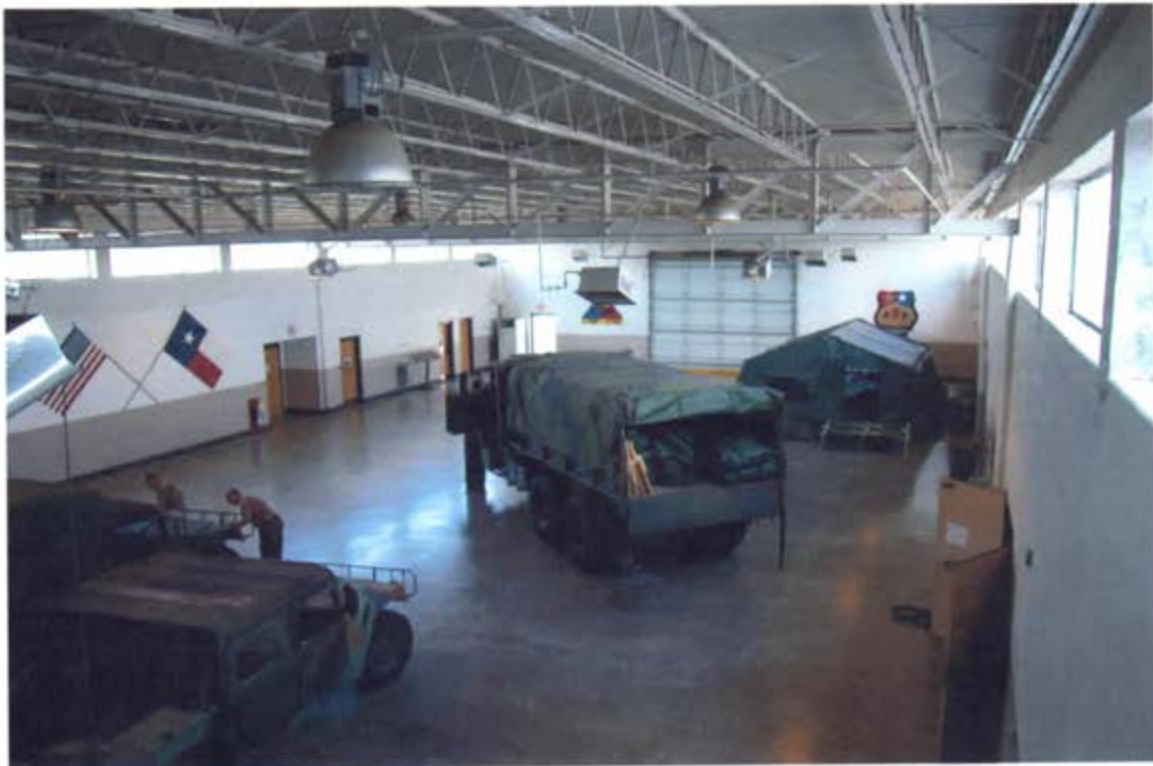
Photo #6: Drill hall facing west.

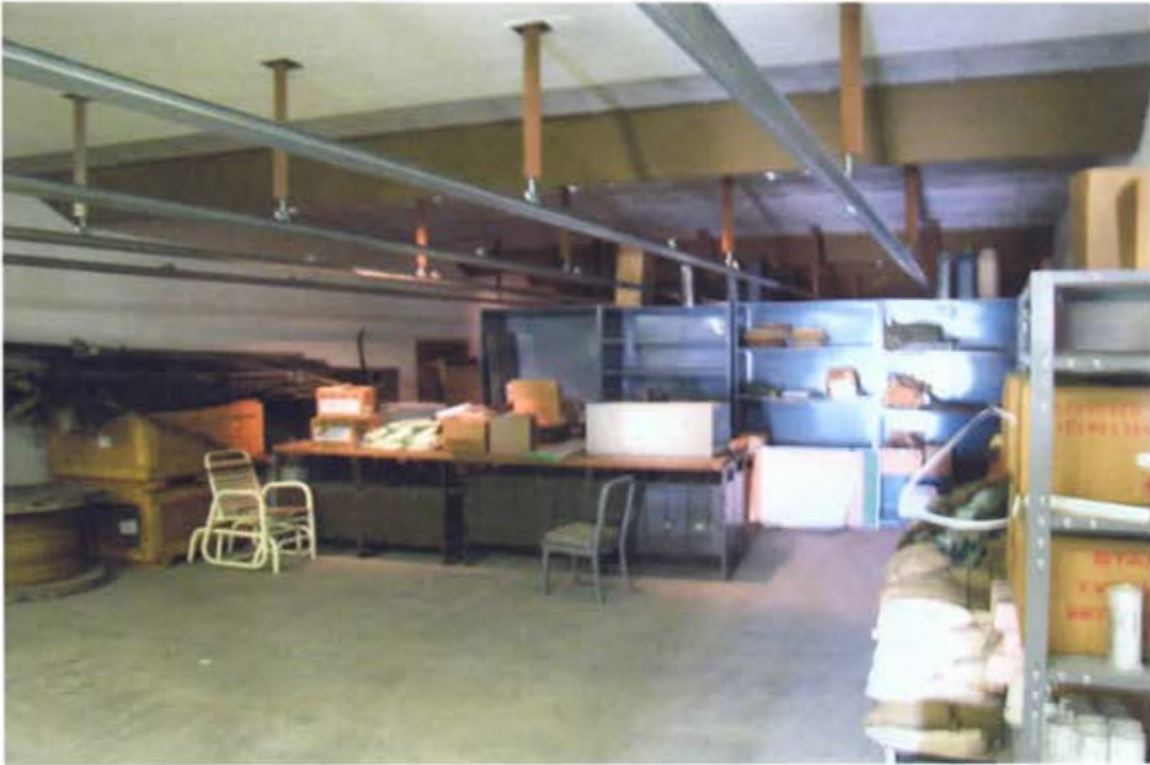
Photo #7: Indoor firing range facing the bullet trap.

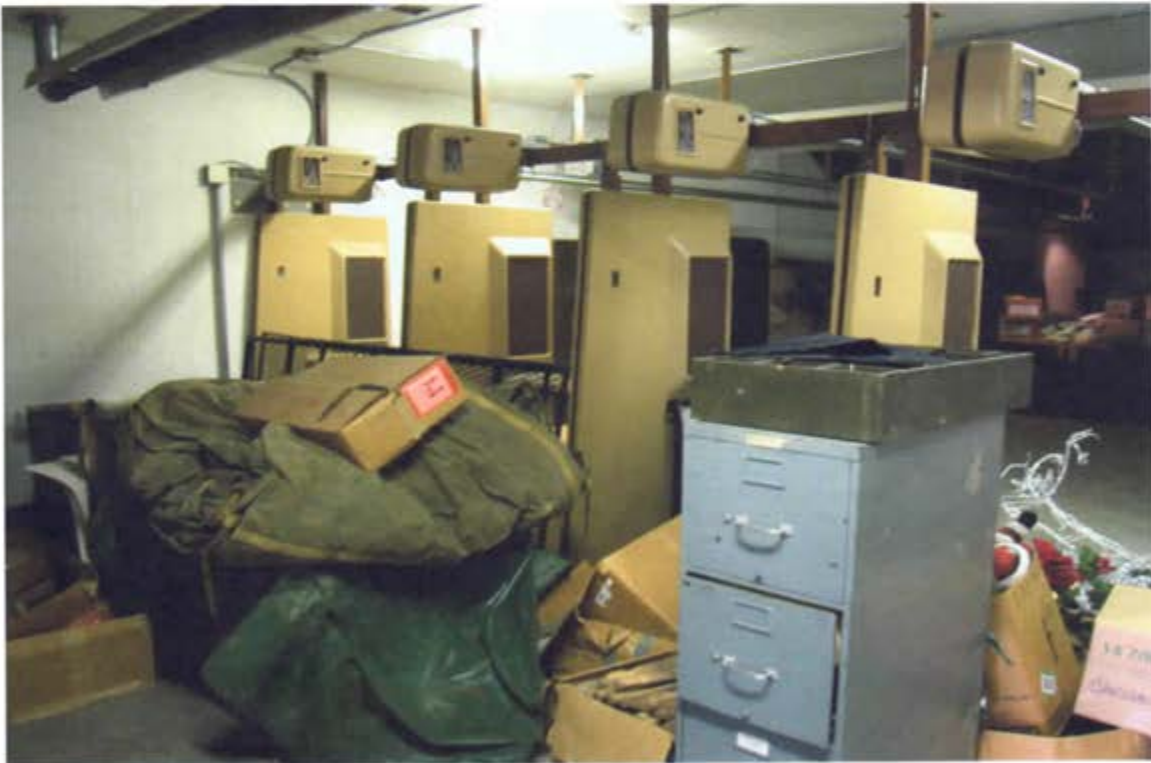
Photo #8: Indoor firing range facing the firing line.

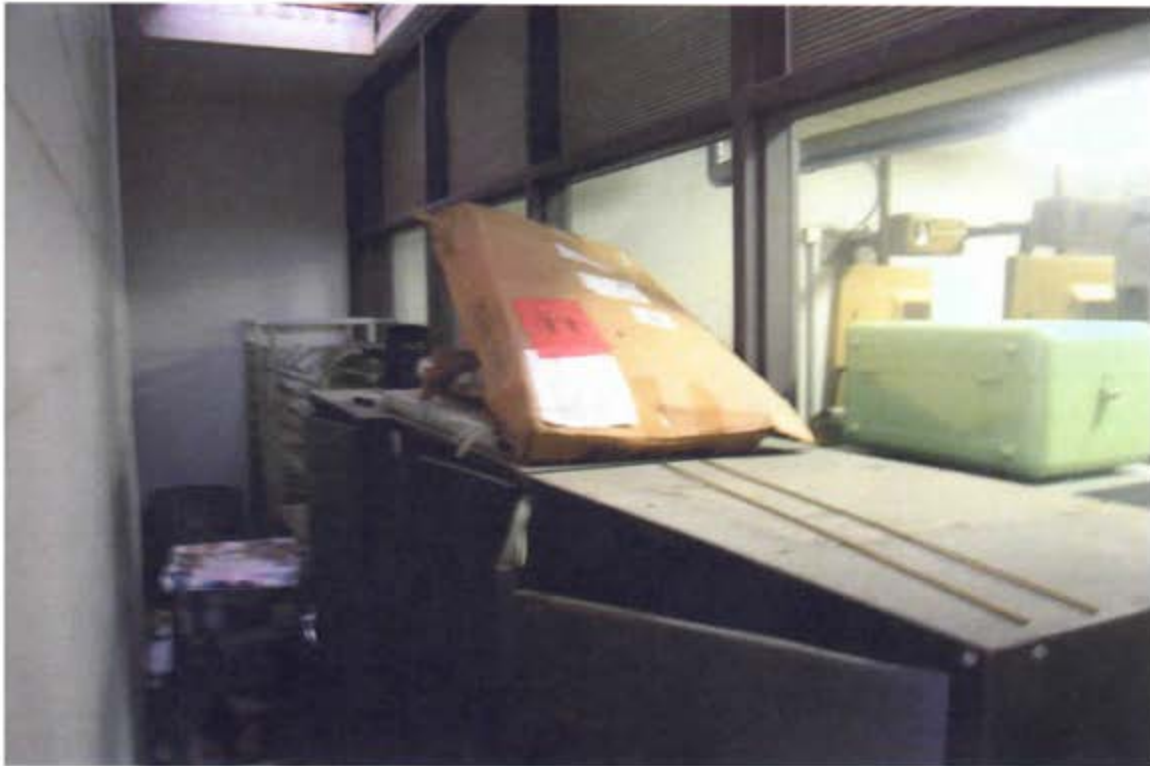
Photo #9: IFR observation deck.

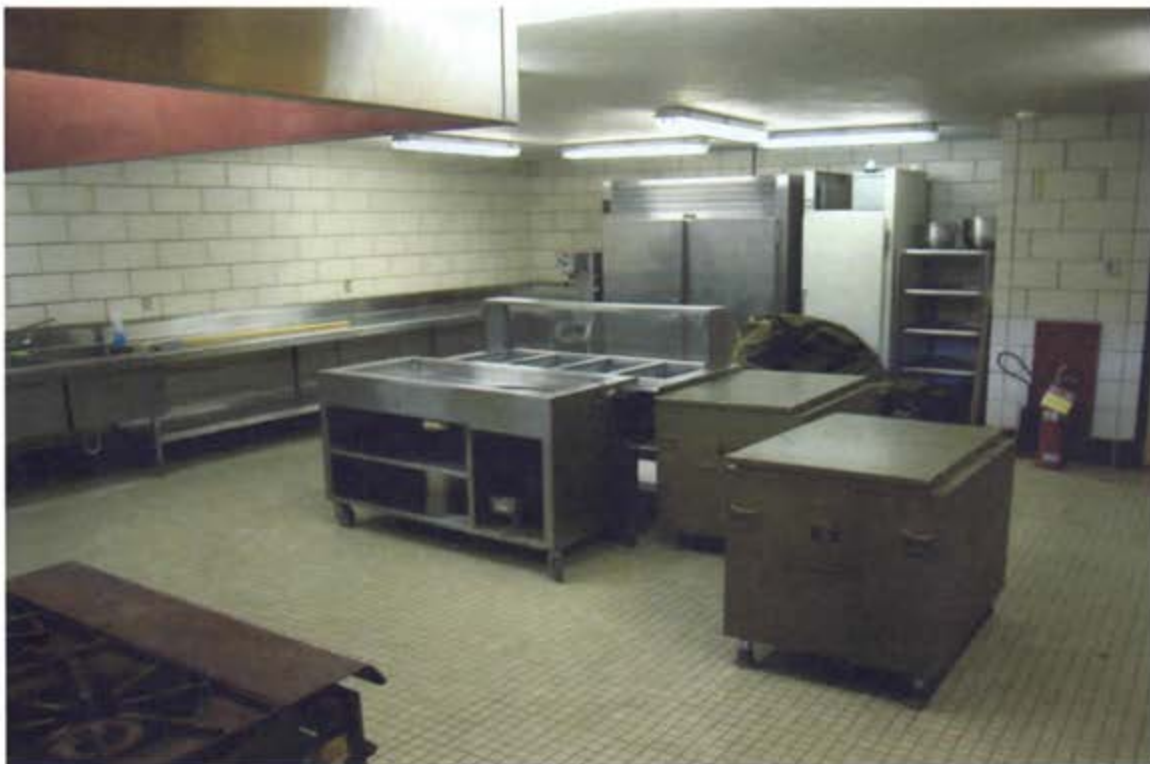
Photo#10: Armory's kitchen.

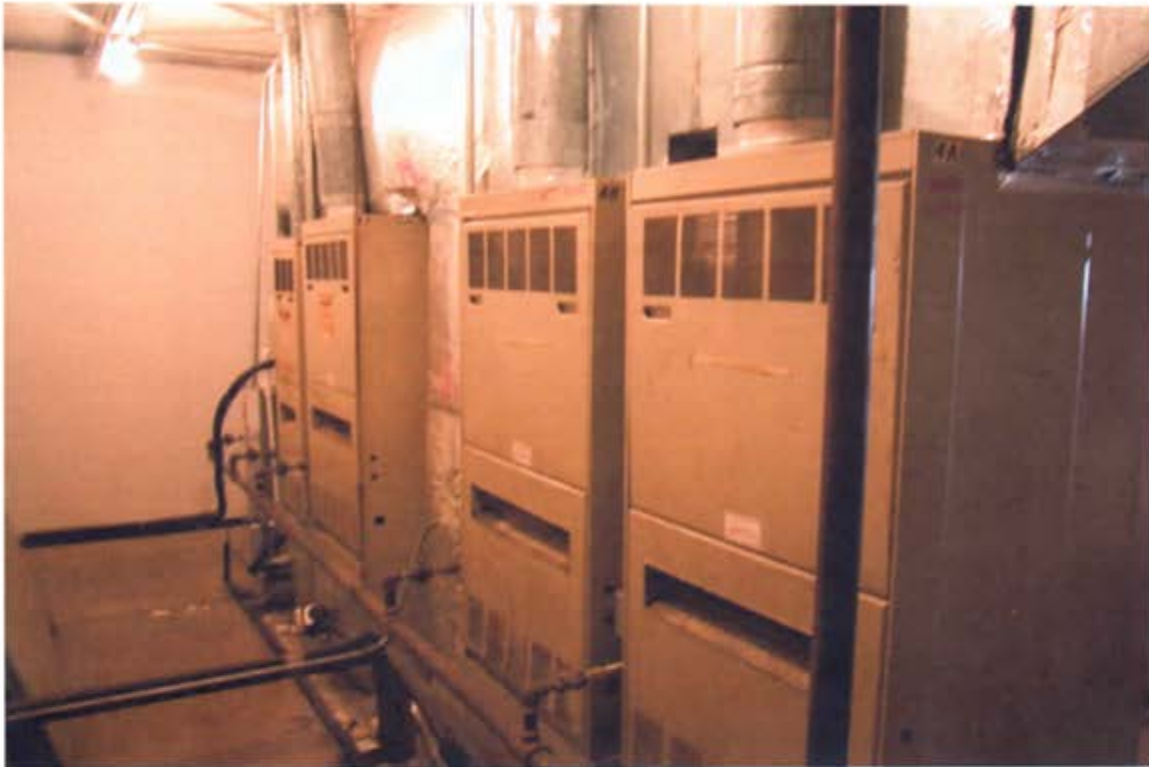
Photo #11: Mechanical room.

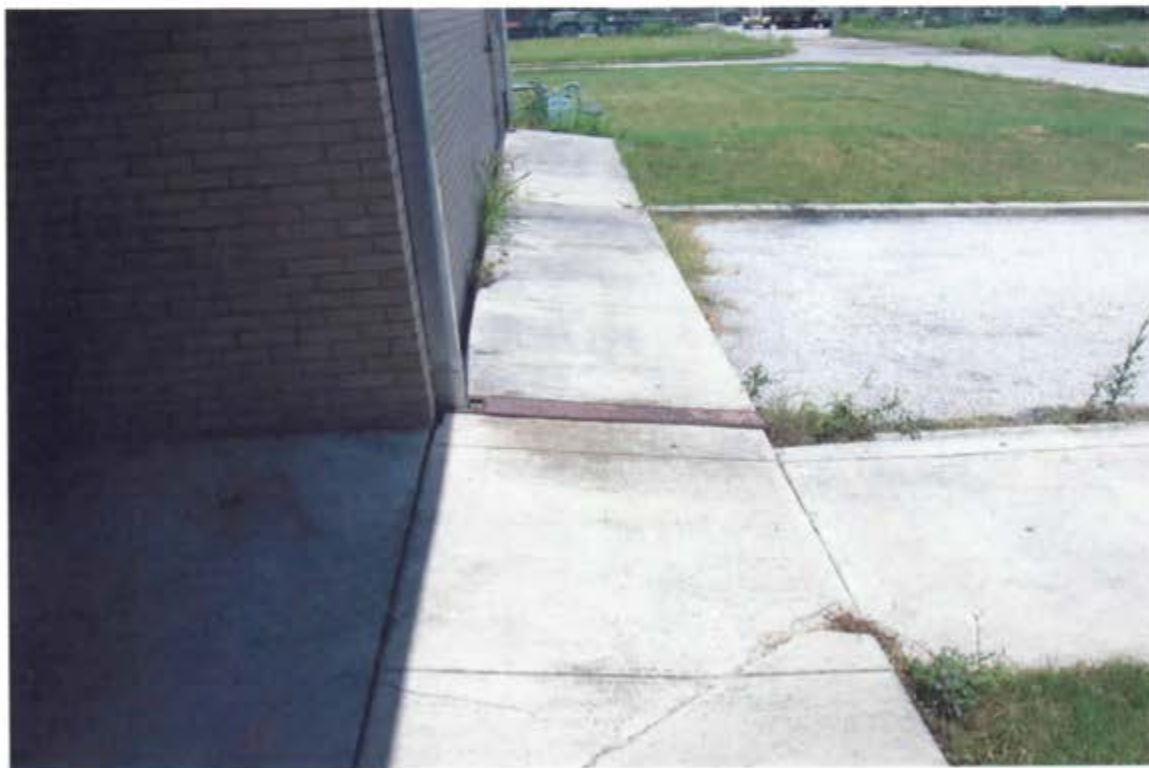
Photo #12: Sidewalk separation on the west side of the armory due to ground settling.

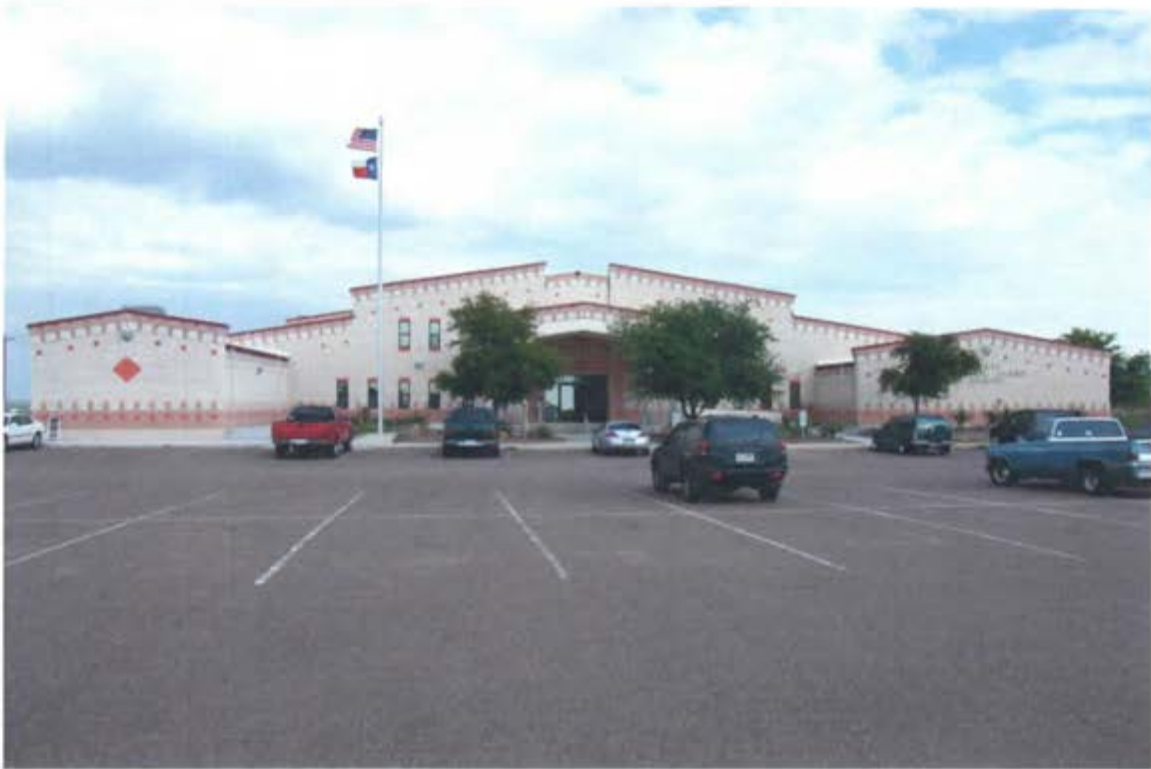
Photo #1: Armory front entrance.

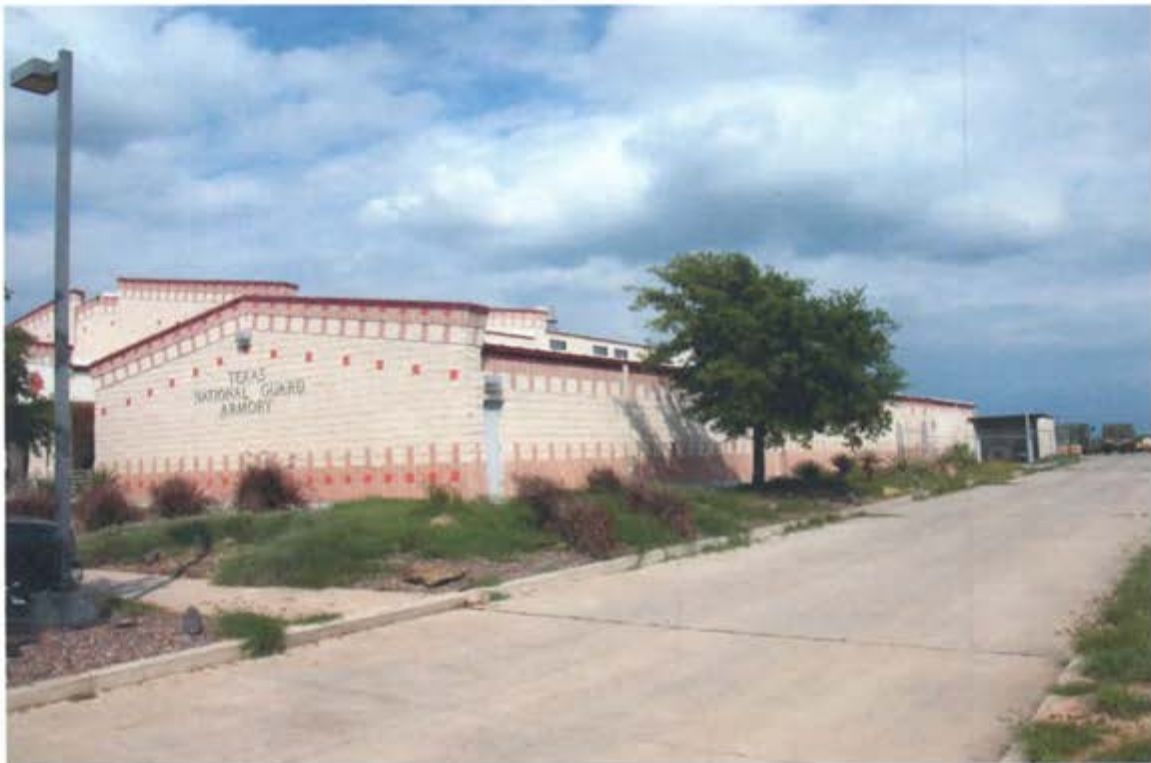
Photo #2: Southwest side of the armory.

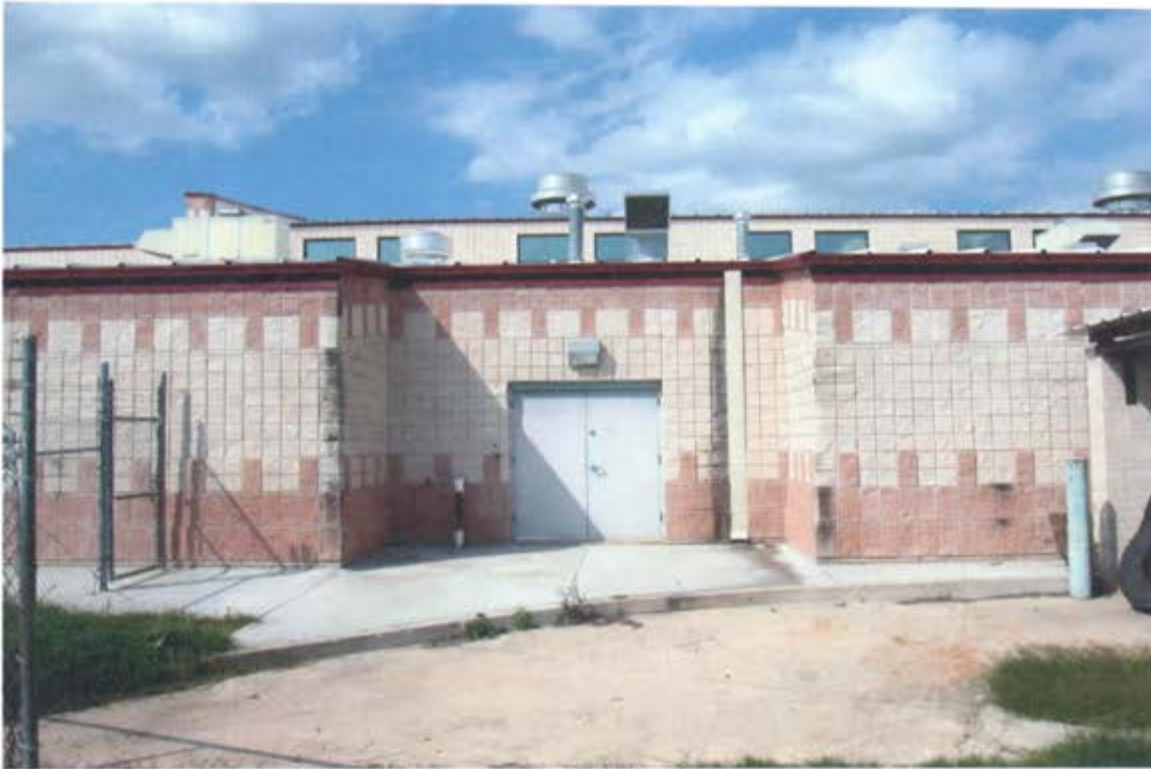
Photo #3: South side of the armory.

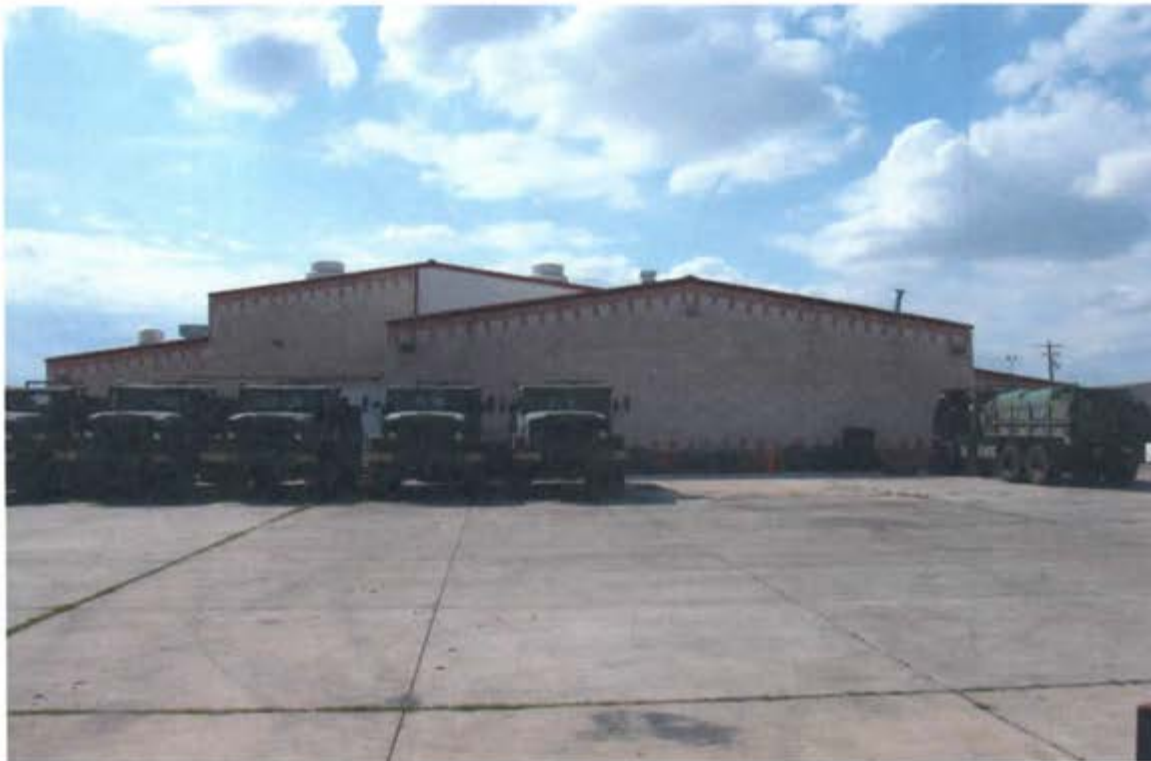
Photo #4: North west side of the armory.

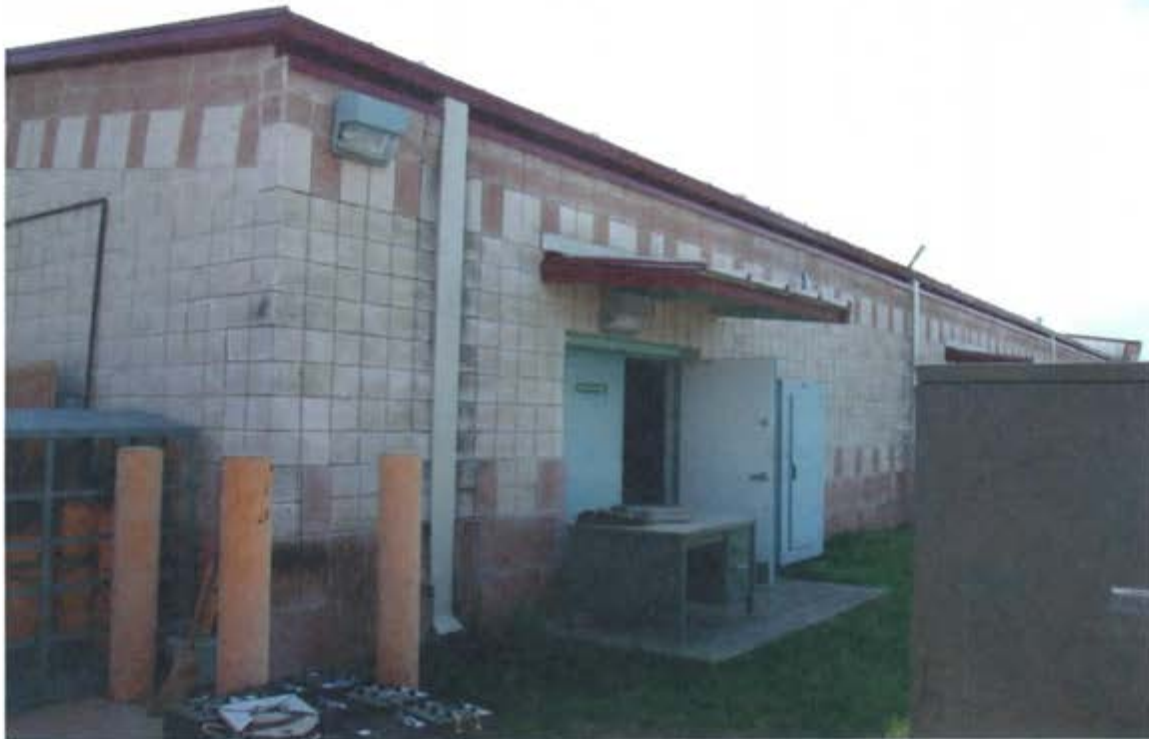
Photo #5: Outside wall of the firing range showing mold growth.

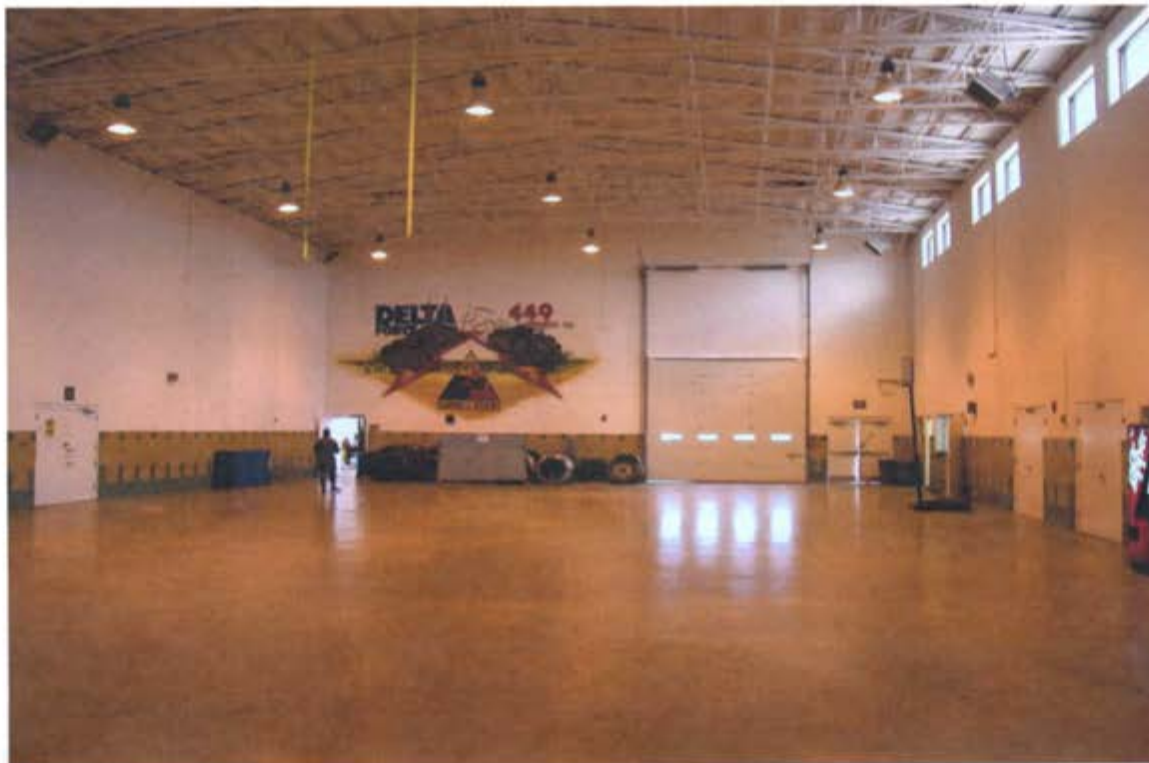
Photo #6: Drill hall facing east

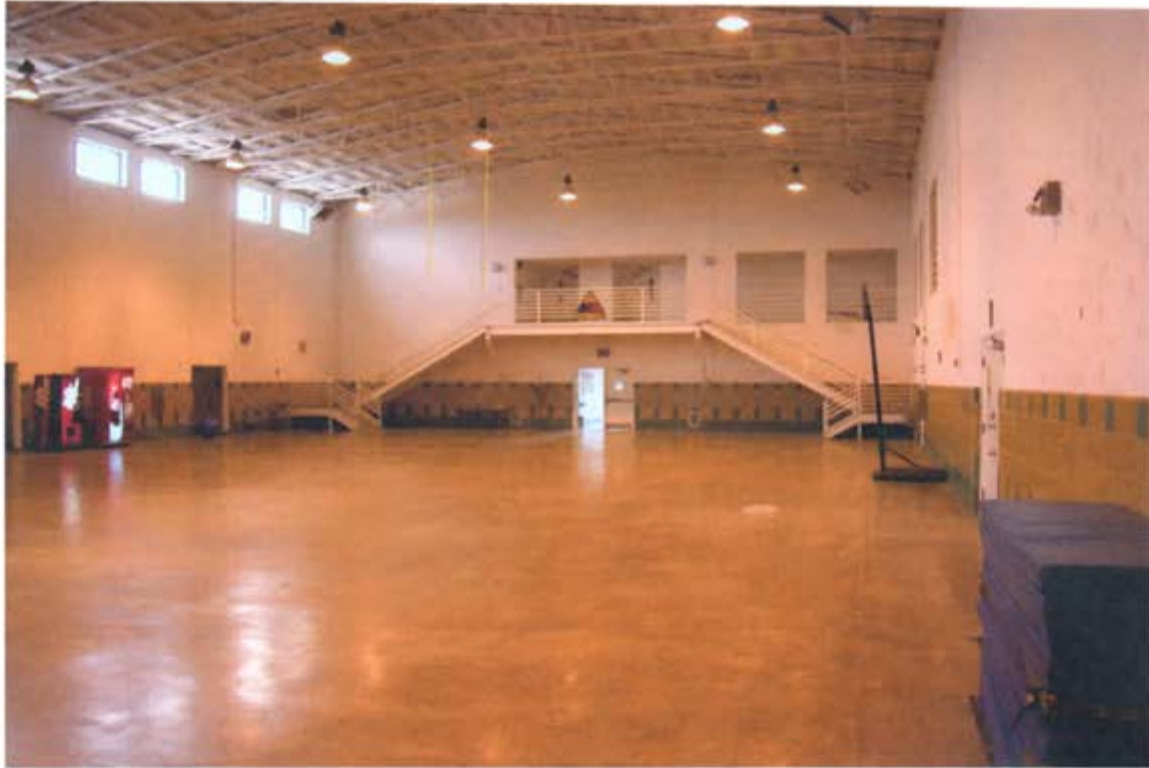
Photo#7: Drill hall facing west south west and showing the second floor.

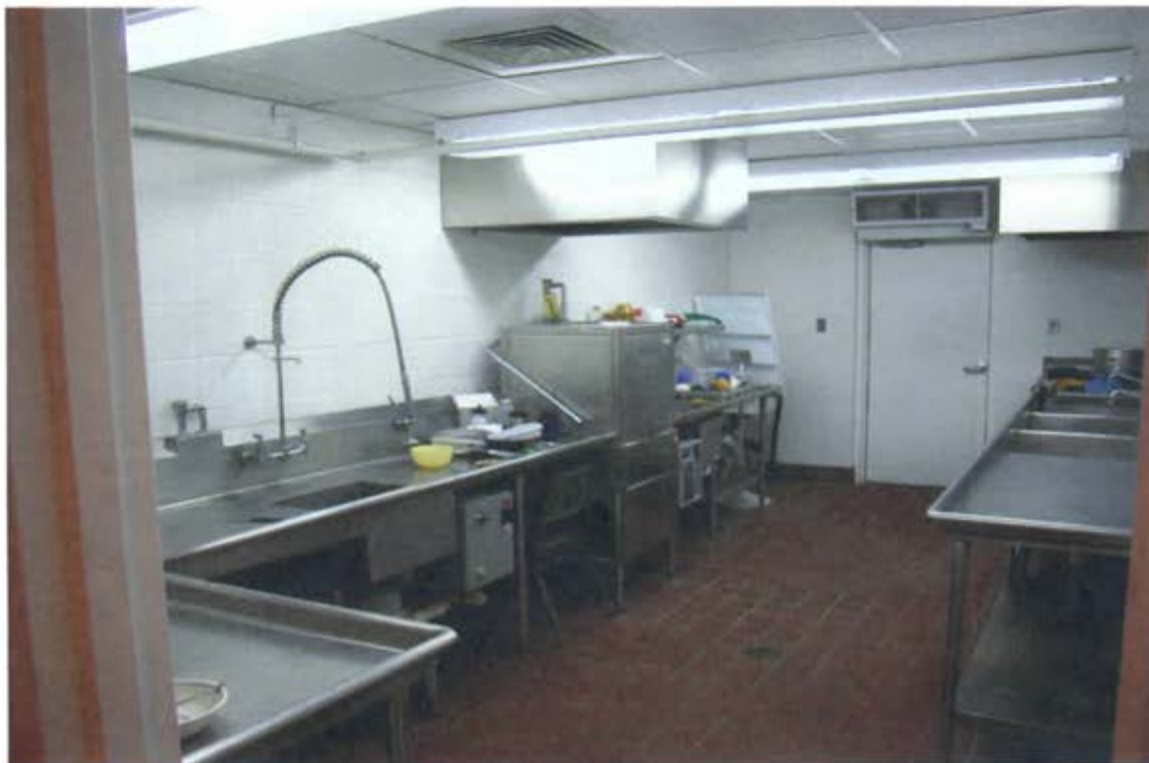
Photo #8: Armory's kitchen showing the sinks and ice maker.

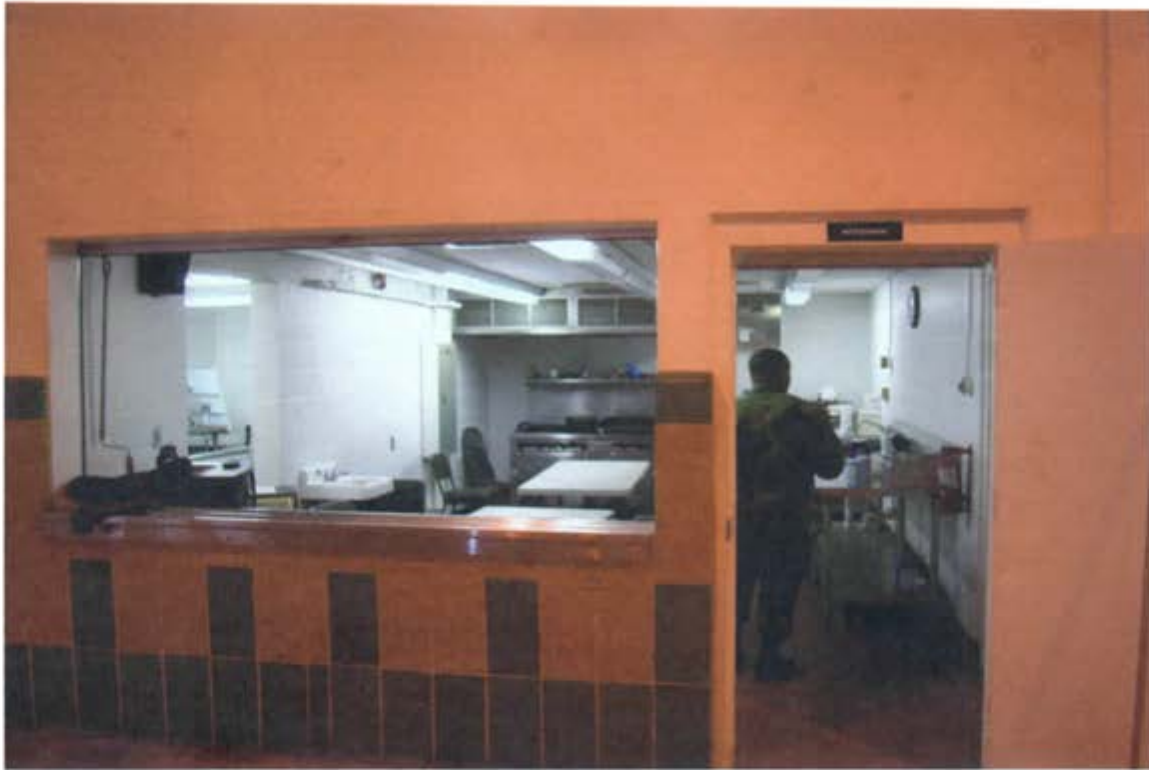
Photo #9: Armory's kitchen showing the serving line.

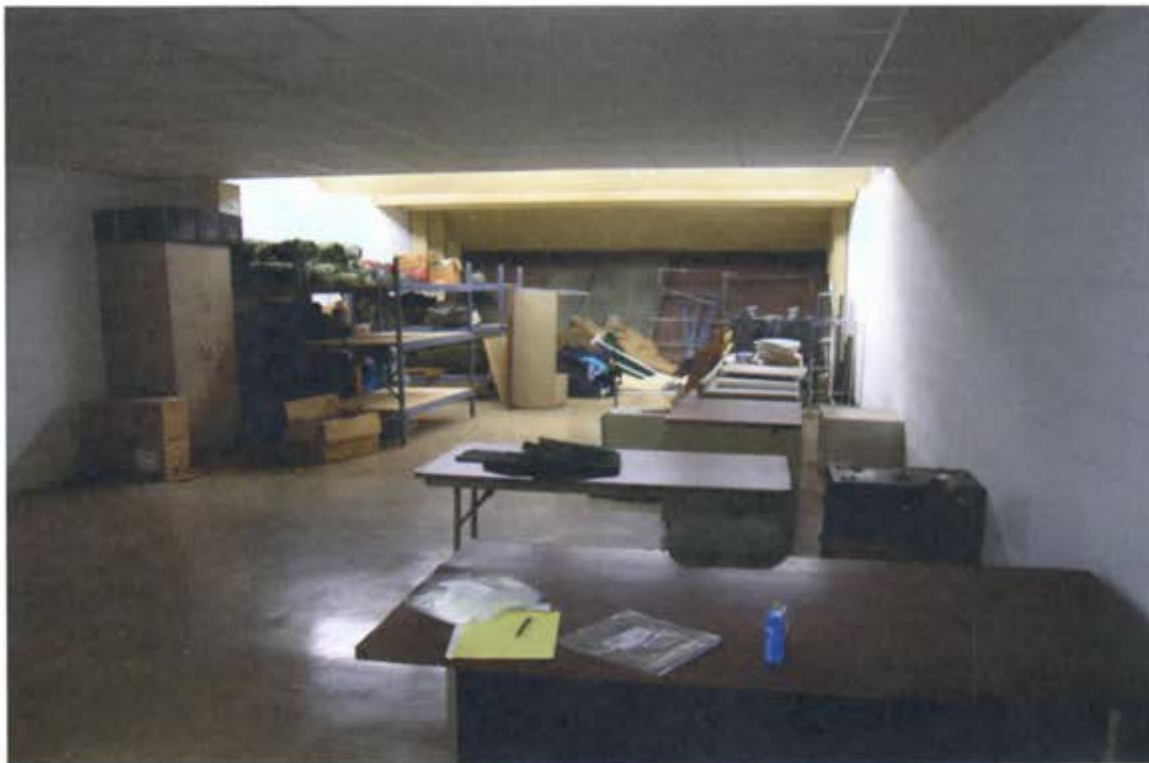
Photo #10: Armory's Indoor Firing Range.

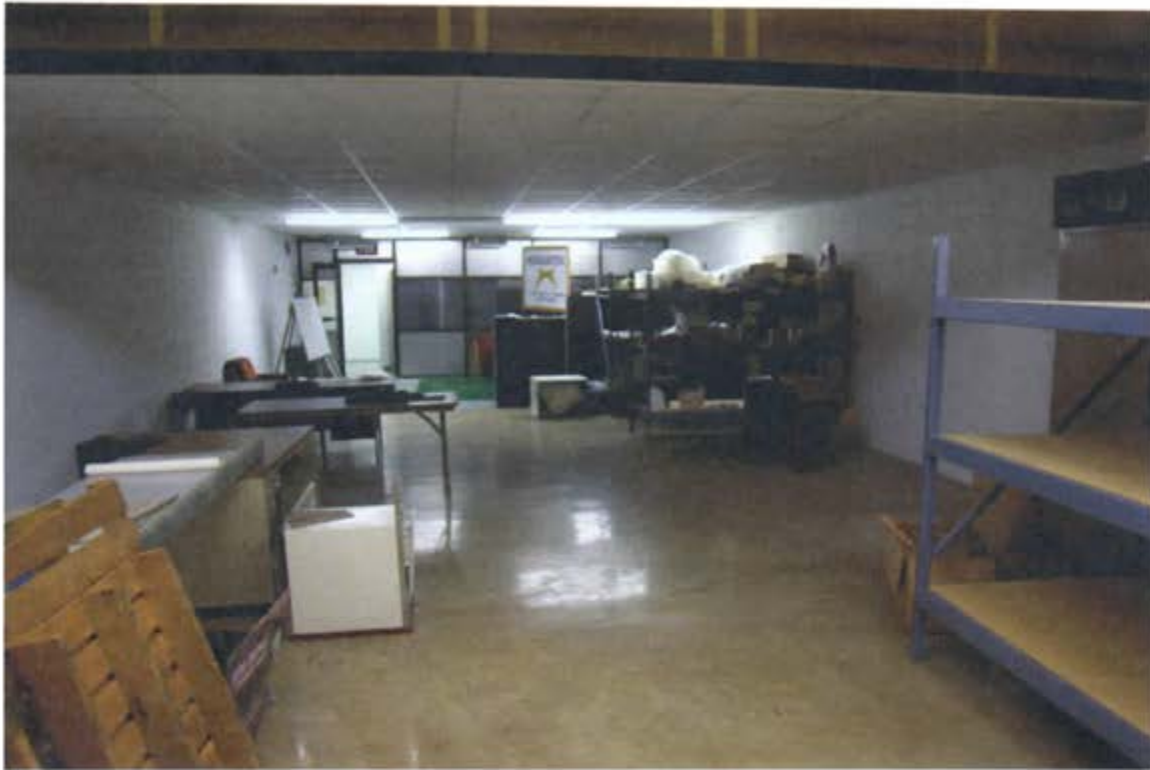
Photo #11: Indoor firing range facing observation deck.

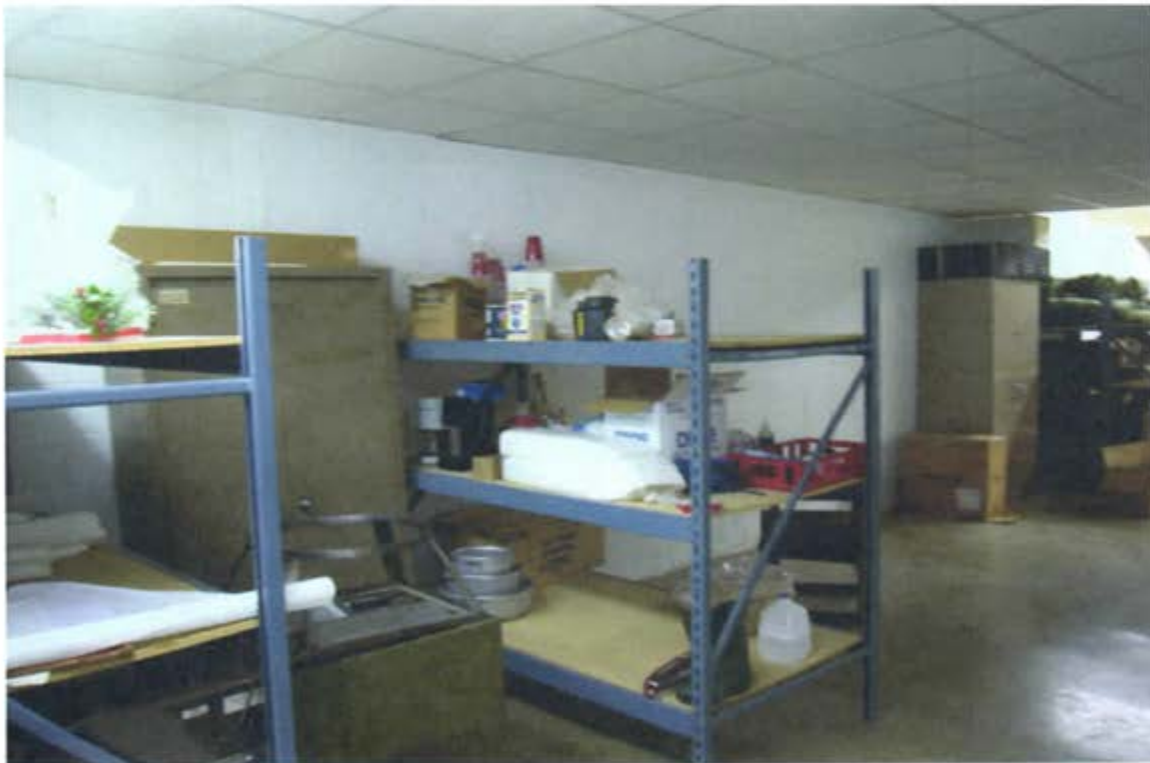
Photo #12: Storage shelves in the indoor firing range.

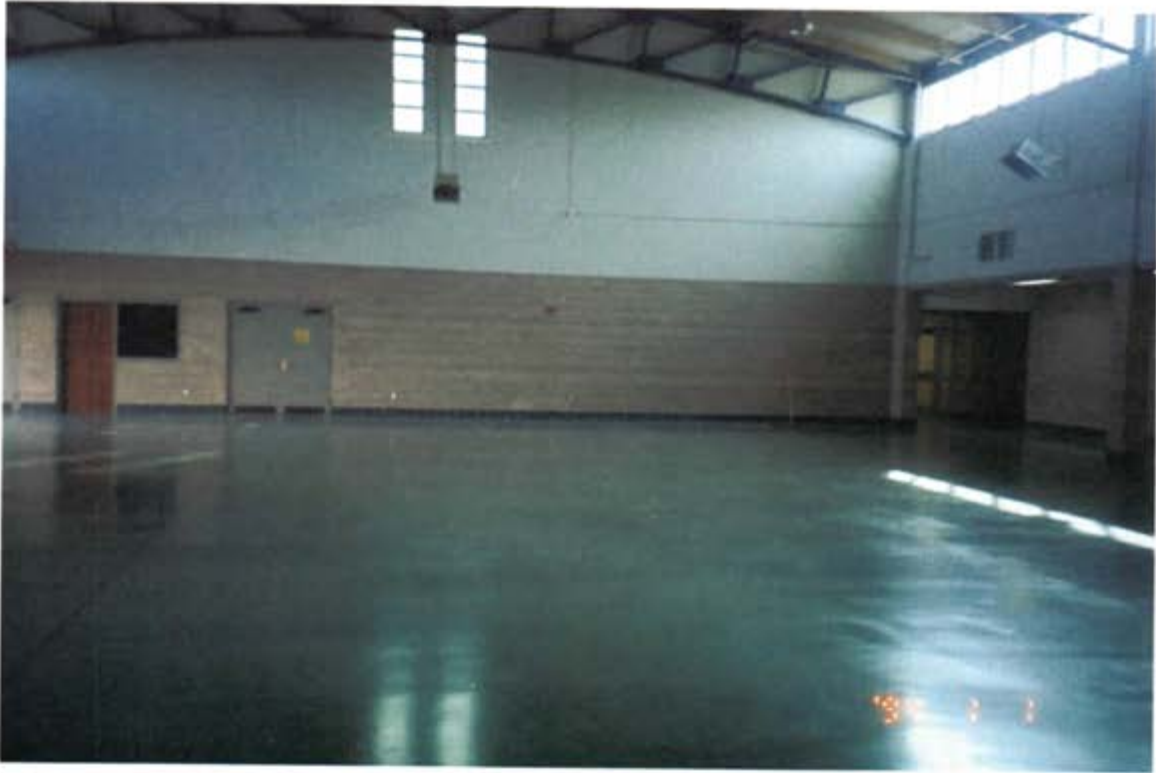
Views of Lubbock Texas National Guard
Armory's Drill Hall
