In accordance to the JFTX-H-OH Industrial Hygiene Implementation Plan of 2009, a follow-up industrial hygiene survey was performed at the Irving Armory located at 1007 O'Connor Road Irving, Texas 75061. The purpose of the survey was to evaluate potential health hazards present in the building

**DEPARTMENT OF THE ARMY AND THE AIR FORCE
NATIONAL GUARD BUREAU
REGIONAL INDUSTRIAL HYGIENE OFFICE
AIRPORT PLAZA SUITE 1530
510 PLAZA DRIVE
COLLEGE PARK, GA 30349**

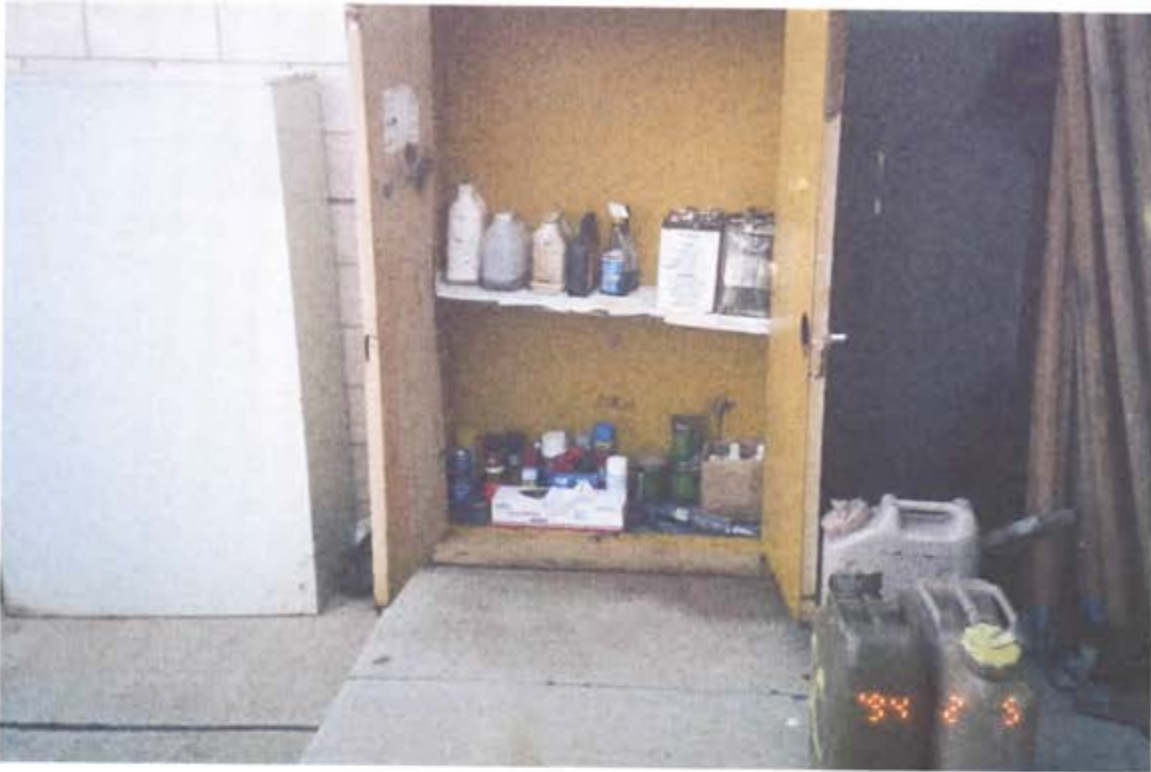
View of Hazardous Materials stored in a Flammable storage cabinet

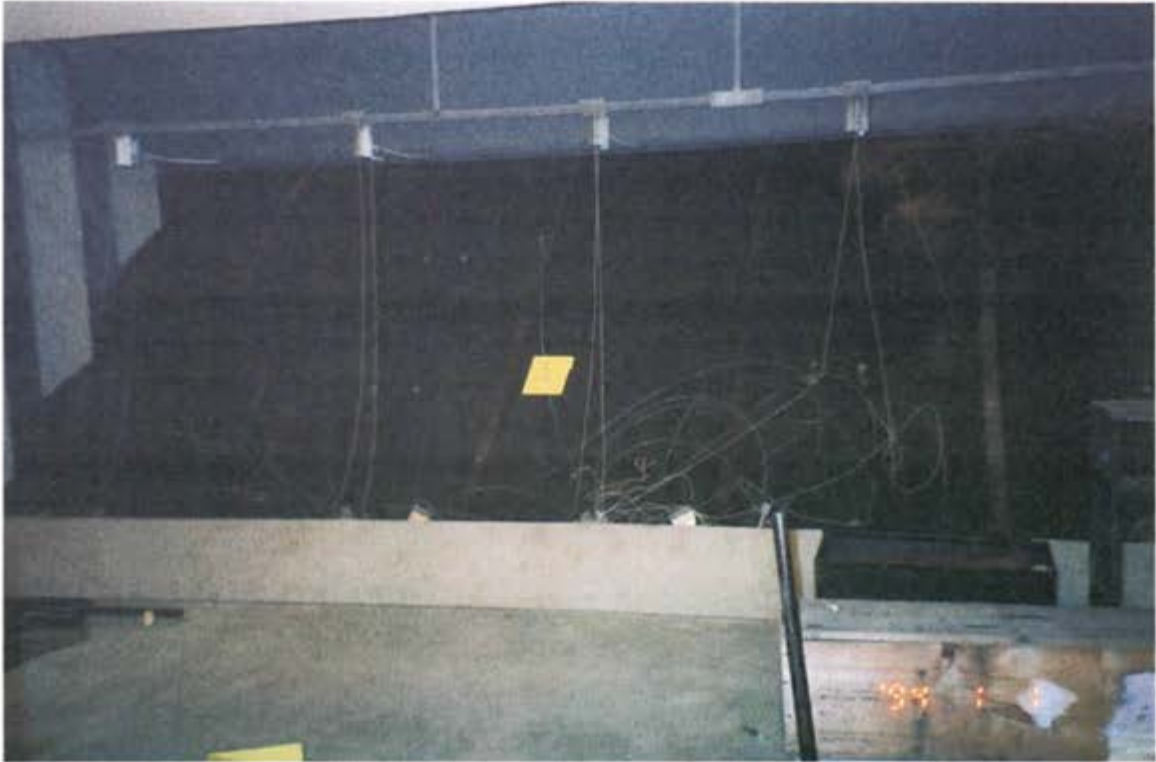
View of Lead wipe sample location 1, the backstop

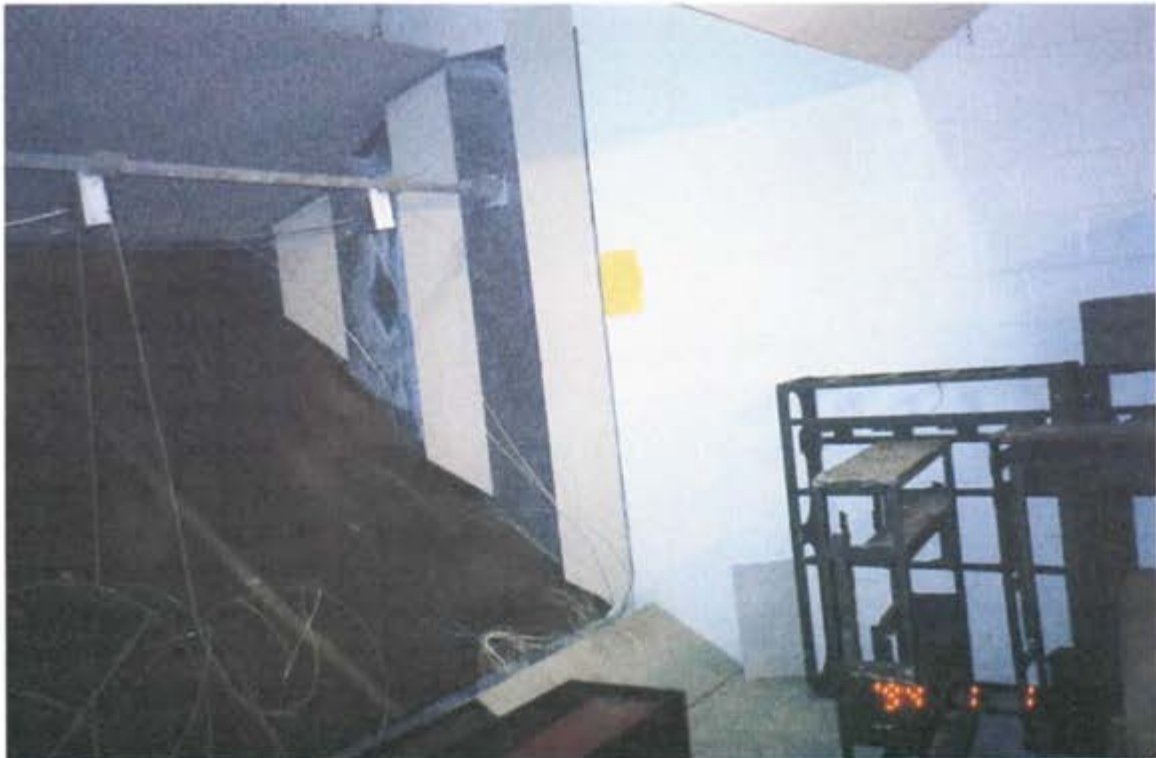
View of Lead wipe sample location #2

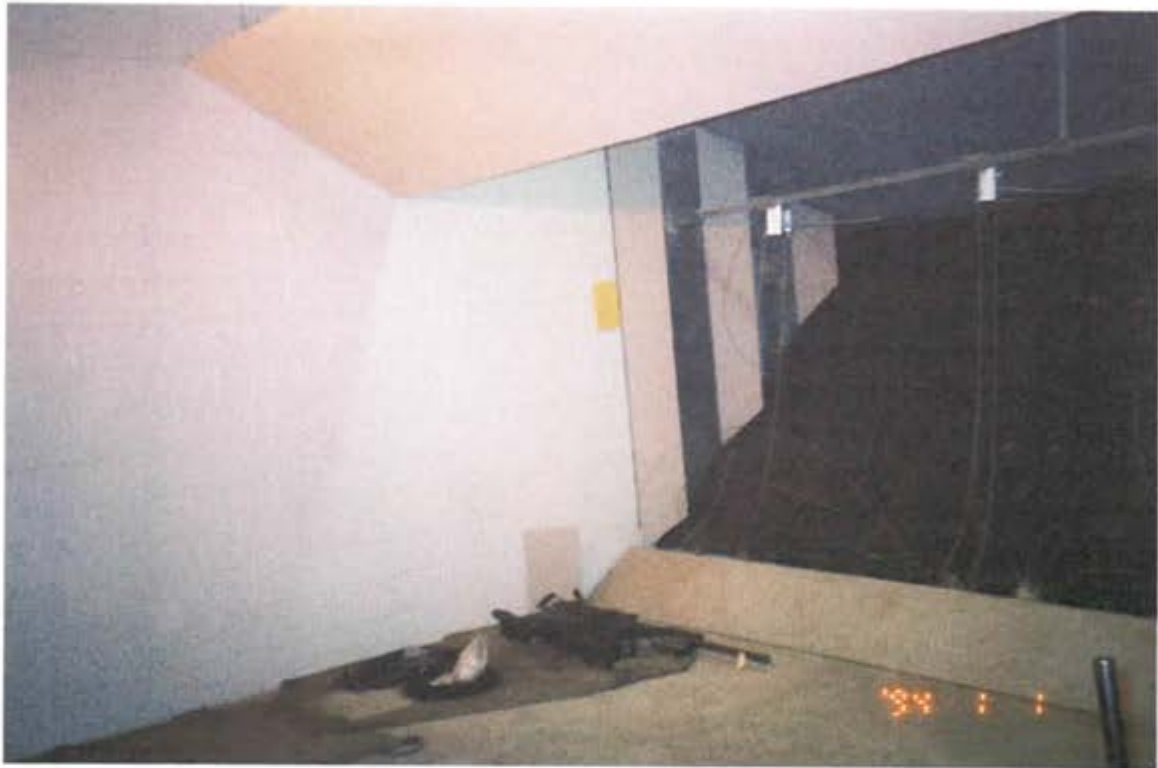
View of lead wipe sample location #3

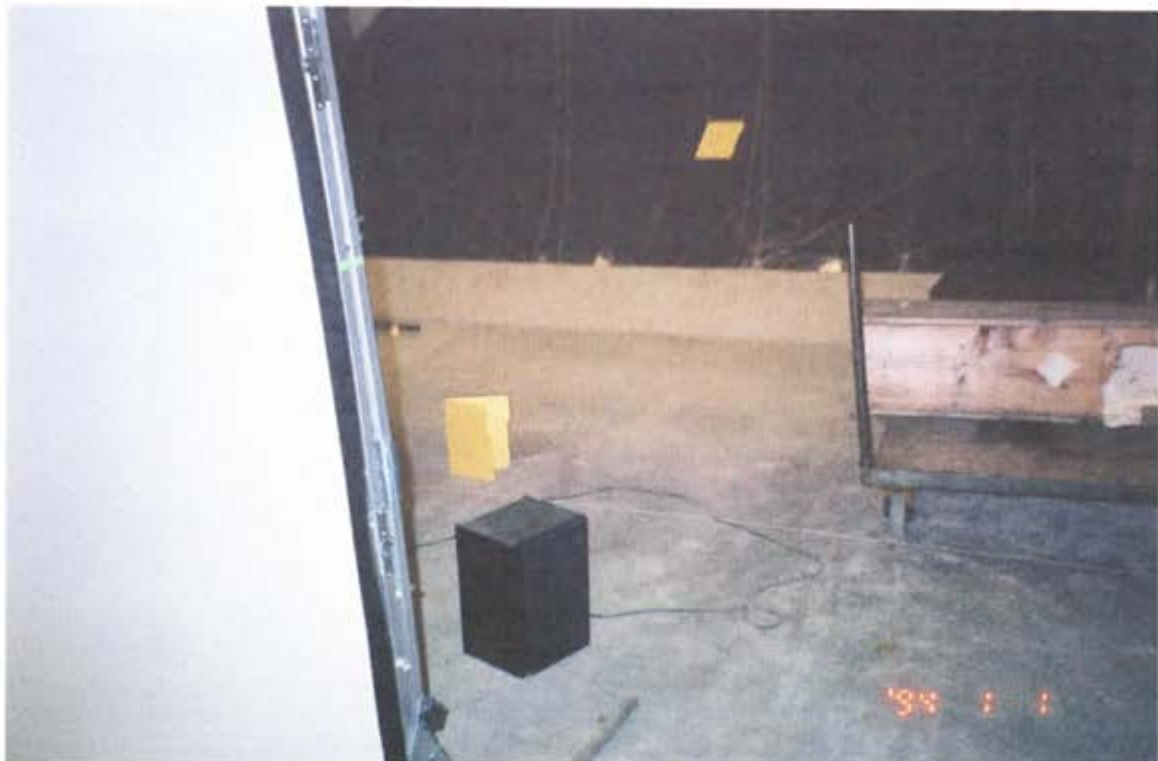
View of lead wipe sample location #4

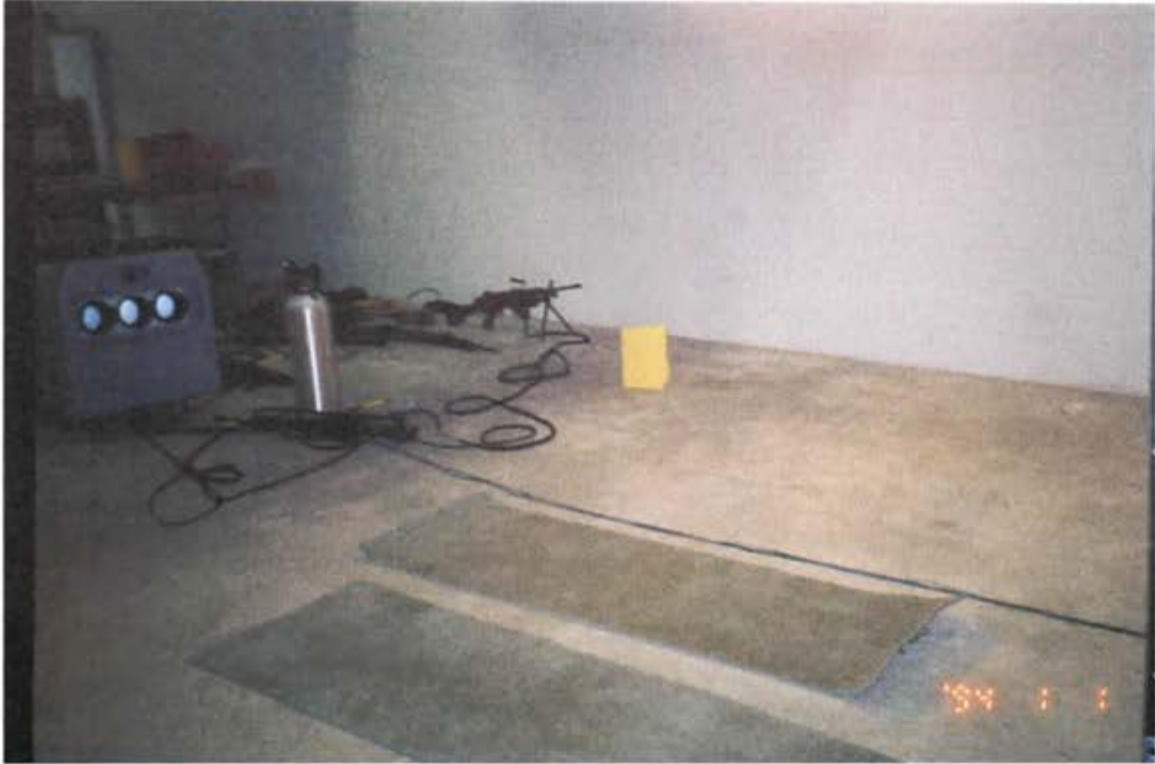
View of Lead wipe sample location #5

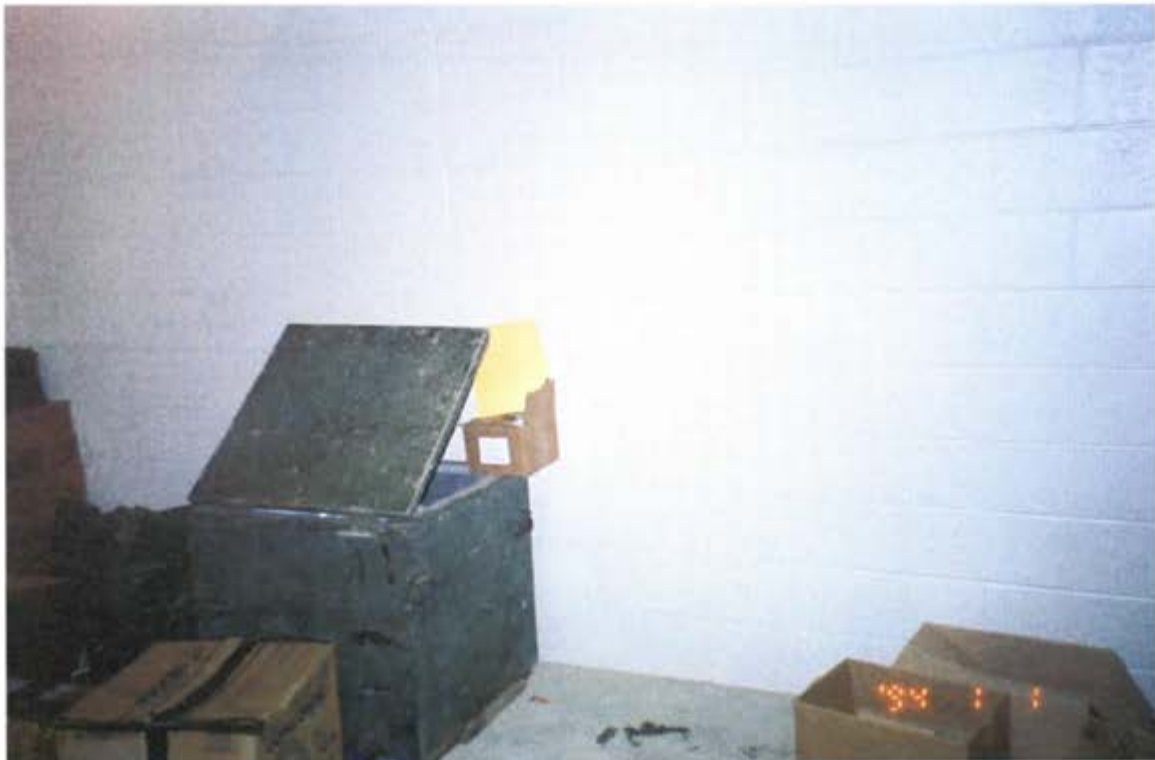
View of lead wipe sample location #6

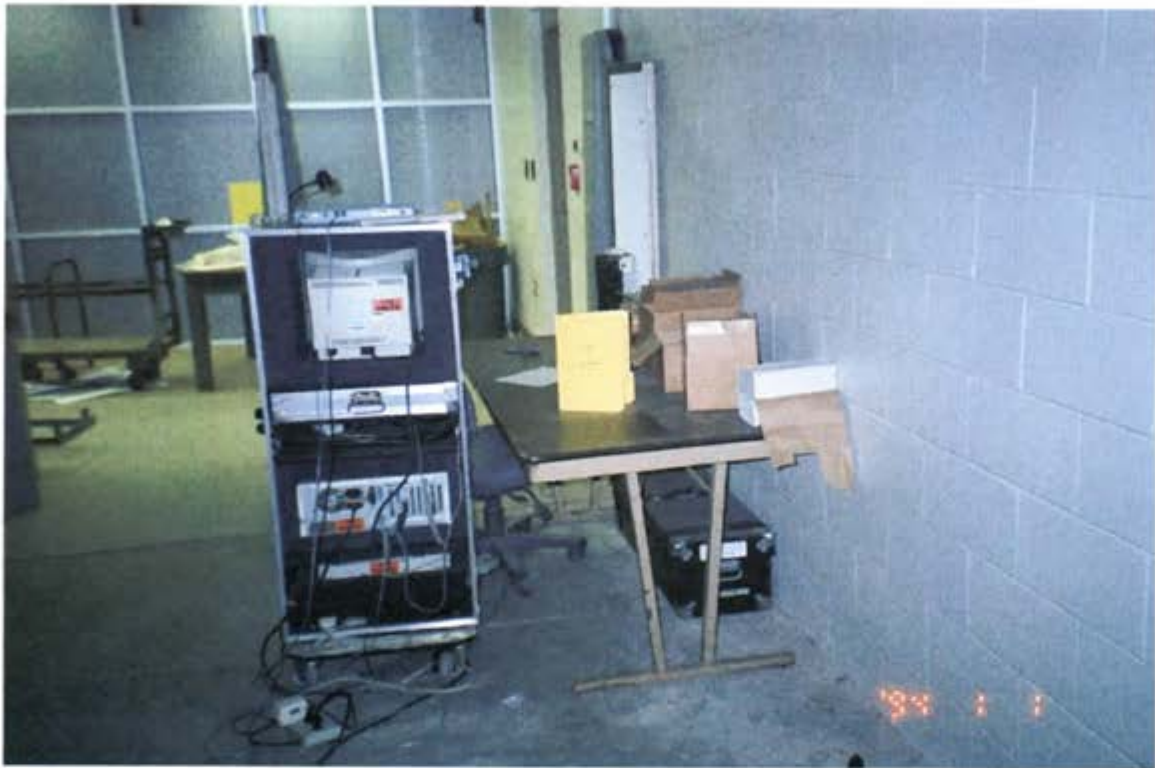
View of Lead wipe sample location #7

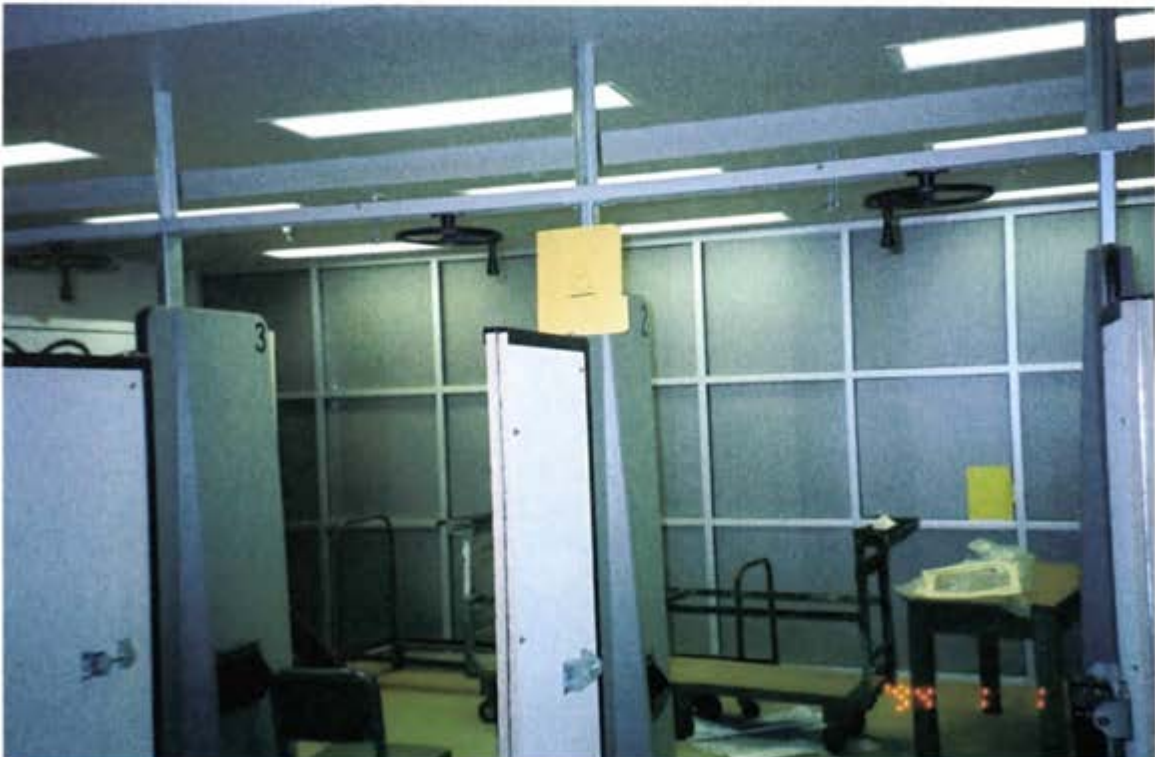
View of Lead wipe sample location #8

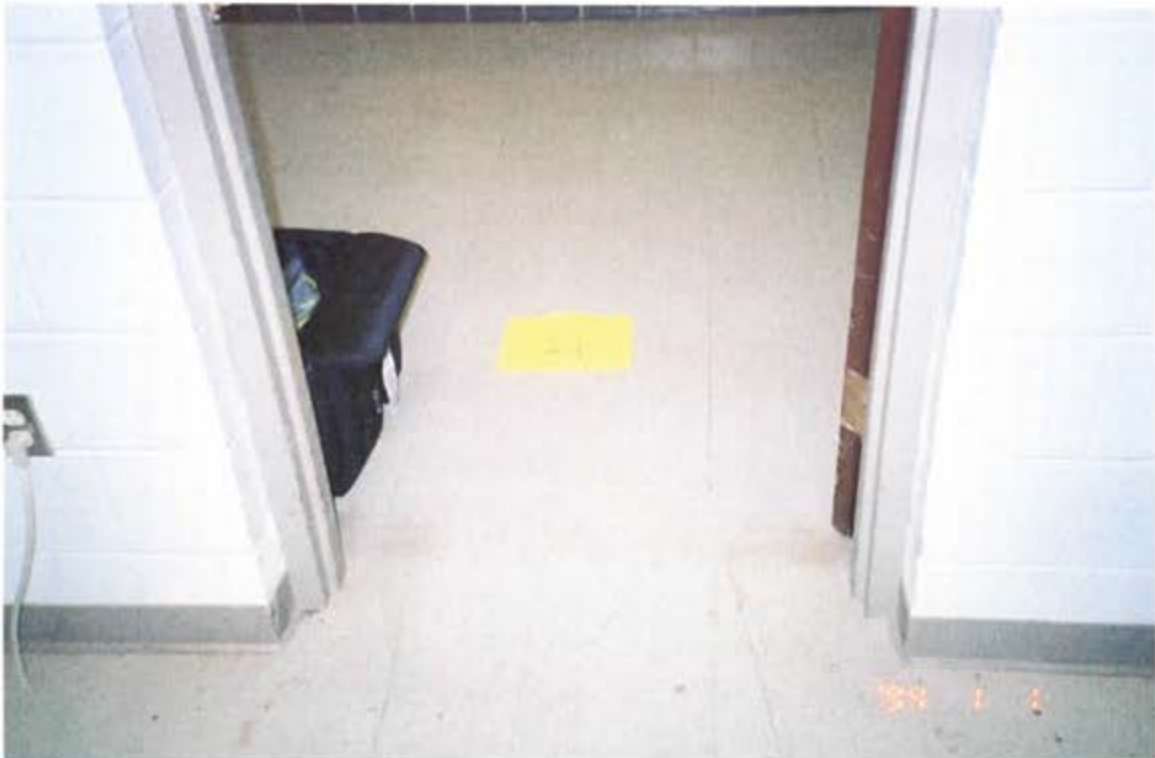
View of Lead wipe sample location #10

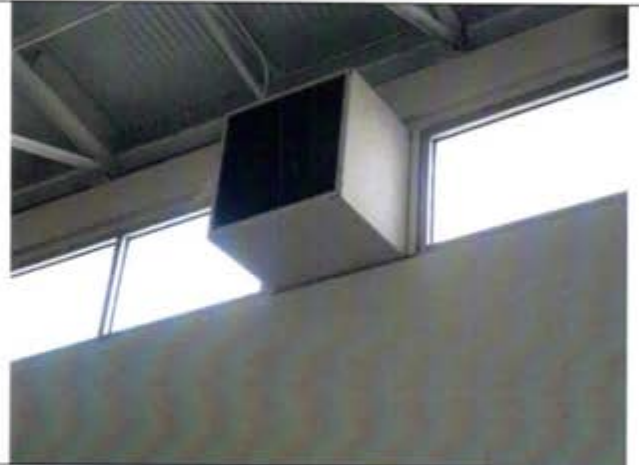
Drill Hall, One OF Six Air Exhaust Ventilators

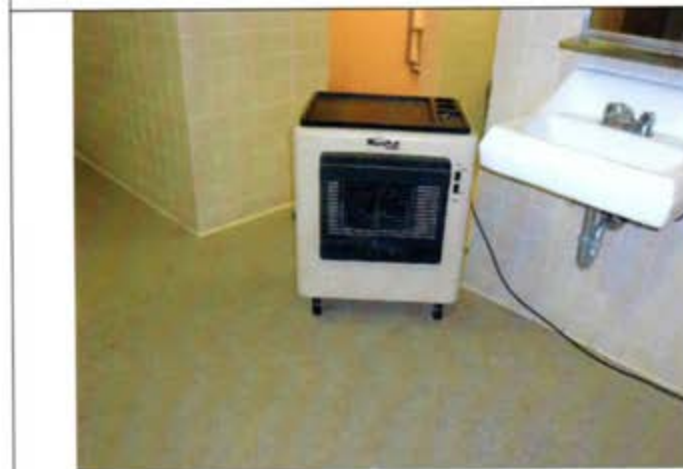
Whisper Cool Unit In Men's Bathroom

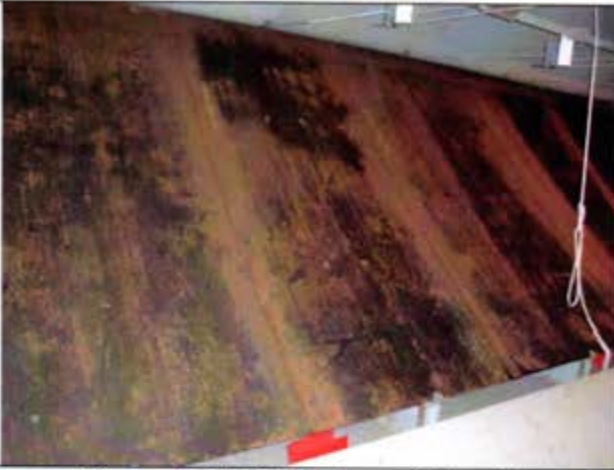
Converted IFR, Backstop Close Up

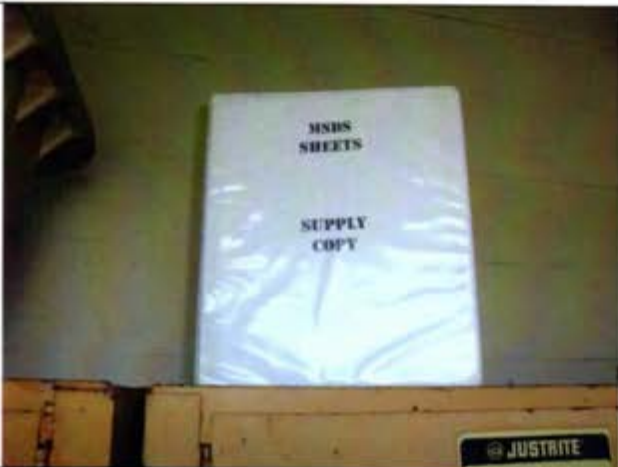
Two Flammables Cabinets Inside POL

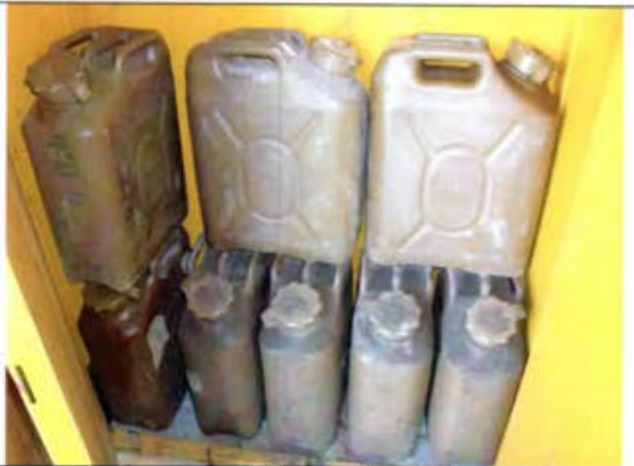
MSDS Book On Top Of Flammables Cabinet

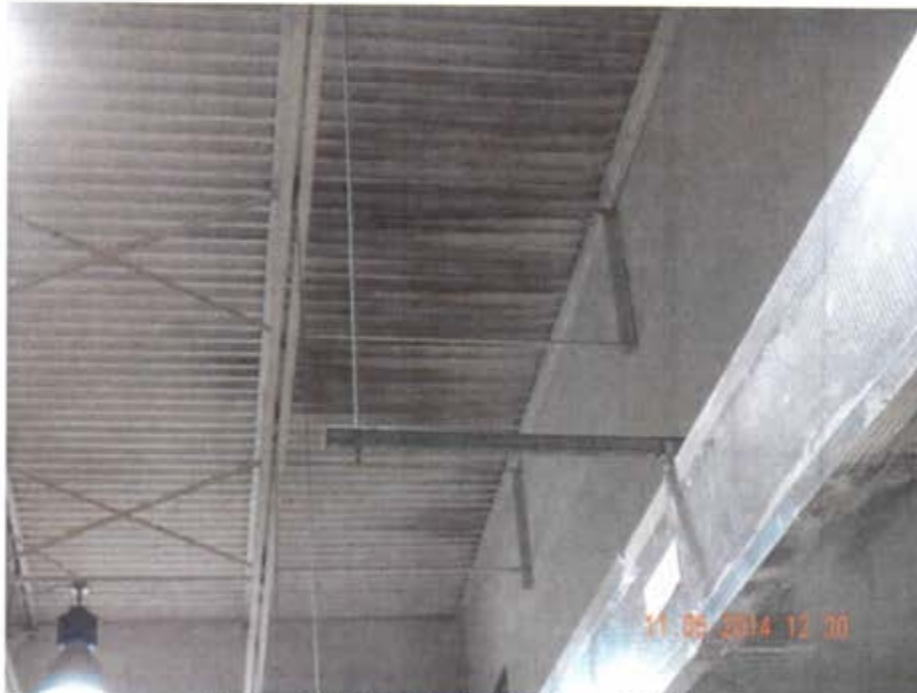
Potential Mold – Drill Floor Ceiling

- c. Control water infiltration in the armory and/or replace or repair damaged surfaces or components (ceiling and floor tiles). Building conditions that present IAQ concerns or problems not only exacerbates normally minor health issues but also tend to promote or accelerate building deterioration.

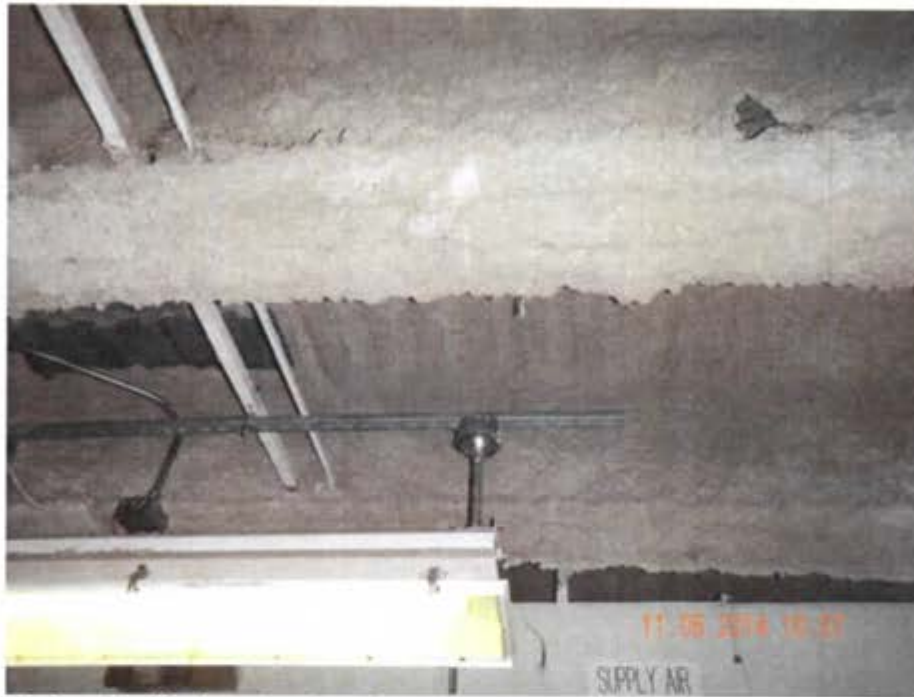
Potential Asbestos Insulation - Test Results were negative

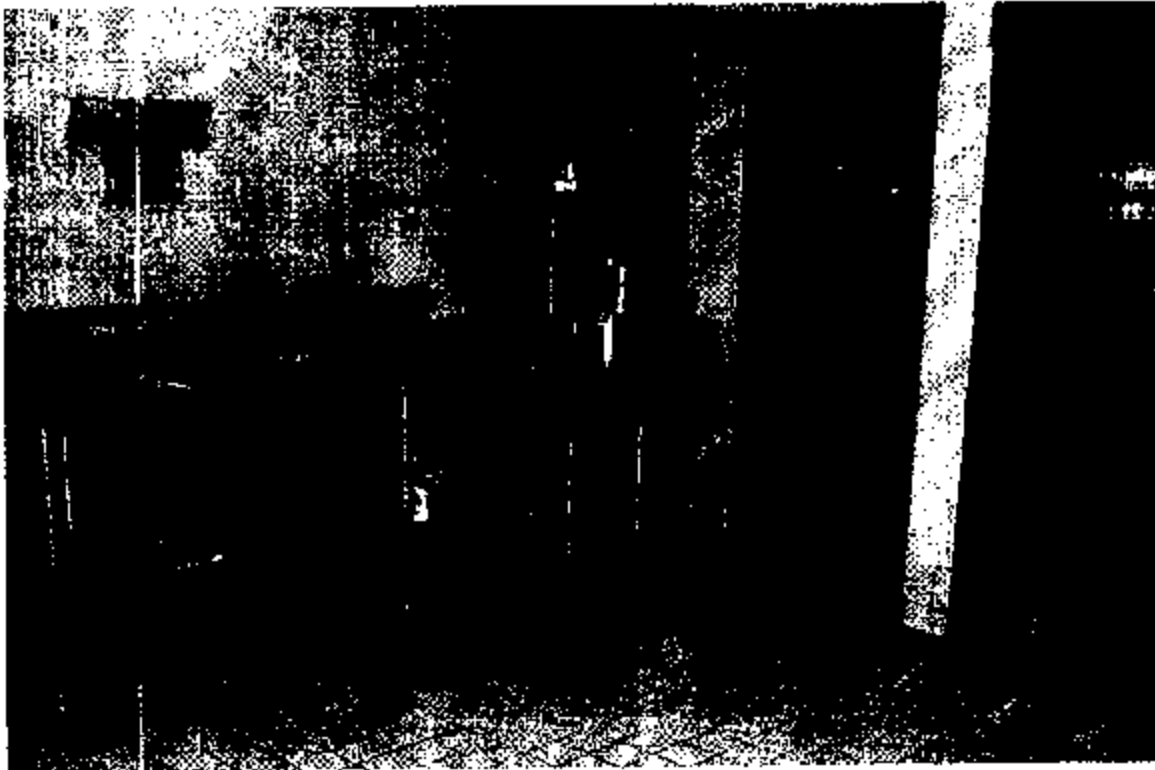
Photo #10: Armory's forced air furnace showing the wooden air plenum.

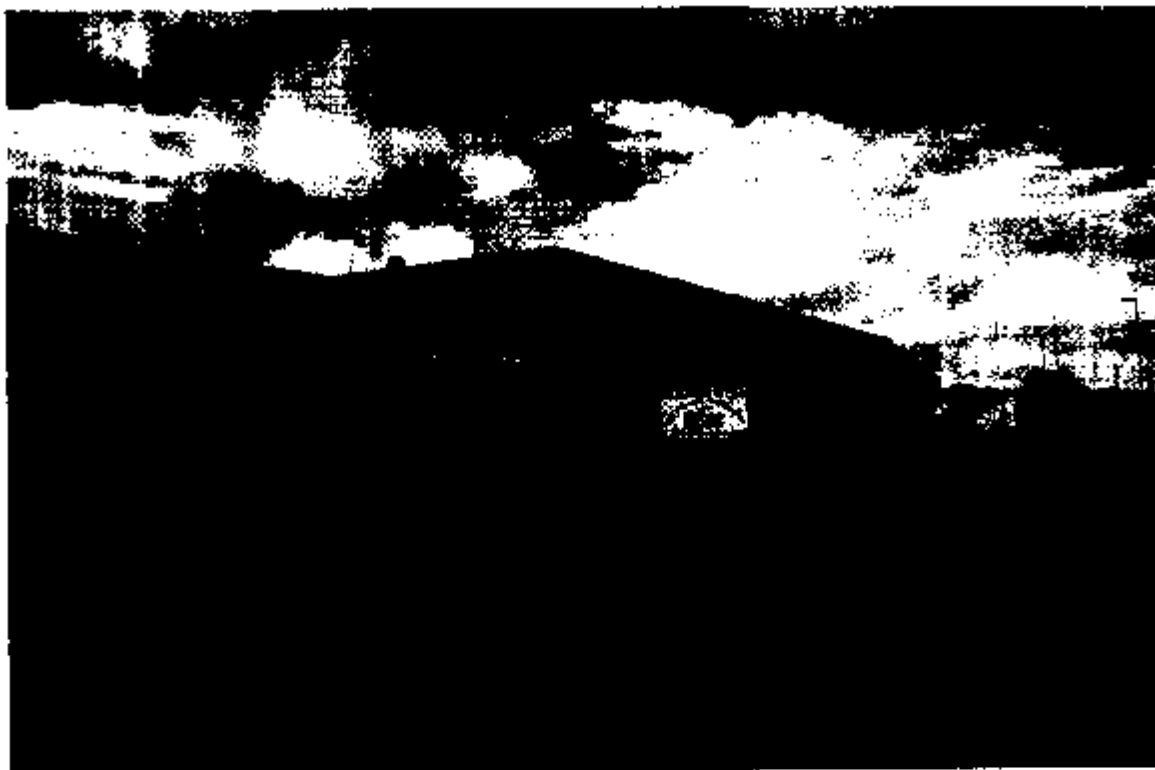
Photo #1: Armory front entrance.

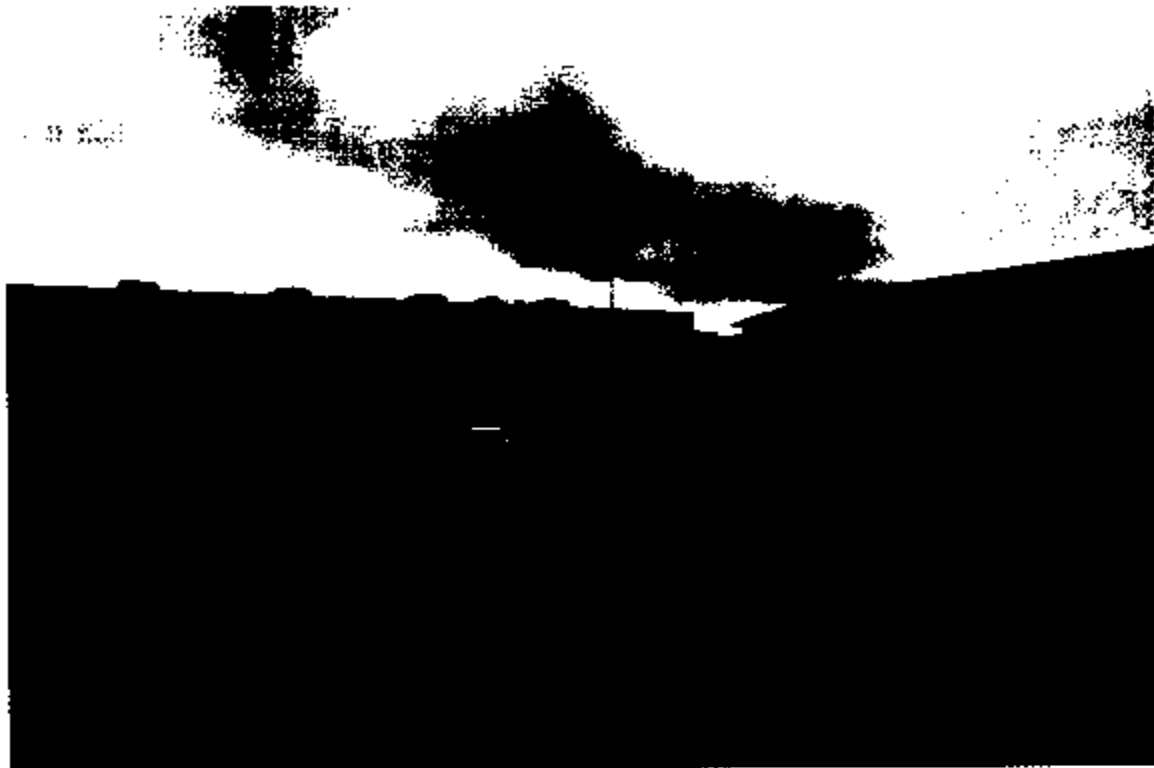
Photo #3: north side of the armory.

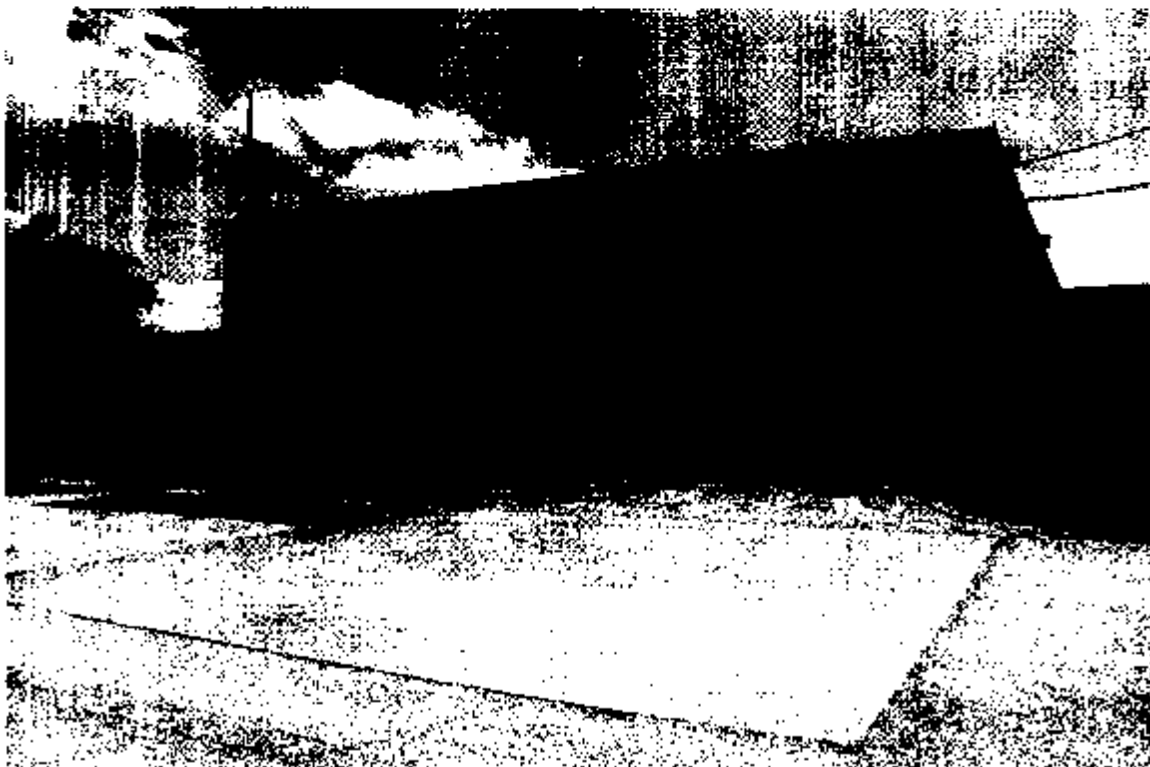
Photo #2: North side of the armory.

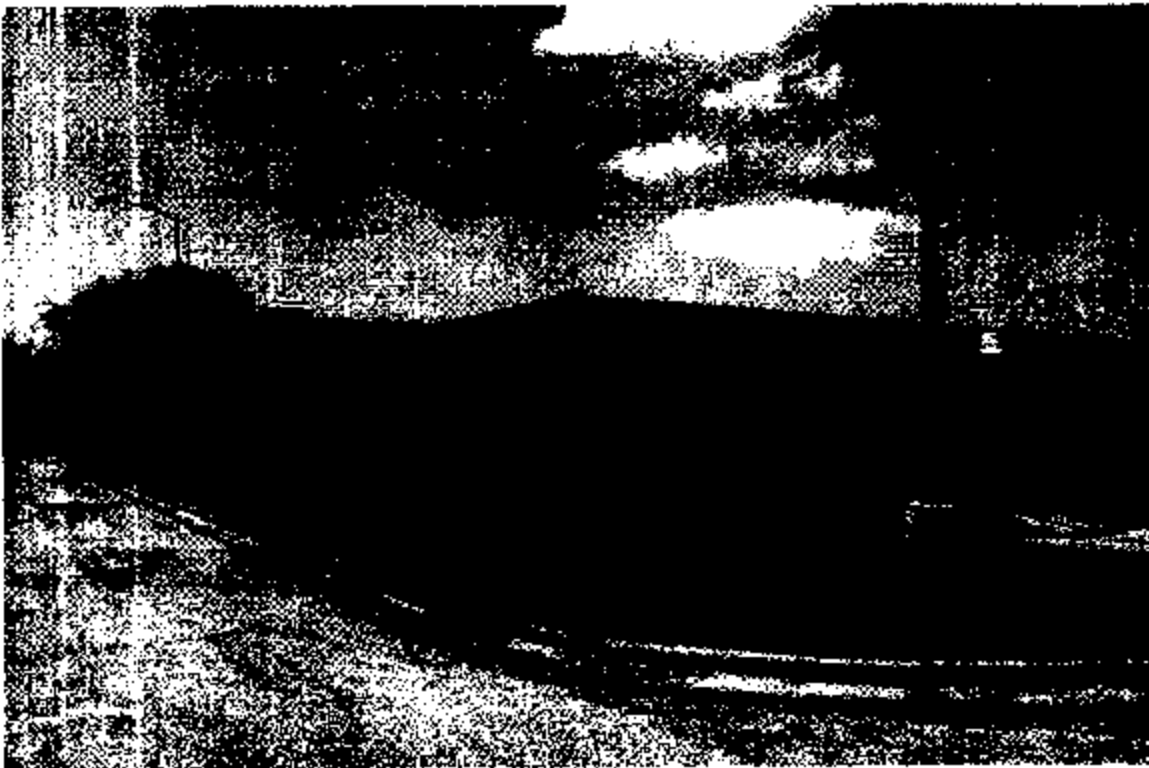
Photo #4: South side of the armory.

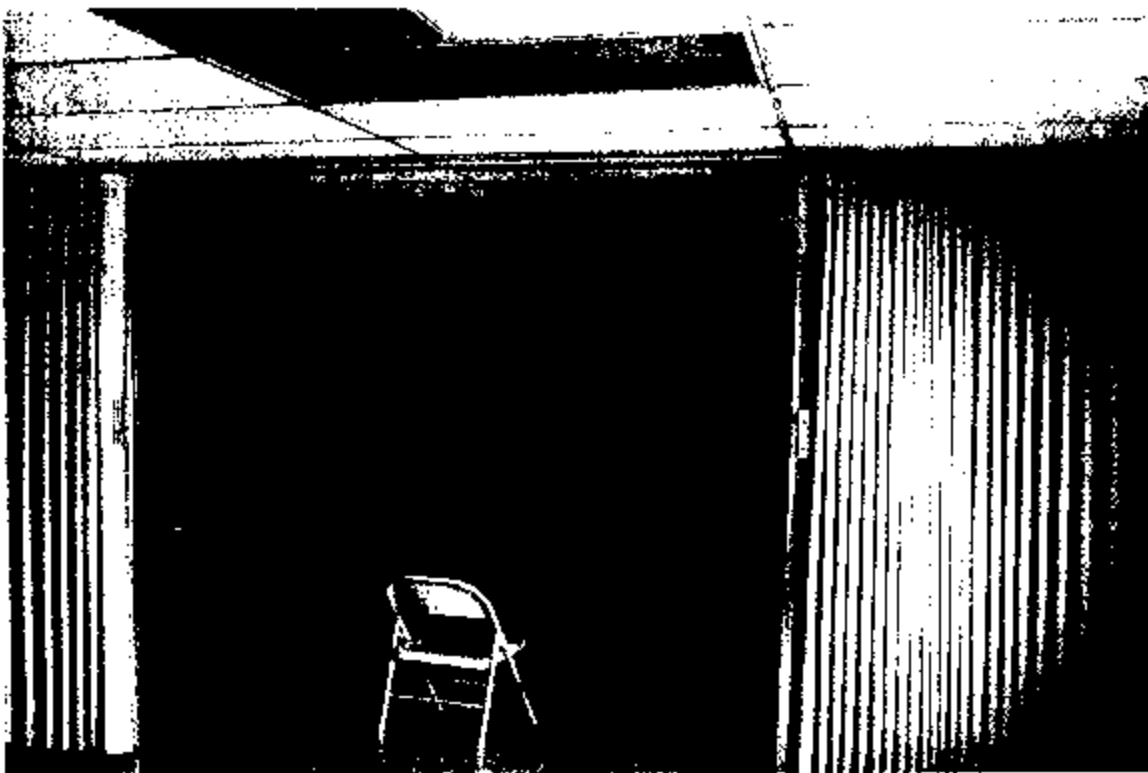
Photo #13: The Armory's classrooms.

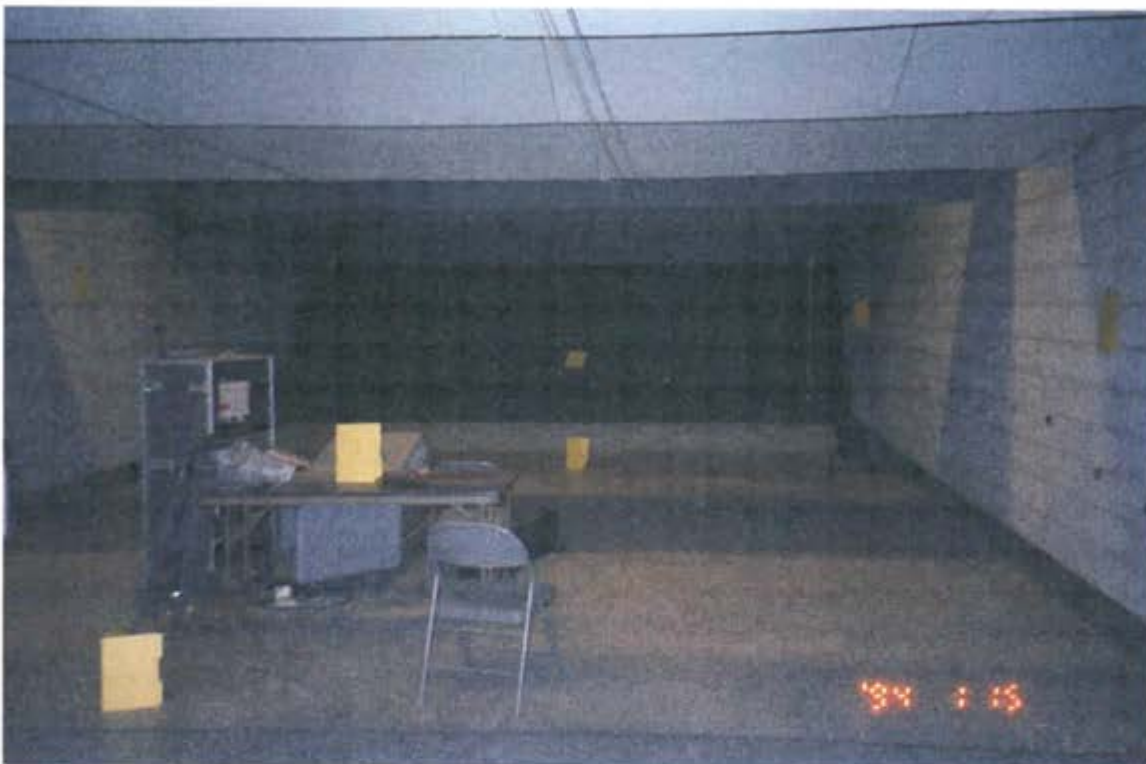
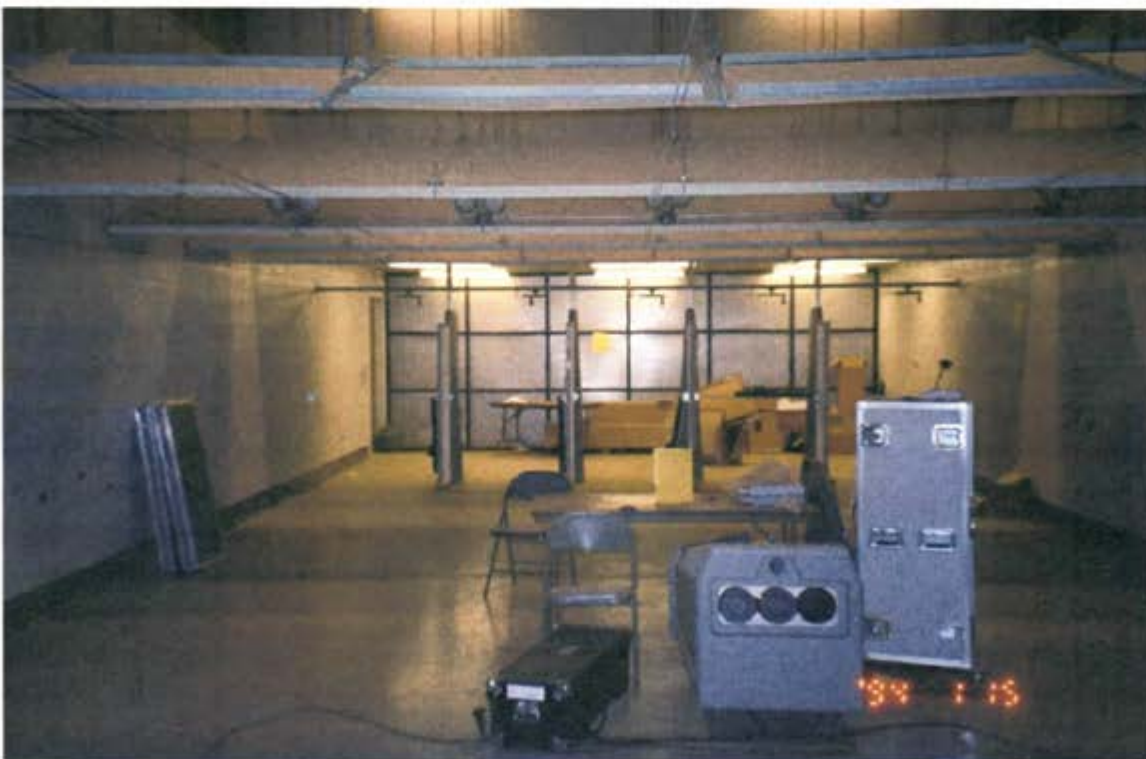
Up and down range views of
the deactivated indoor firing range

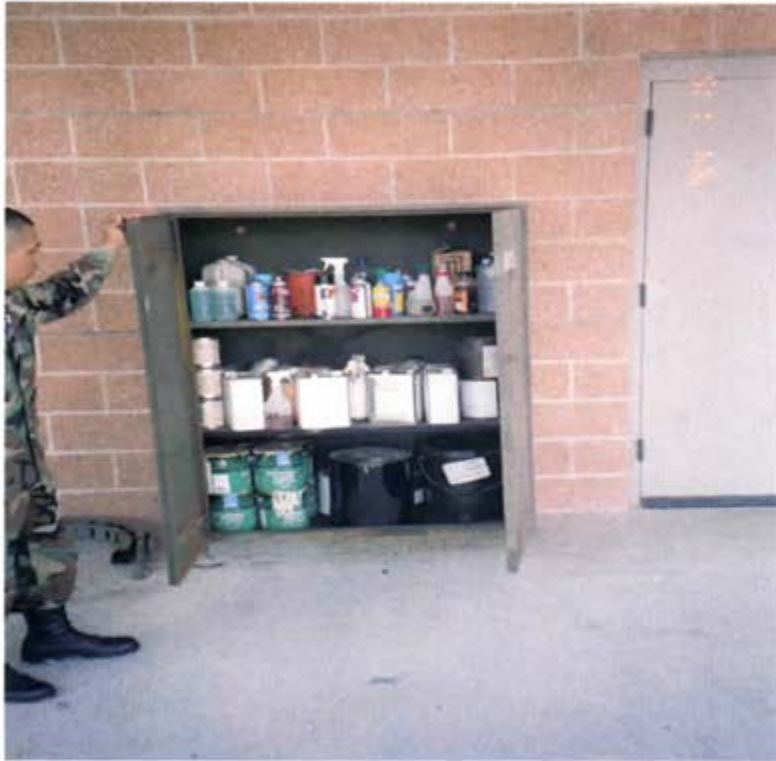
View of Hazardous Material storage cabinet

- a. Place CLP in the original container. If it must be transferred to another container, label the container with the name of the chemical. Produce a Chemical Inventory for the chemicals that are utilized by the Armory. Contact your supply channels to obtain Material Safety Data Sheets for the chemicals on your inventory. Place MSDSs in a location that accessible and known to all Armory personnel (i.e. a wall on the Drill Hall floor) Suggest all Armory personnel obtain education on Hazard Communication. Contact the Texas Occupational Safety and Health Office for assistant on training requirements.

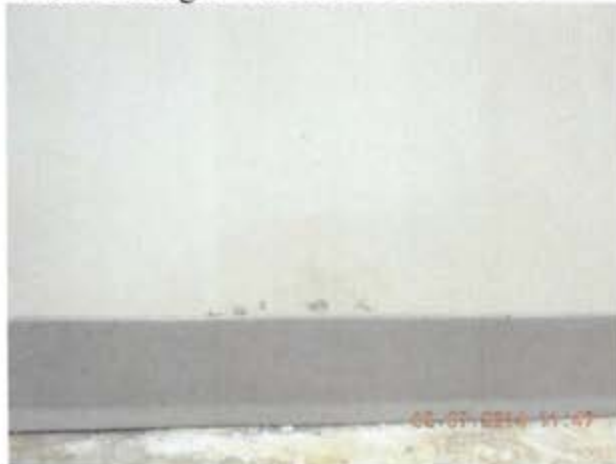
Water-damaged wall in converted IFR

- c. Control water infiltration in the armory and/or replace or repair damaged surfaces or components (ceiling and floor tiles). Building conditions that present IAQ concerns or problems not only exacerbates normally minor health issues but also tend to promote or accelerate building deterioration.
