Industrial Hygiene Site Assistance Visit

American Fork Armory
251 South 200 East
American Fork, UT 84003

SUBJECT: Executive Summary for Industrial Hygiene Site Assistance Visit for the American Fork Armory, 251 South 200 East, American Fork, UT conducted on 28 June 2012.

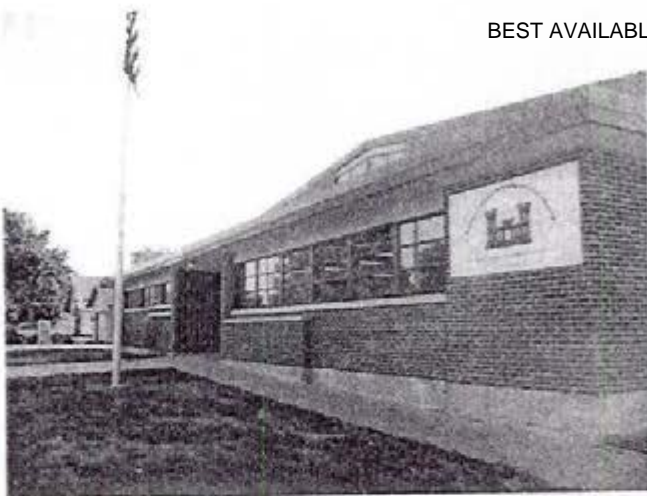
Photograph 1
American Fork Armory, Front, Exterior

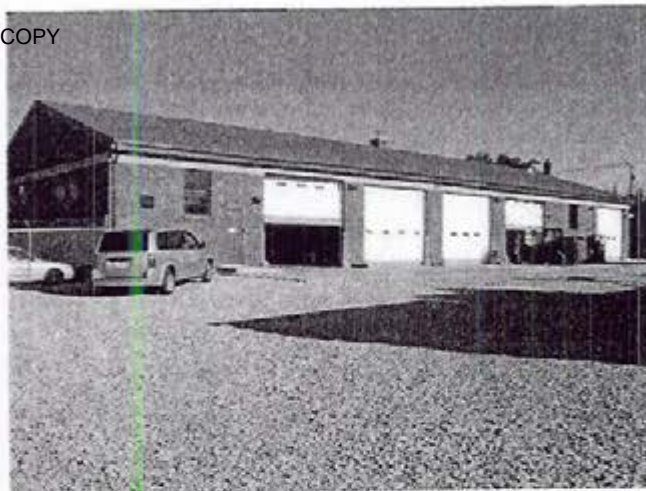
Photograph 2
American Fork Armory, Rear, Exterior

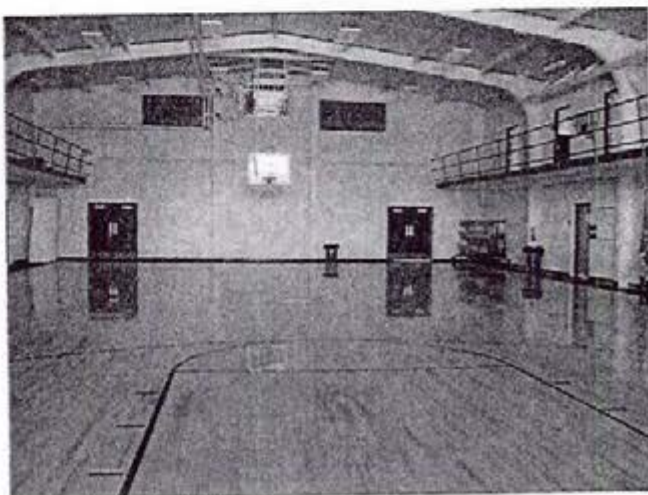
Photograph 3
American Fork Armory, General View, Interior

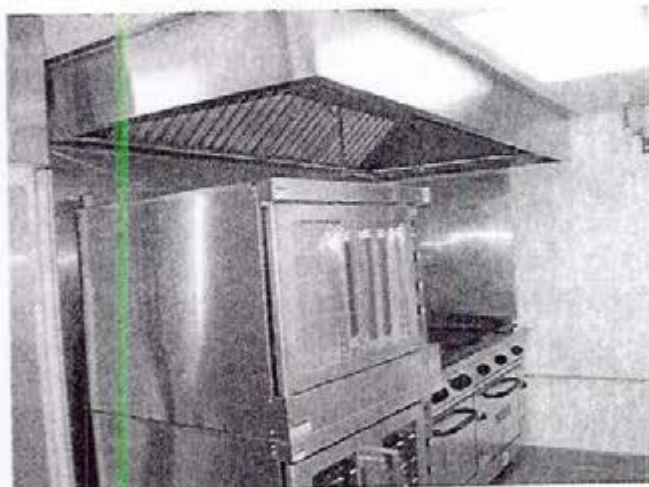
Photograph 6
Kitchen exhaust duct, Interior

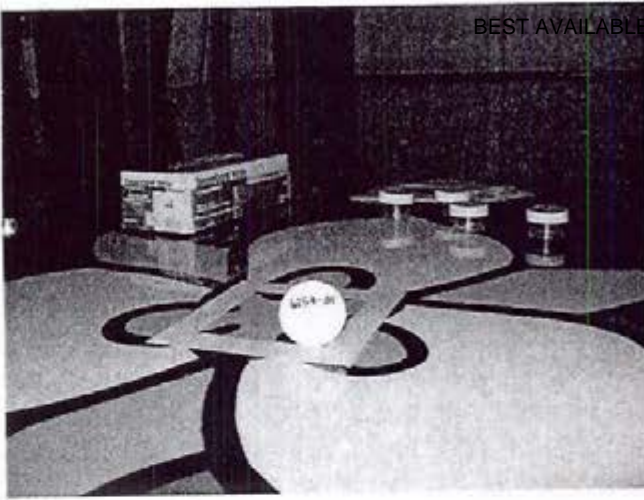
Photograph 7
Location of lead wipe sample number 6154-01

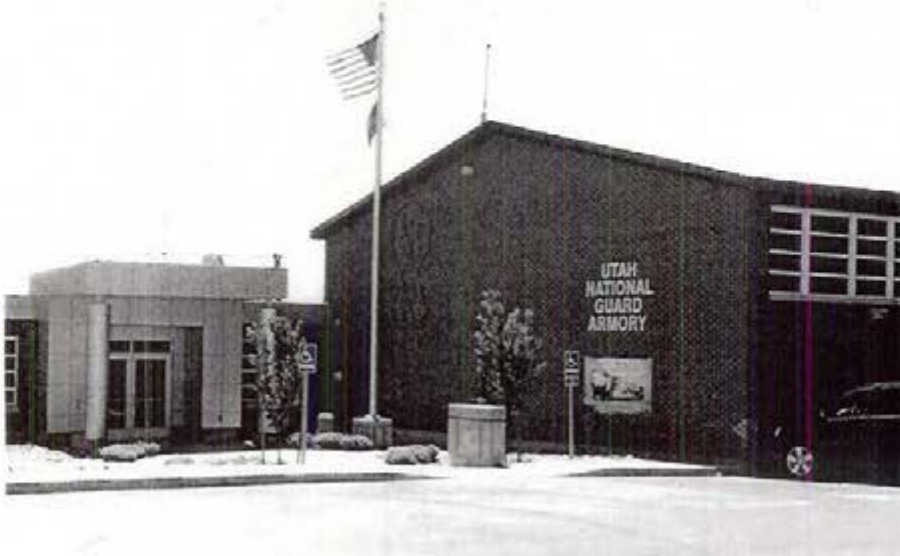
Photo 1: Beaver Readiness Center facility, view to the south.

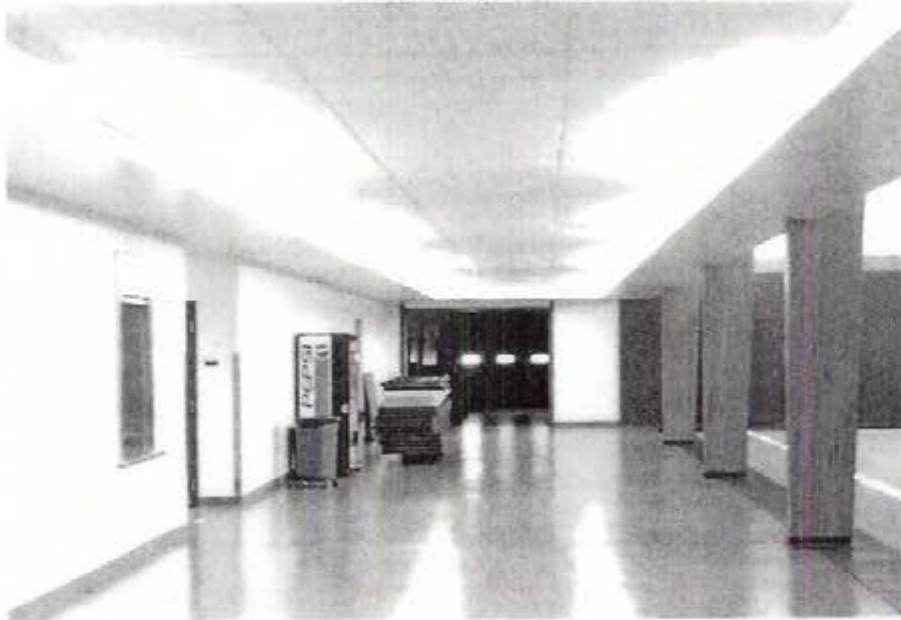
Photo 3: Hallway to the south of the drill floor where the rifle range once was.

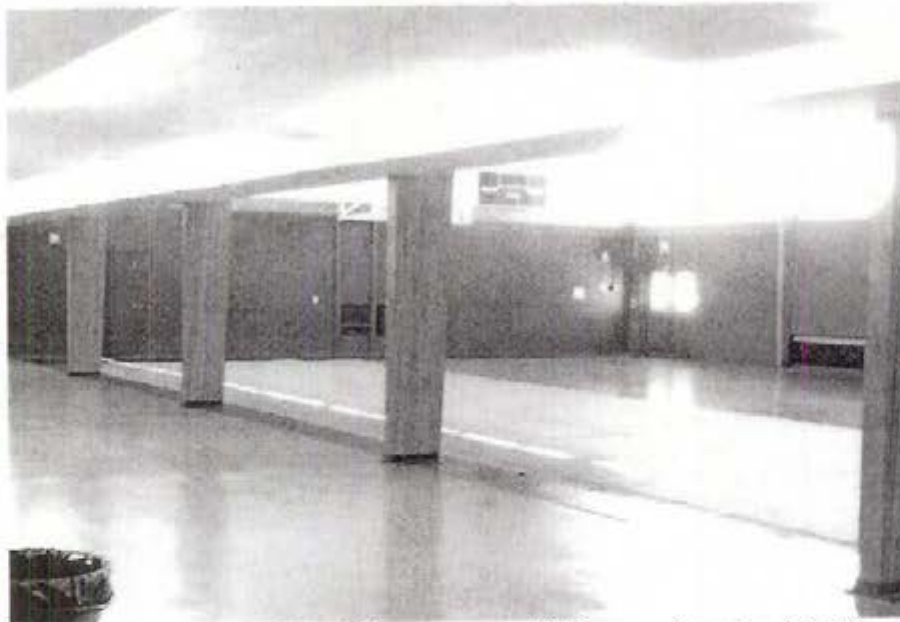
Photo 4: The north side of the converted IFR open into the drill floor; same as the historical layout.

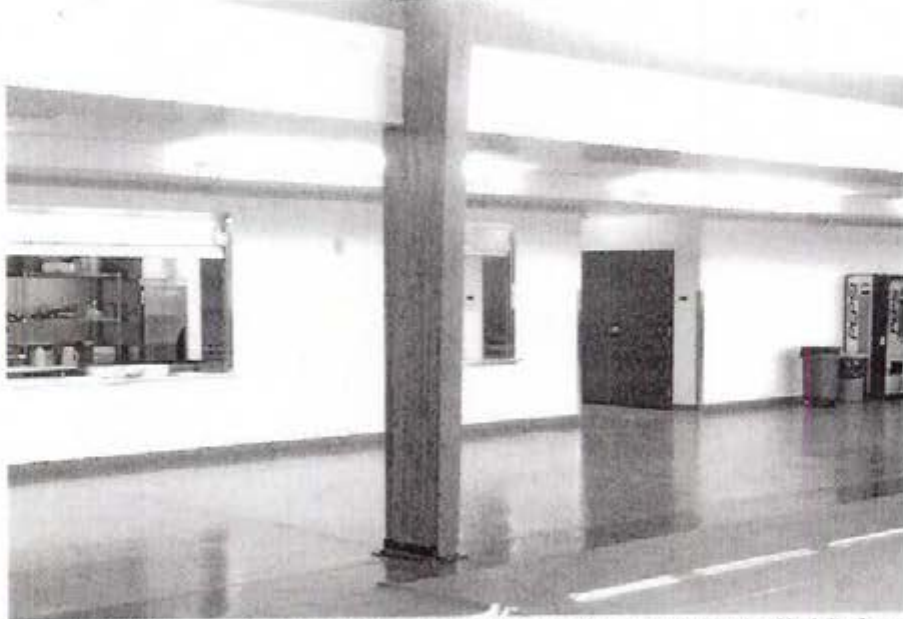
Photo 5: The south side of the converted IFR is a newly built kitchen and classrooms.

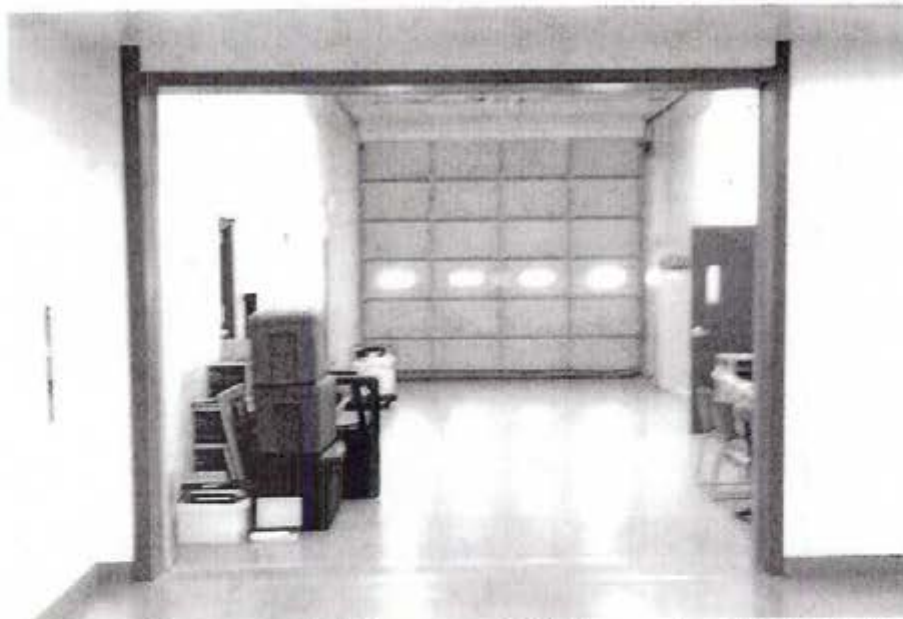
Photo 6: The west end of the converted IFR, now the entrance to the maintenance bay area.

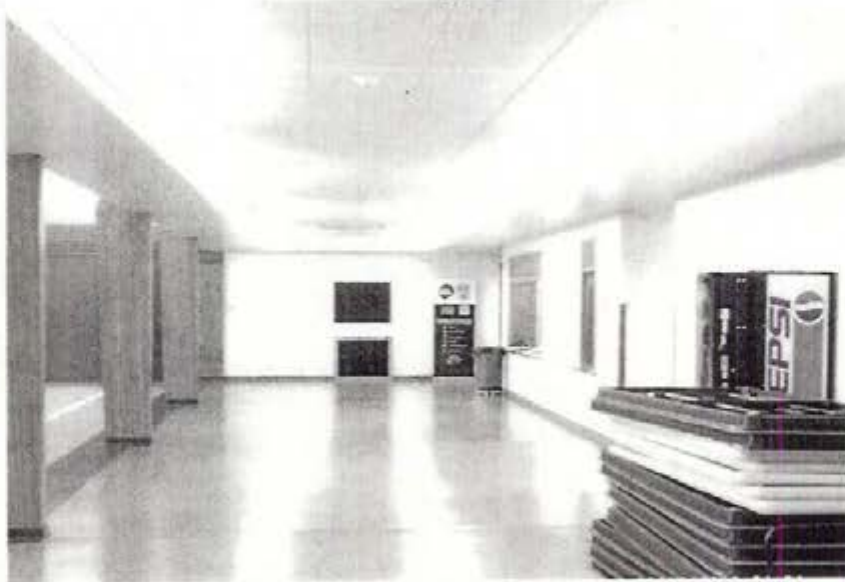
Photo 7: View to the east end of the converted IFR.

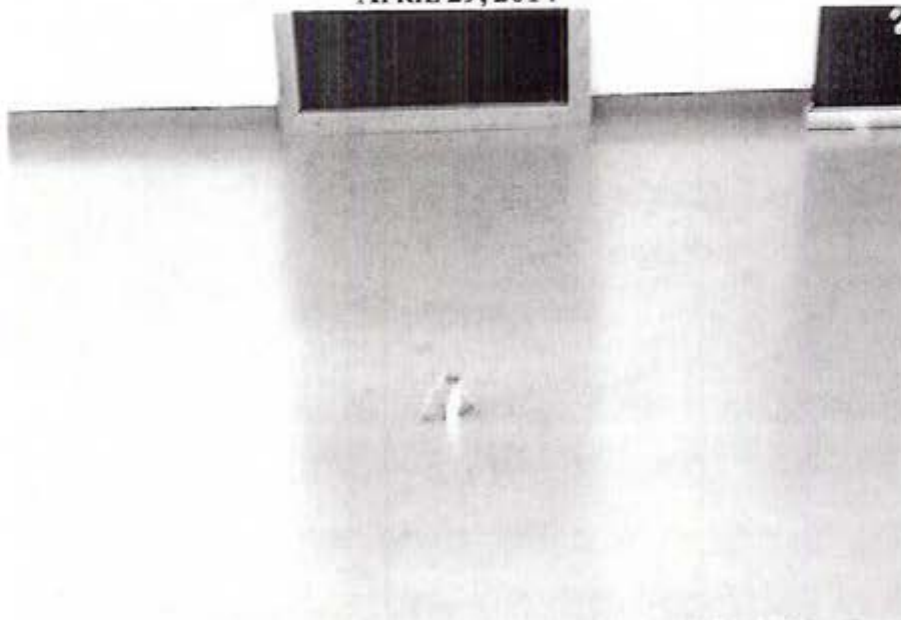
Photo 9: Lead wipe sample (042914-IFRB-W-01) collected from the hallway floor; east end.

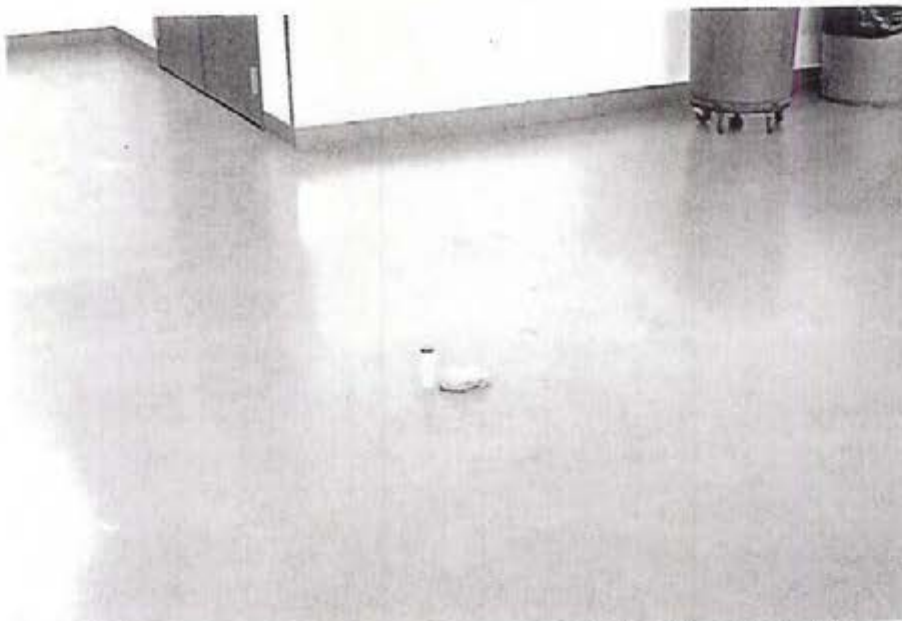
Photo 10: Lead wipe sample (042914-IFRB-W-02) collected from the hallway floor; center.

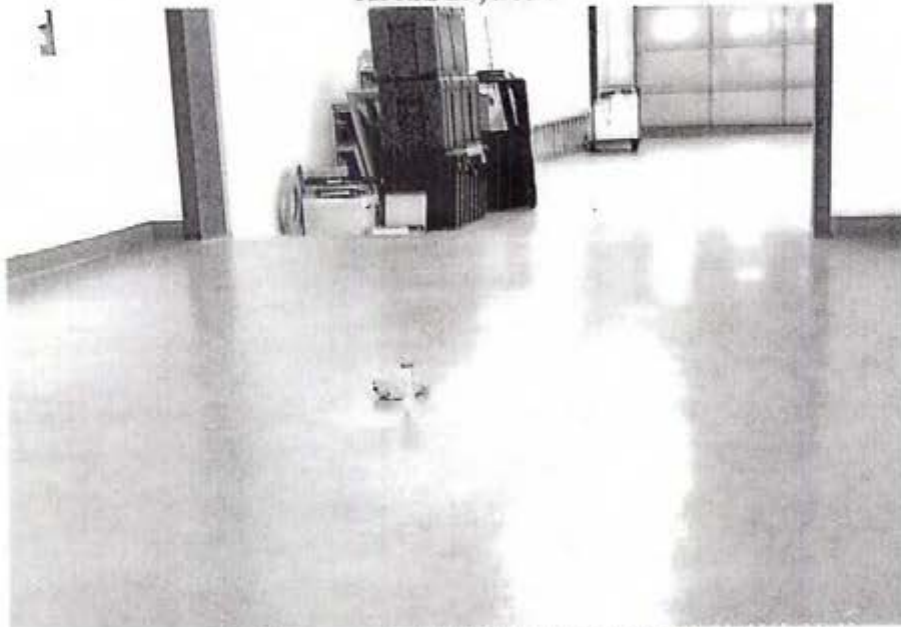
Photo 11: Lead wipe sample (042914-IFRB-W-03) collected from the hallway floor; west end.

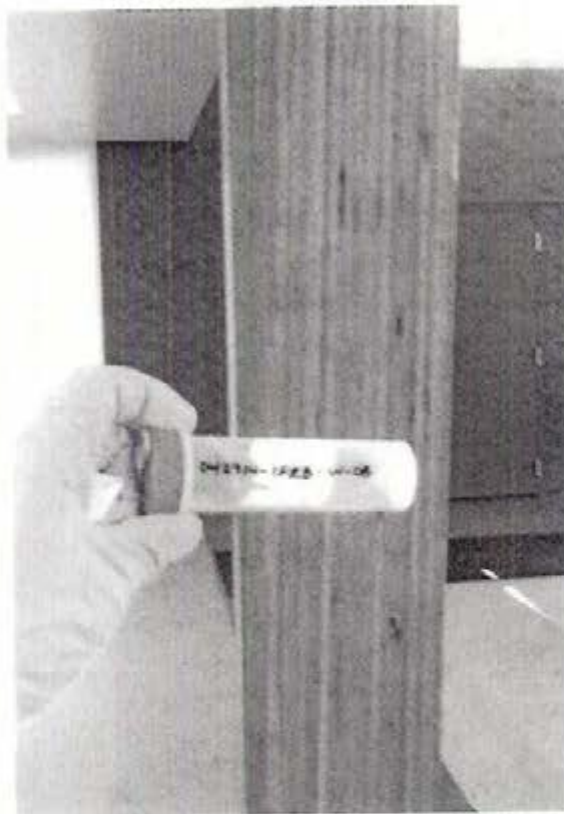
Photo 16: Lead wipe sample (042914-IFRB-W-08) collected from a vertical wood column; west end of hallway.

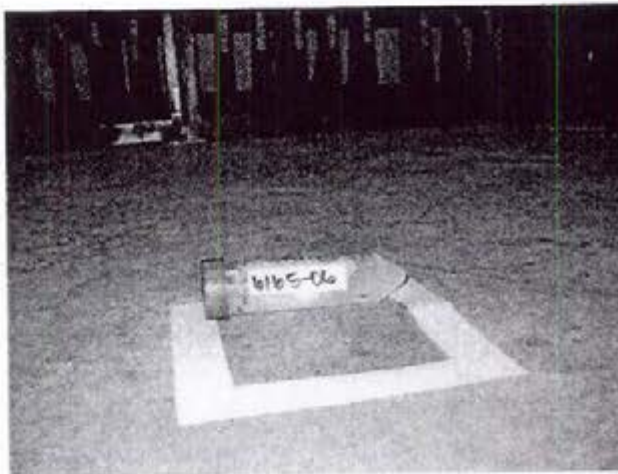
Photograph 15
Location of lead wipe sample number 6165-06

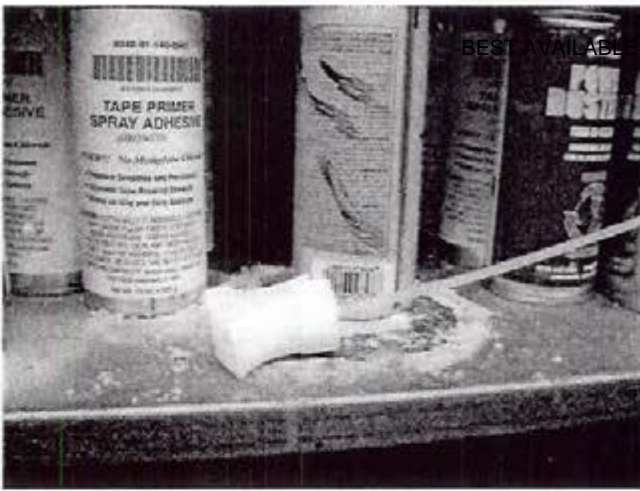
Photograph 7
Chemical spill in flammable cabinet

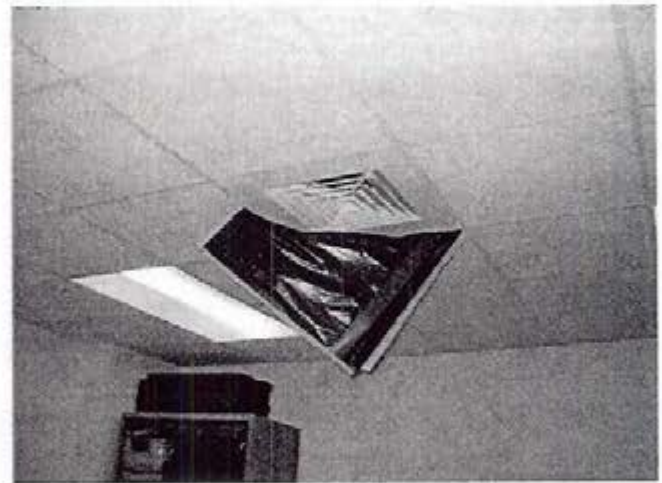
Photograph 12
Vents covered due to cold air blowing in during winter

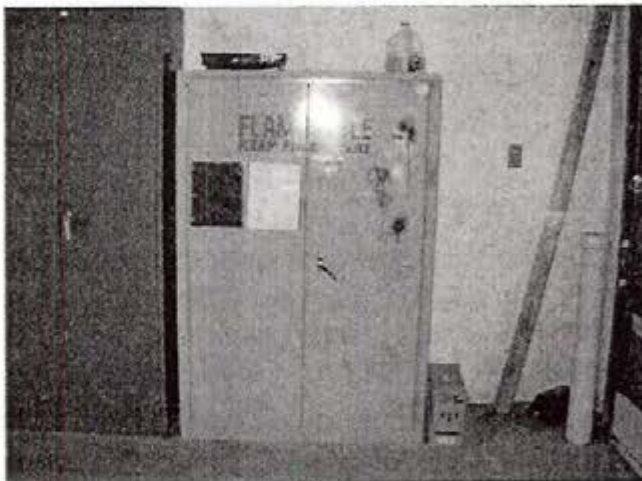
Photograph 5
Flammable cabinet closed

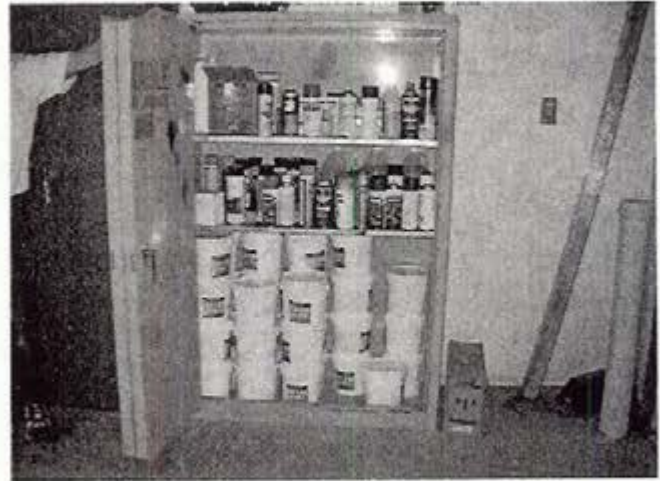
Photograph 6
Flammable cabinet open

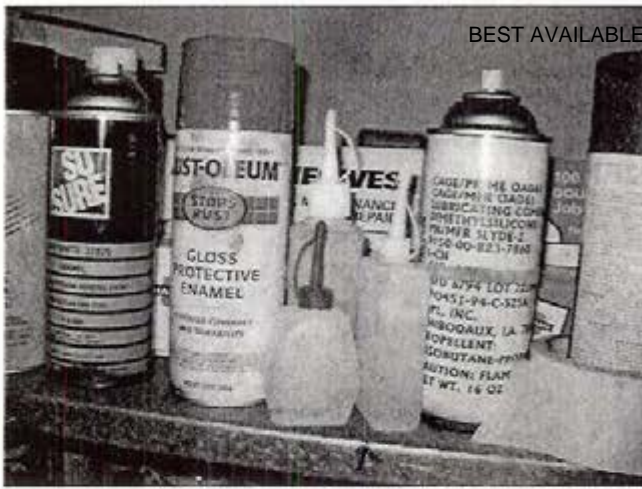
Photograph 7
Unmarked chemicals in flammable cabinet

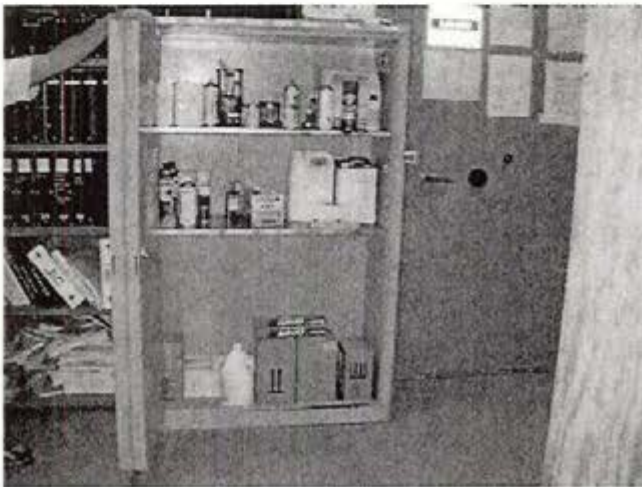
Photograph 9
Flammable cabinet open

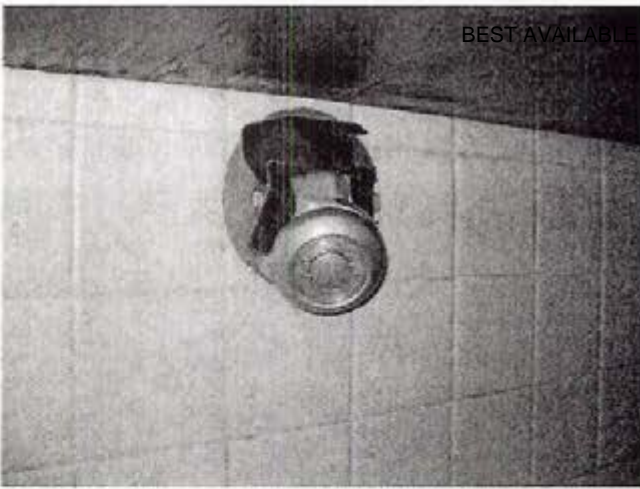
Photograph 13
Exposed wiring in breakroom

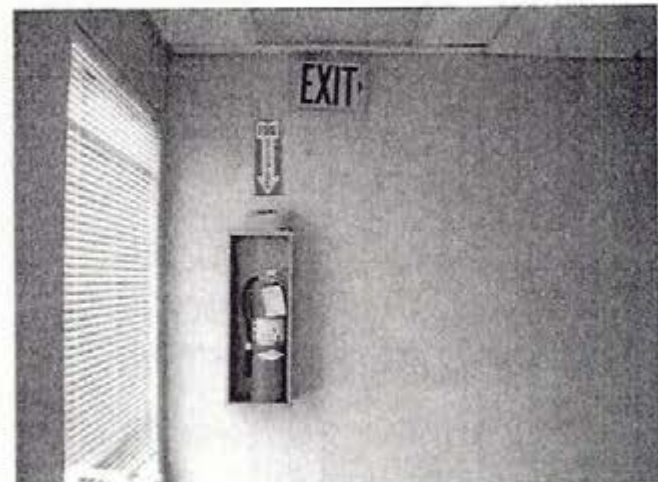
Photograph 6
Fire extinguishers without monthly or annual inspections and Egress signs not working

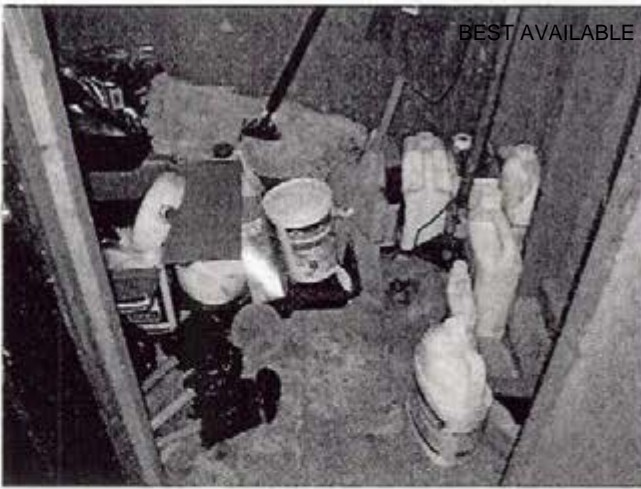
Photograph 7
Chemicals without MSDSs or Chemical Inventory

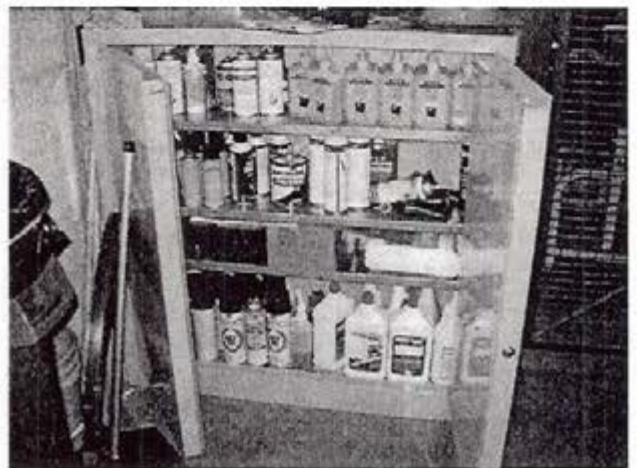
Photograph 9
Flammable Storage Cabinet closed

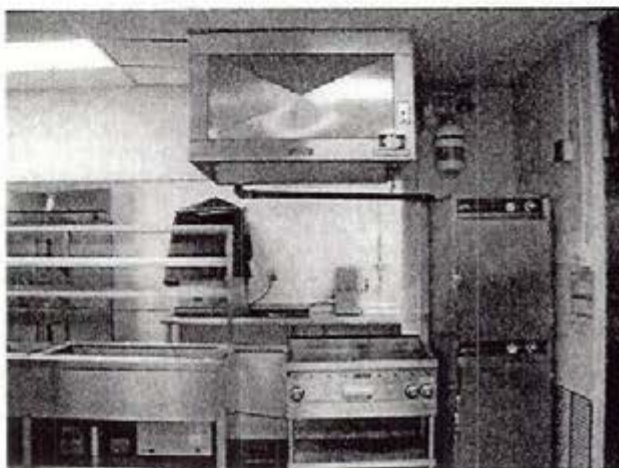
Photograph 14
Hood over stoves and oven
