Army National Guard Armory Survey **(To Be Included In Report)**

Summary of Recommendations for UTARNG
Camp Williams Readiness Center, Riverton, Utah

INDUSTRIAL HYGIENE ASSISTANCE VISIT CEDAR CITY ARMORY CEDAR CITY, UTAH

**Industrial Hygiene Site Assistance Visit
Draper / IFR
Draper, UT
April 24, 2014**

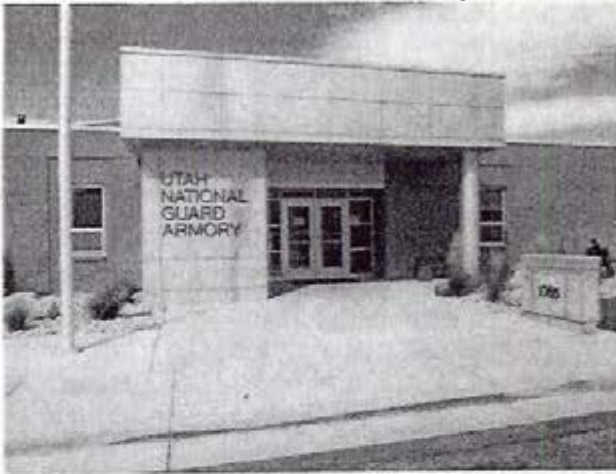
Photograph 1
Cedar City, Utah Armory, front entrance, exterior

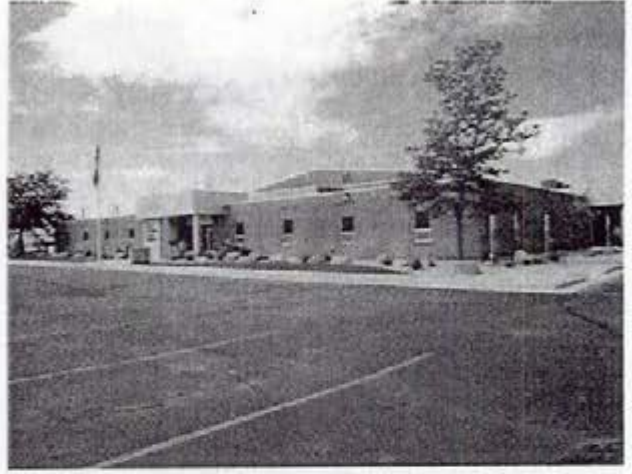
Photograph 2
Cedar City, Utah Armory, front view, exterior

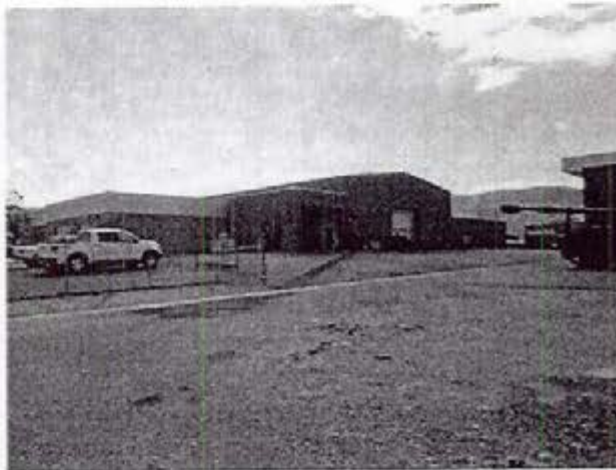
Photograph 3
Cedar City, Utah Armory, rear view, exterior,
showing former range at open door to
maintenance bay

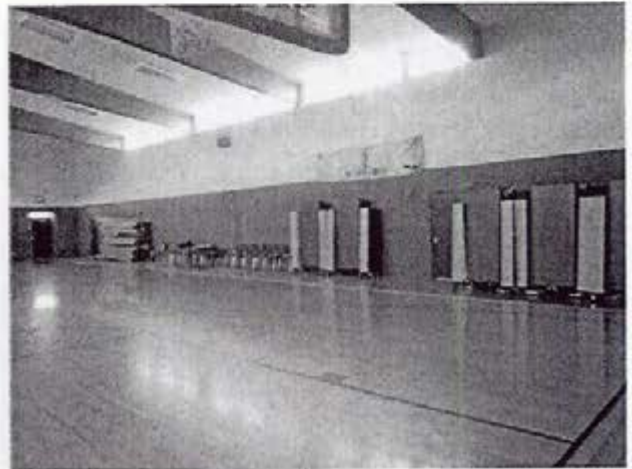
Photograph 4
Drill hall floor with door leading to former indoor
firing range

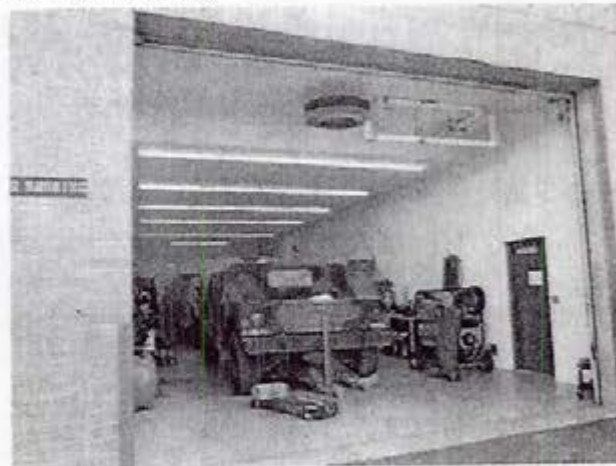
Photograph 5
Exterior entrance to maintenance bay where
firing line of former indoor firing range was
located

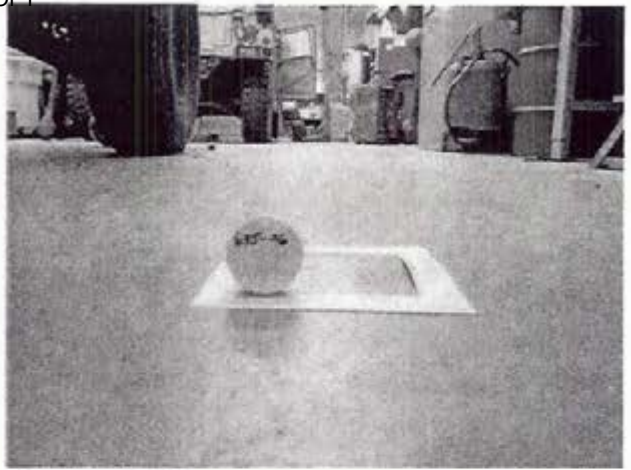
Photograph 8
Sample location 635-06, floor, firing line area of former IFR (painted concrete)

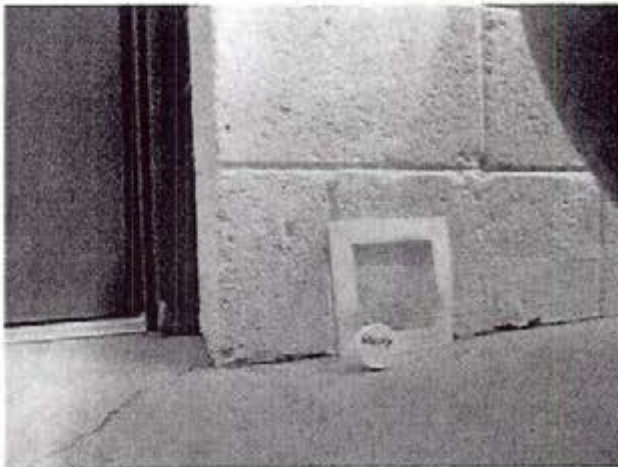
Photograph 9
Sample location 635-07, former shooting line area wall (painted concrete block)

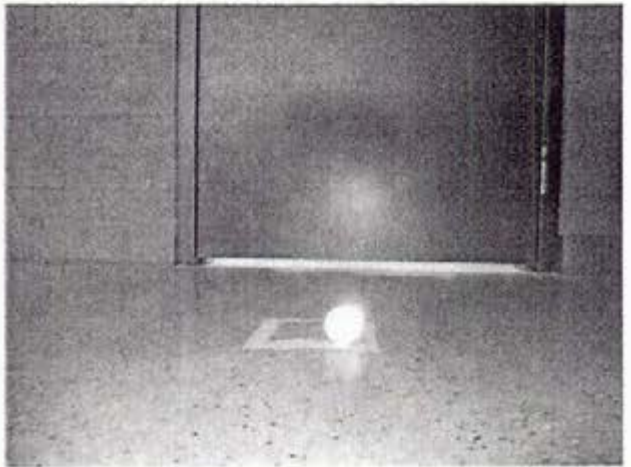
Photograph 10
Sample location 635-08, interior entrance to former IFR leading to the work site office area

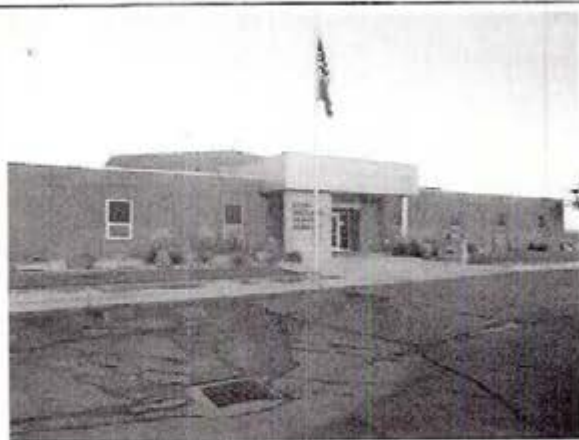
Photo #1 – Cedar City Armory

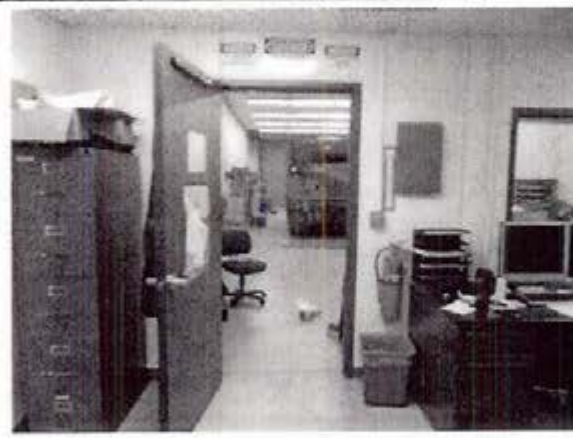
Photo #12 –CIFR

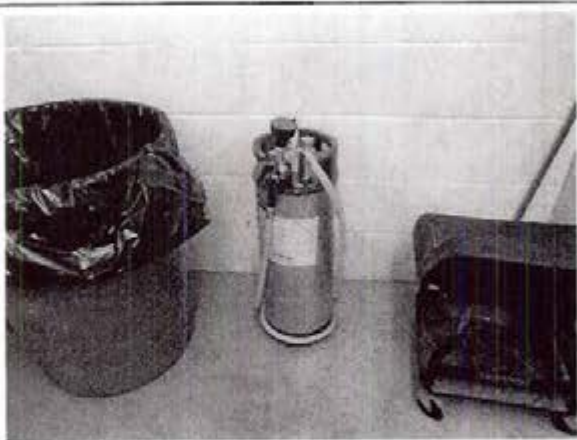
Photo #13 – Eye wash

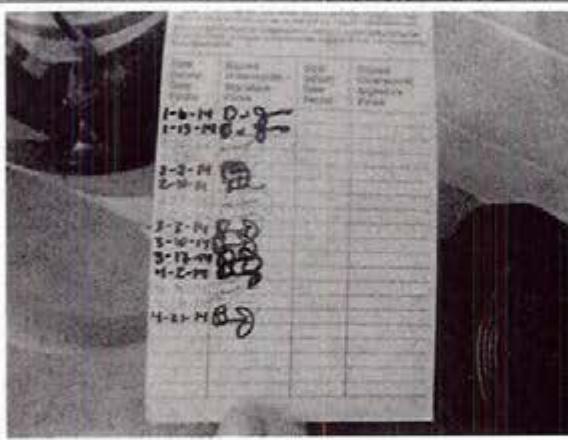
Photo #14- Eye wash weekly tags

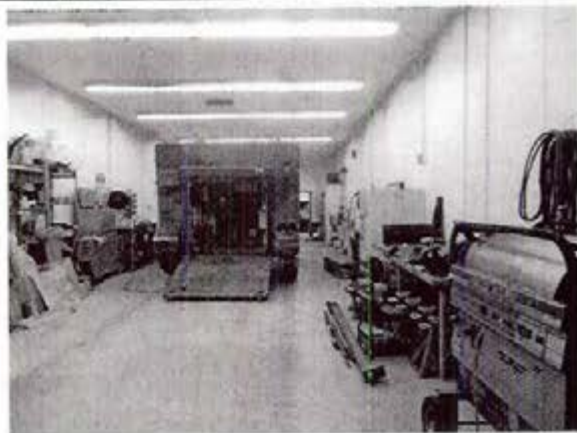
Photo #15- Maintenance shop

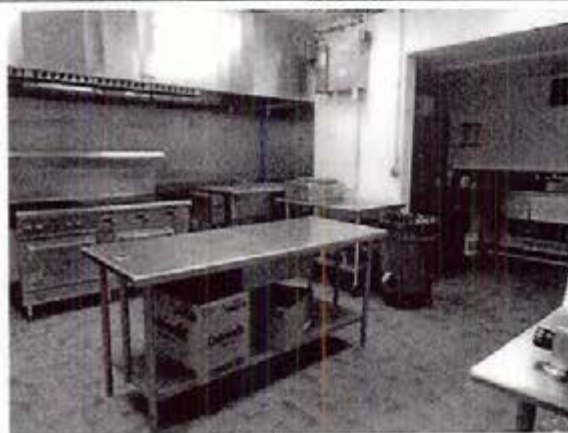
Photo #16- Kitchen

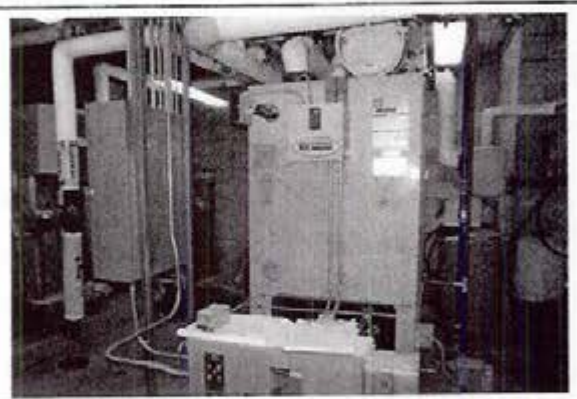
Photo #17 –Mech/Electrical

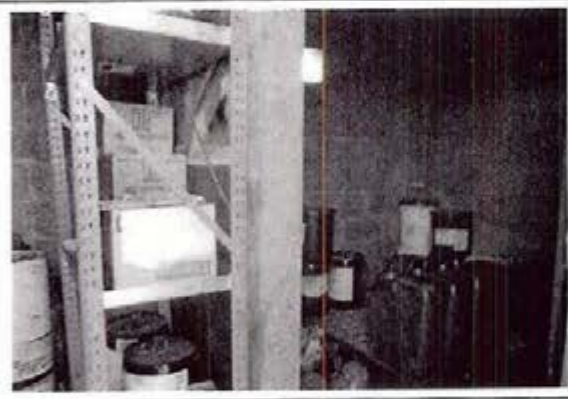
Photo #18 – POL shed

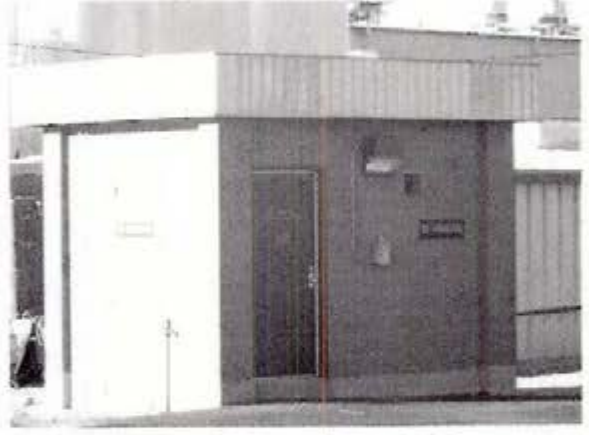
Photo #20-Outside POL shed

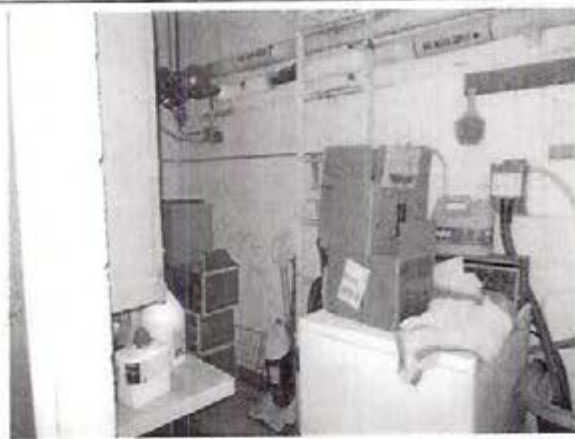
Photo #21-Janitorial closet

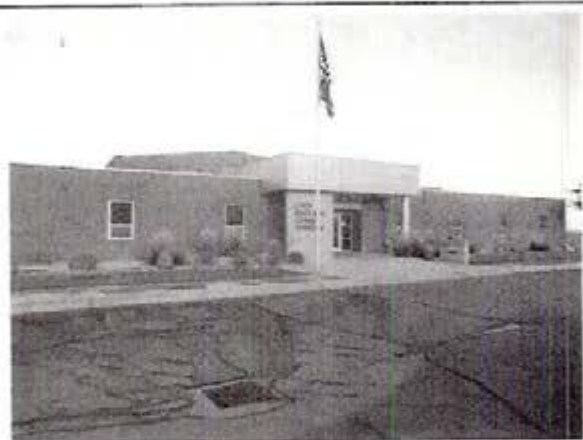
Photo #1 – Cedar City Armory

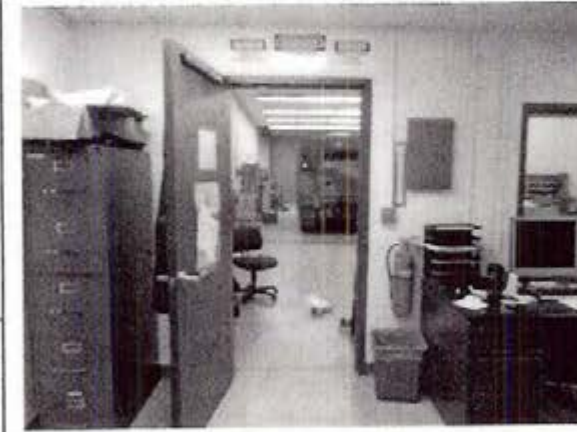
Photo #12 –CIFR

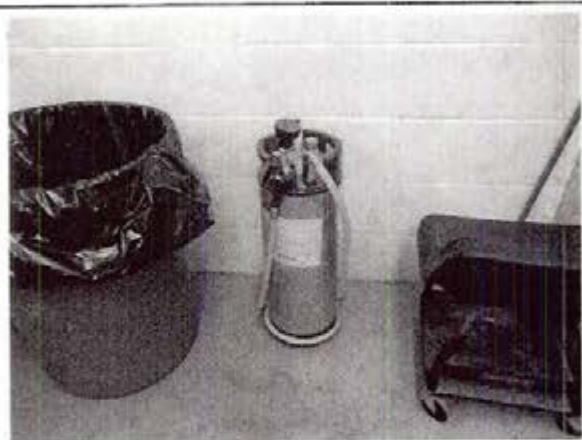
Photo #13 – Eye wash

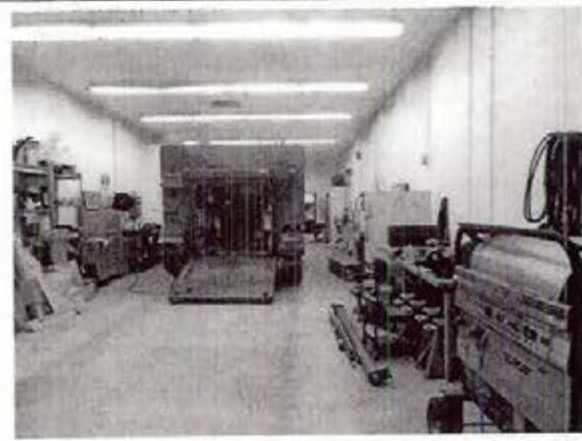
Photo #15- Maintenance shop

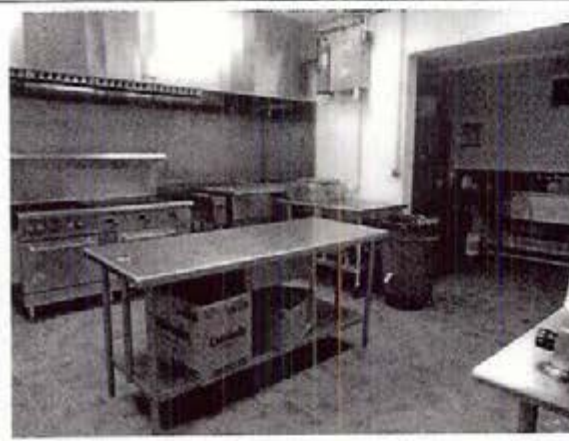
Photo #16- Kitchen

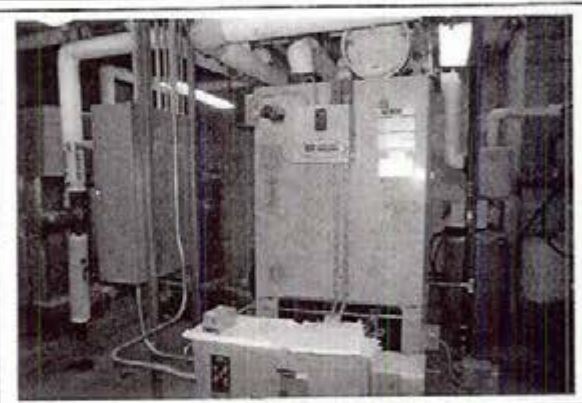
Photo #17 –Mech/Electrical

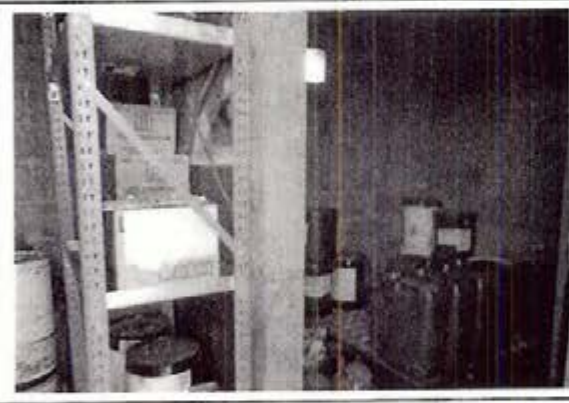
Photo #18 – POL shed

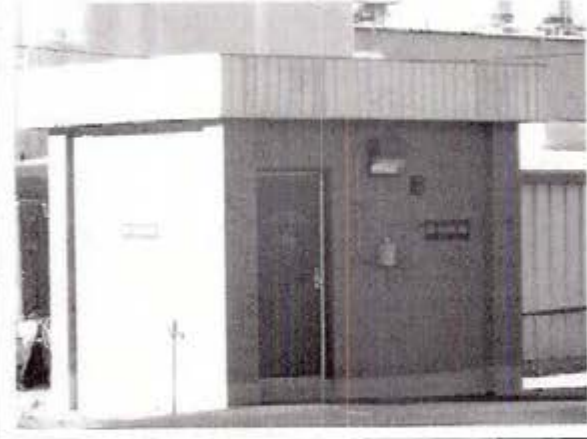
Photo #20-Outside POL shed

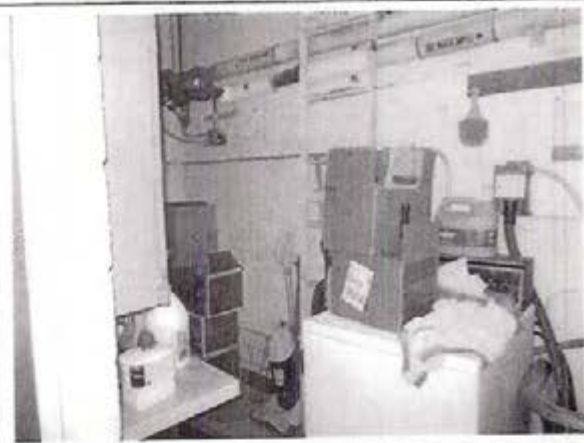
Photo #21-Janitorial closet

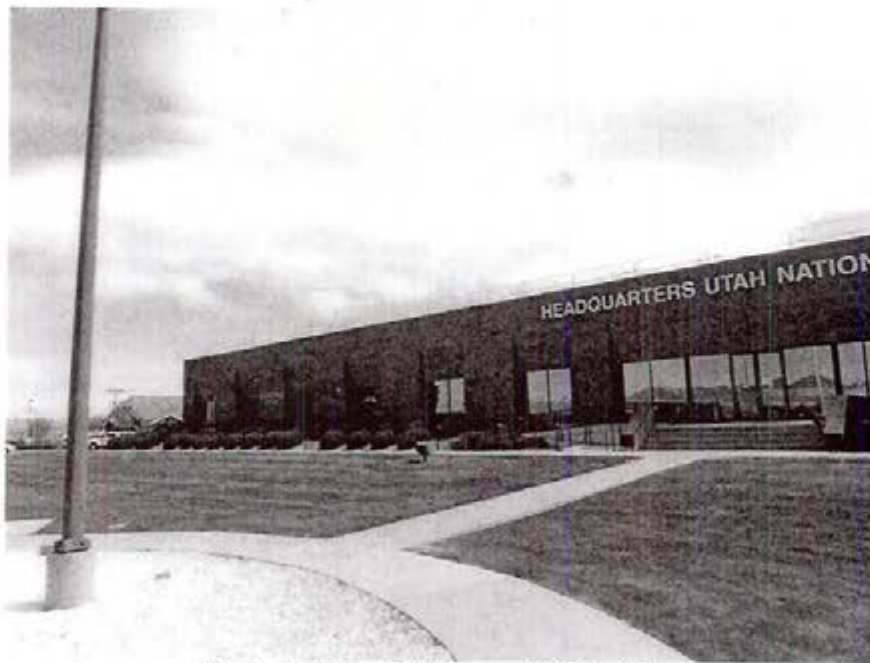
Photo 1: Front of Draper IFR facility.

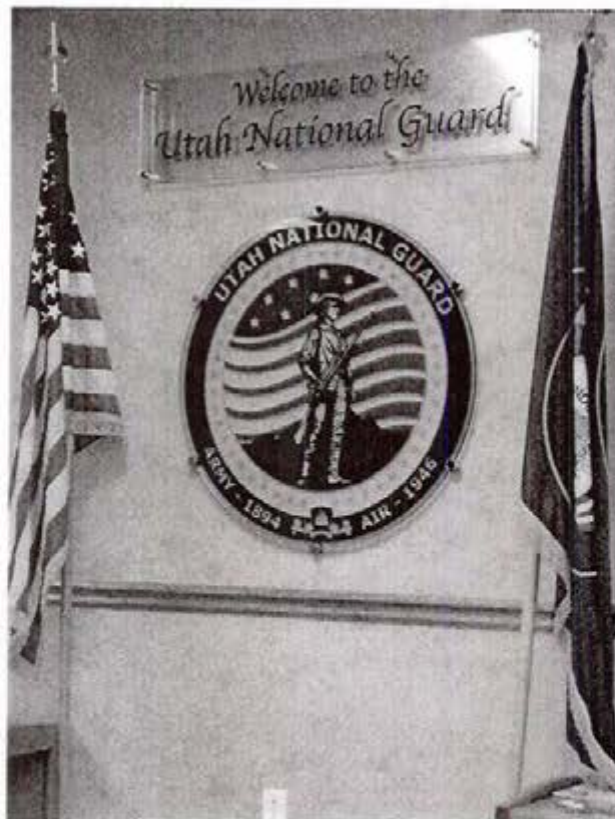
Photo 2: Draper IFR facility signage; front entryway.

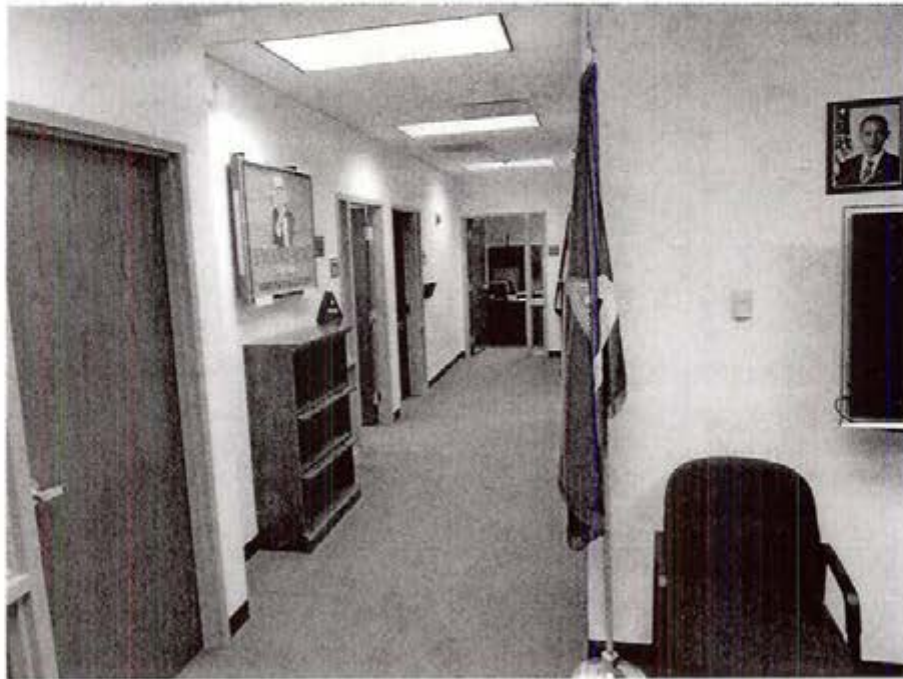
Photo 3: Office hallway.

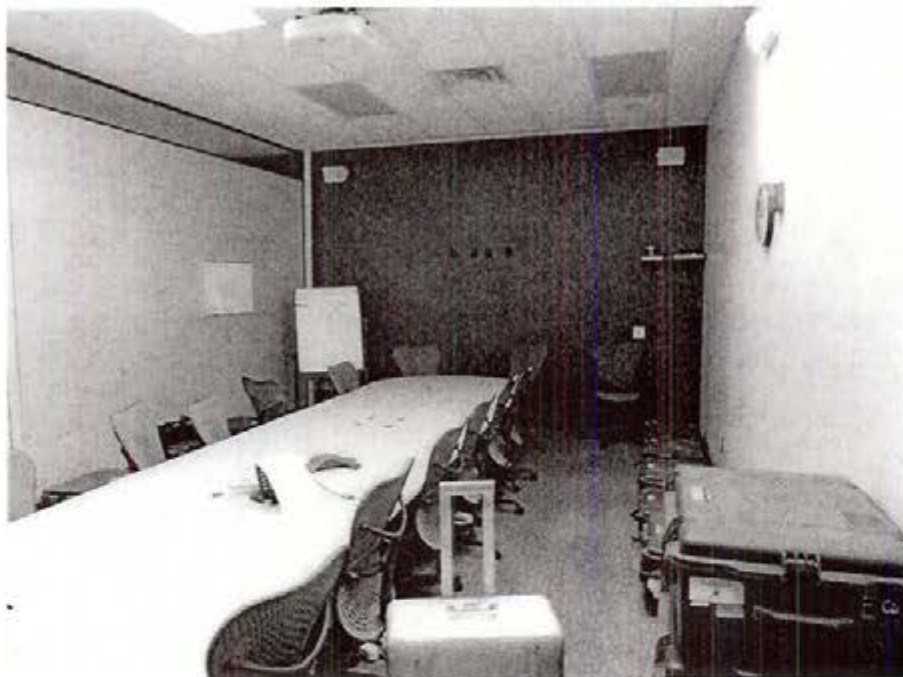
Photo 4: Conference Room; DOL-14.

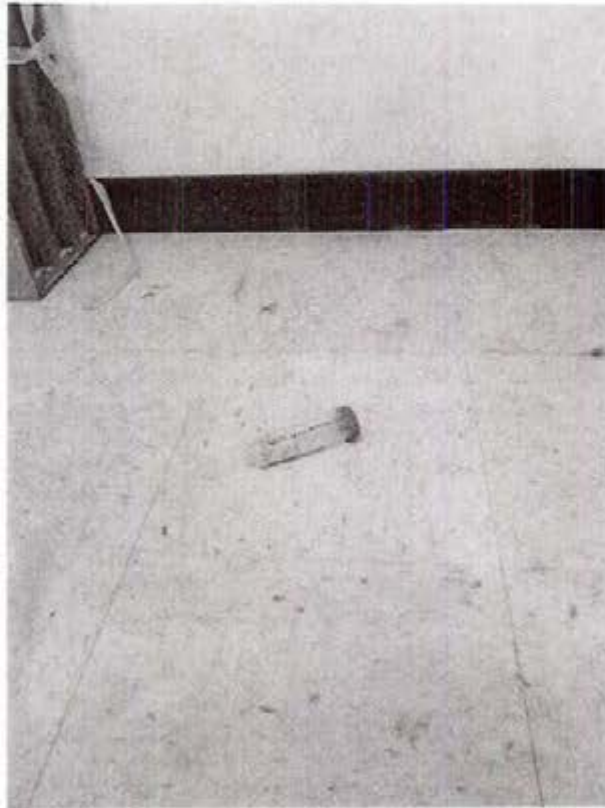
Photo 13: Lead wipe sample (042414-IFR-W-06) collected from the electrical room floor.

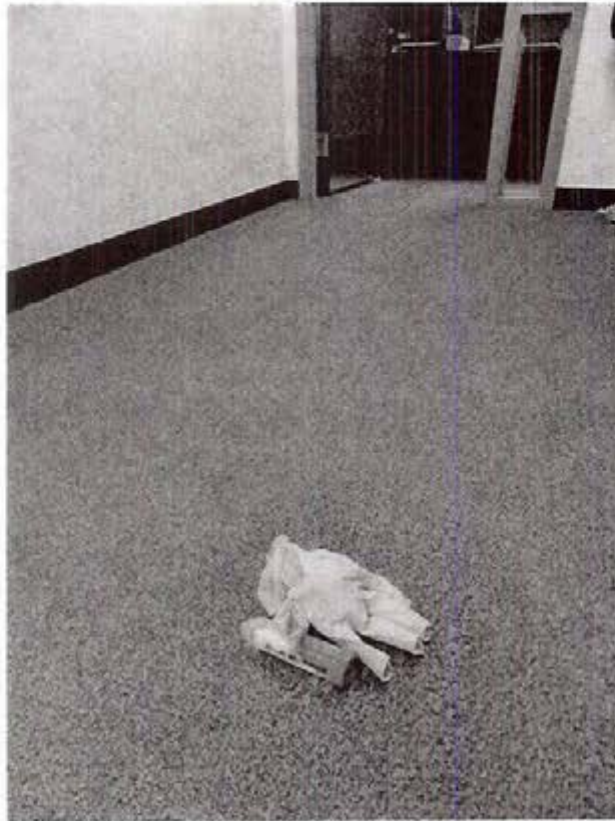
Photo 19: Lead wipe sample (042414-IFR-W-12) collected from the carpet in the hallway outside G-29.

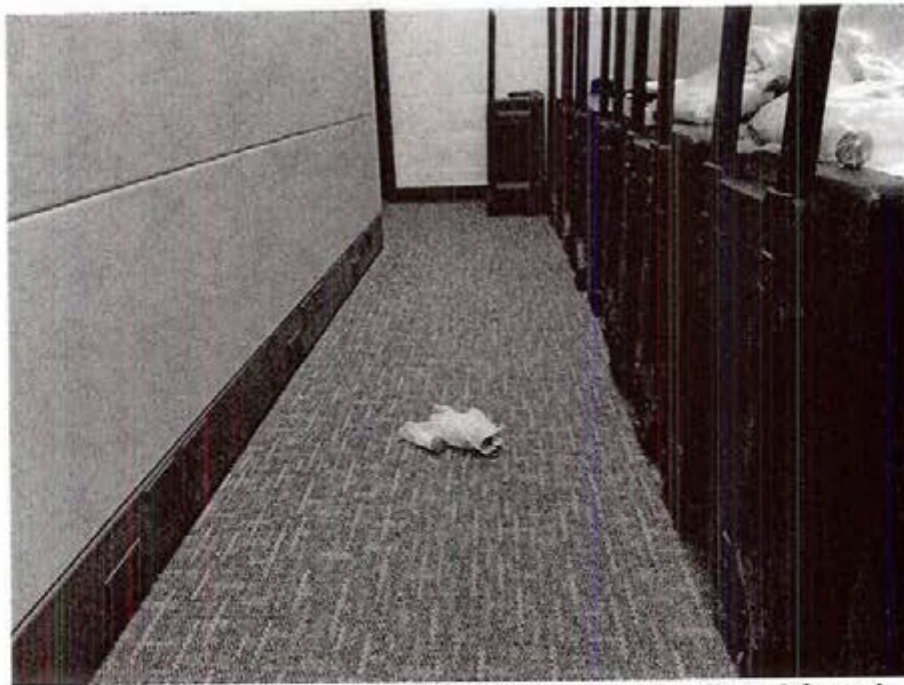
Photo 22: Lead wipe sample (042414-IFR-W-15) collected from the carpet in DOL-15.

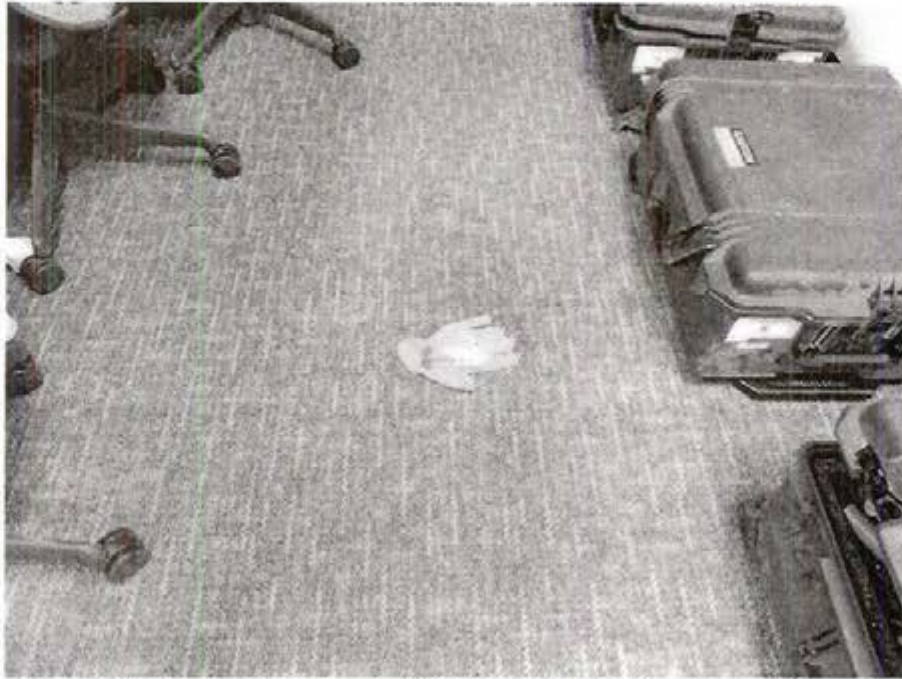
Photo 23: Lead wipe sample (042414-IFR-W-16) collected from the carpet in the conference room; DOL-14.

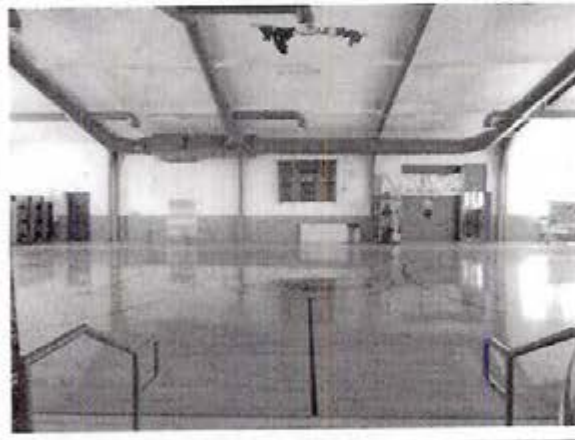
Photo #12 –Drill Hall/ CIFR

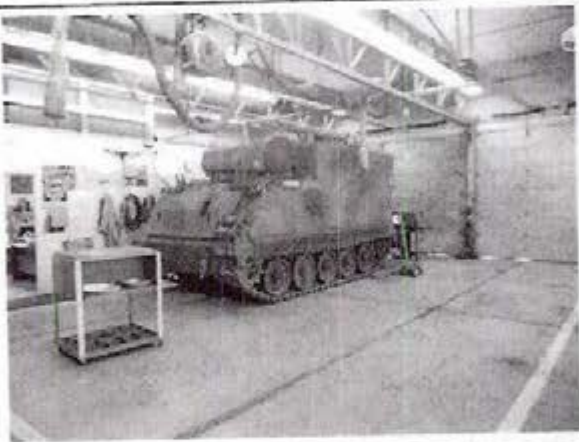
Photo #13-Maintenance shop

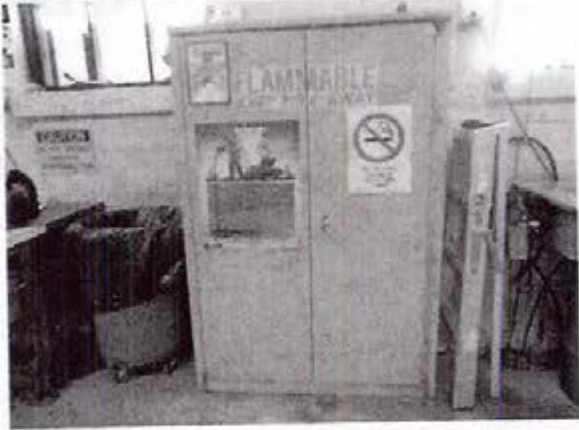
Photo #14-Flammable locker

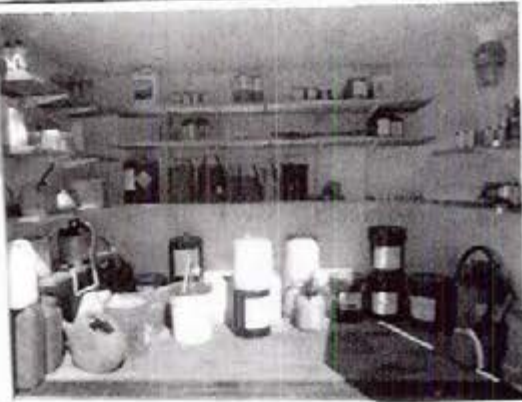
Photo #15-Flammable storage outside

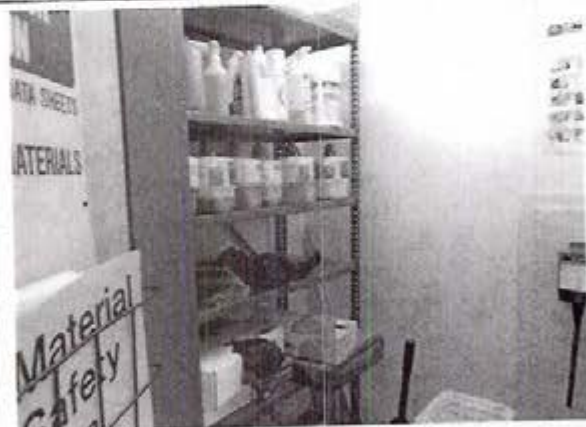
Phot #17-Janitorial storage

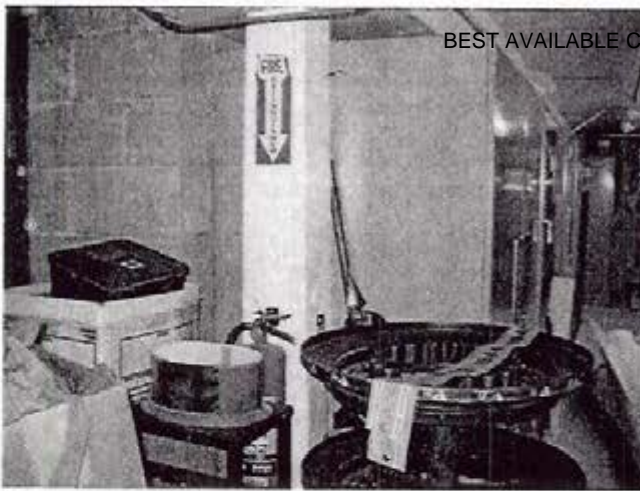
Photograph 7
Blocked fire extinguisher in the basement of 32 Potter

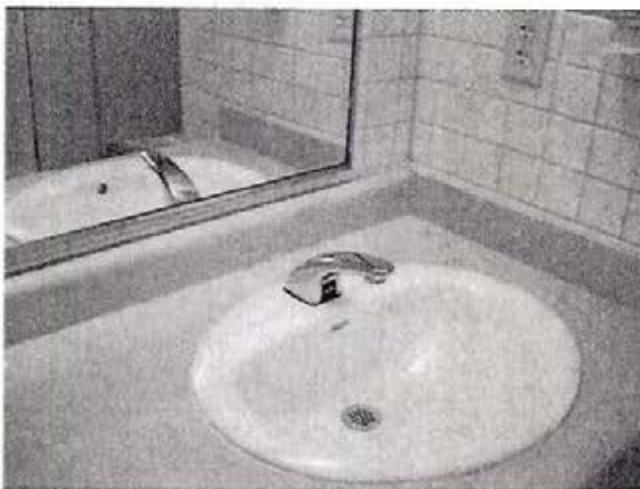
Photograph 9
Non-GFCI protected outlet within 6 feet of water source in Building at 31 Potter

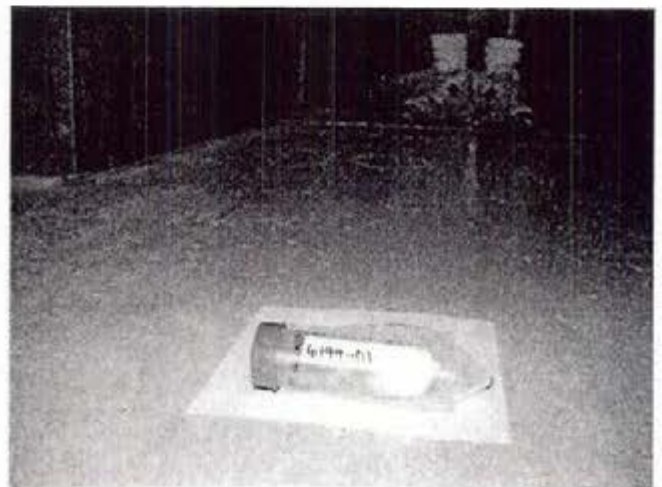
Photograph 10
Location of lead wipe sample number 6169-01

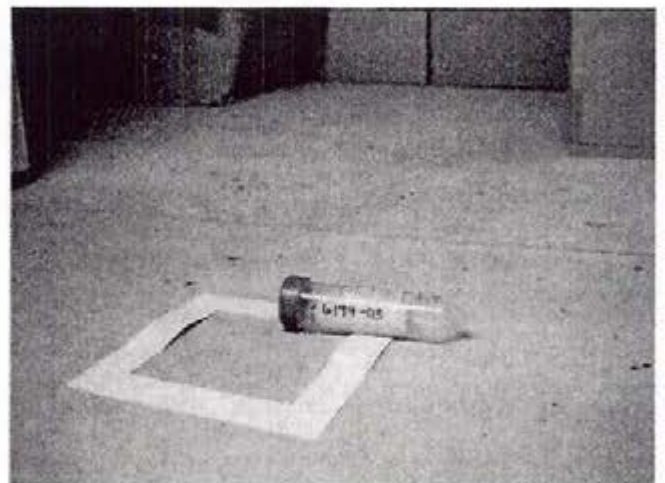
Photograph 12
Location of lead wipe sample number 6169-03

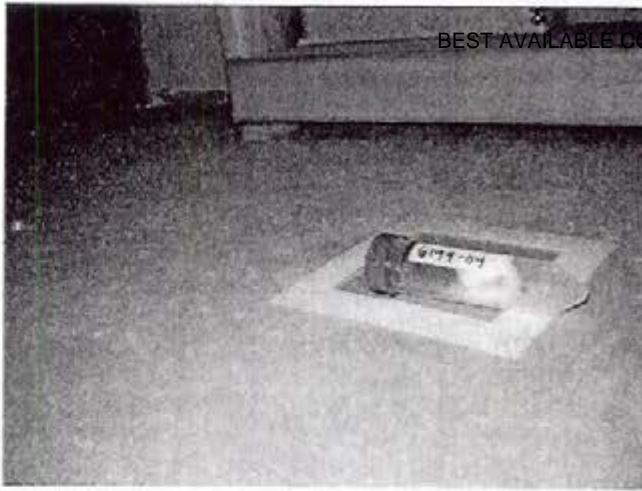
Photograph 13
Location of lead wipe sample number 6169-04

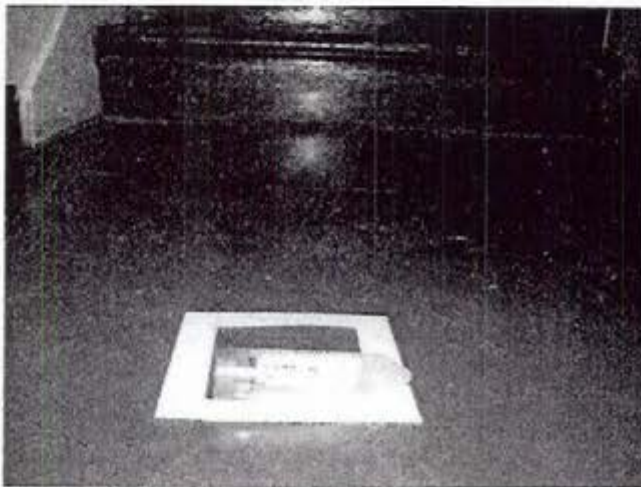
Photograph 15
Location of paint chip sample number 6169-06

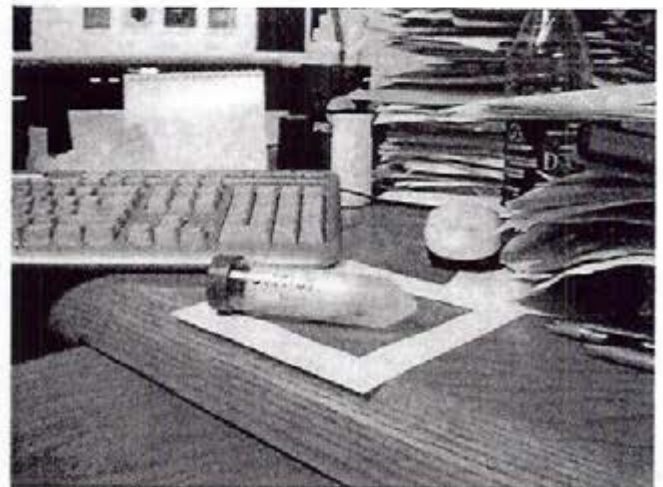
Photograph 16
Location of paint chip sample number 6169-07

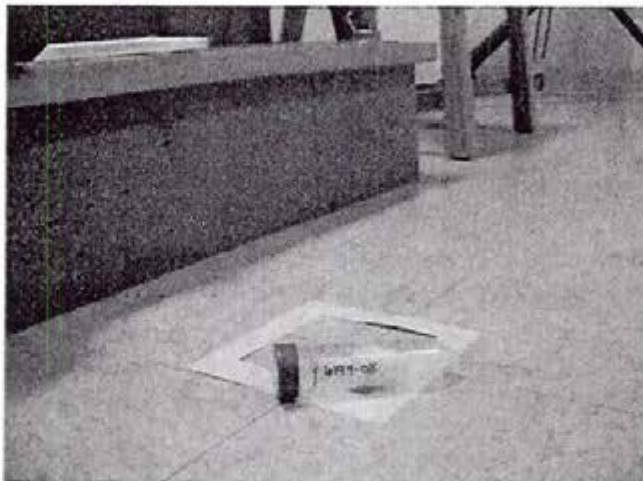
Photograph 17
Location of paint chip sample number 6169-08

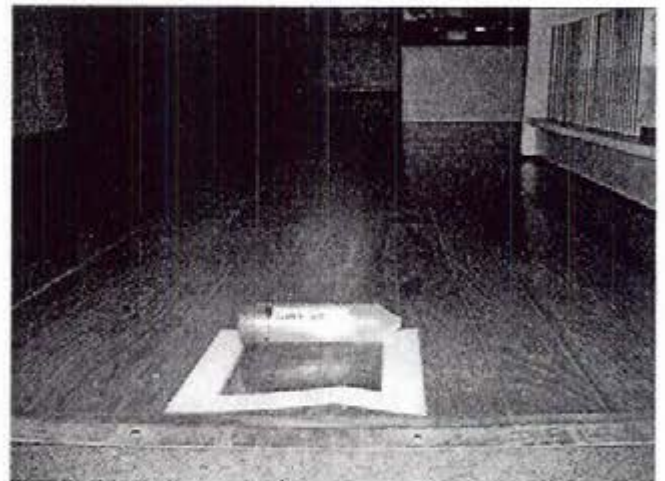
Photograph 18
Location of paint chip sample number 6169-09

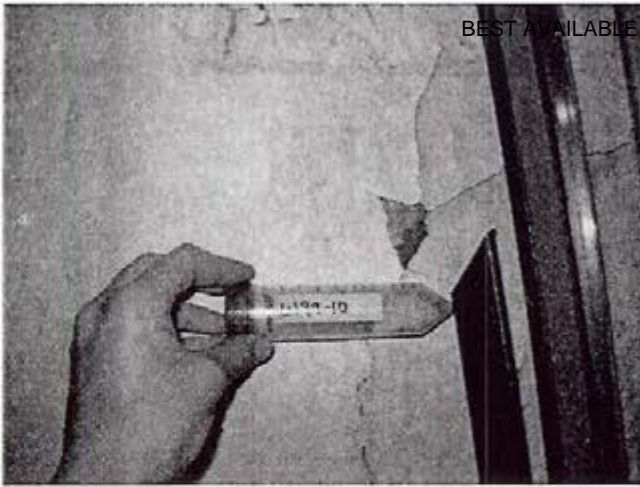
Photograph 19
Location of paint chip sample number 6169-10
