ARMY NATIONAL GUARD INDUSTRIAL HYGIENE - SOUTHWEST

Industrial Hygiene Site Assistance Visit

Anacortes Readiness Center 2219 M Avenue Anacortes, WA 98221

SUBJECT: Executive Summary for the Industrial Hygiene Survey of Anacortes Readiness Center at 2219 M Ave, Anacortes, WA on 20 JUN 2012.

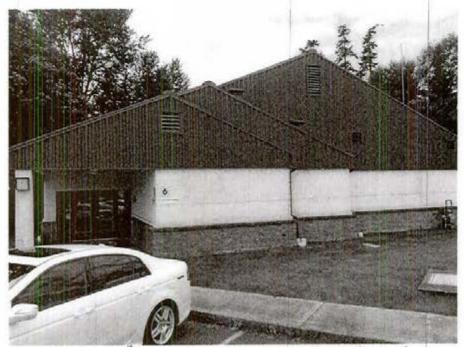
Photo 1: 10th CST Building 6 exterior, view to the south.

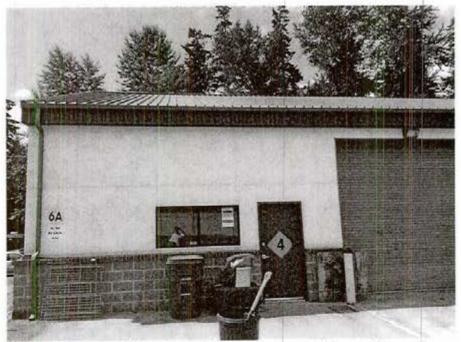
Photo 2: Building 6A used for response vehicle parking and equipment storage.

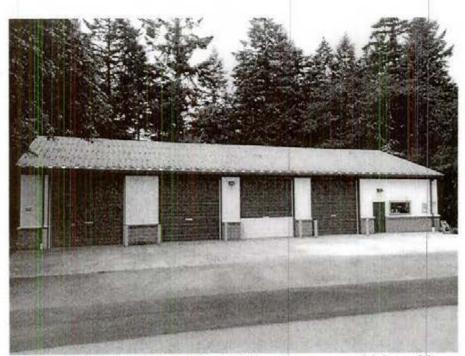
Photo 3: Building 5E used for additional response vehicle parking and equipment storage.

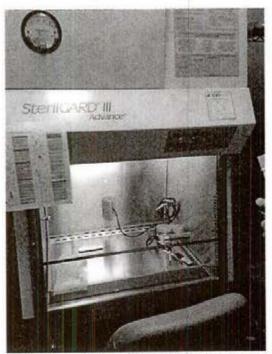
Photo 4: Type 2A biological safety cabinet, located at the west end of Building 6A.

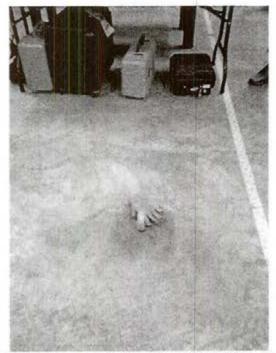
Photo 5: Lead wipe sample 052714-CST-W-01 collected from Building 5E floor near the survey area.

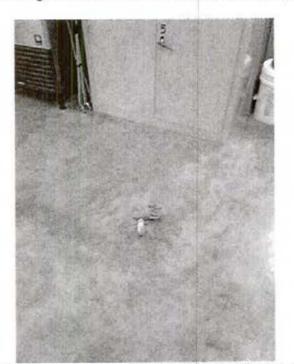
Photo 8: Lead wipe sample 052714-CST-W-04 collected from Building 6A floor at the east end.

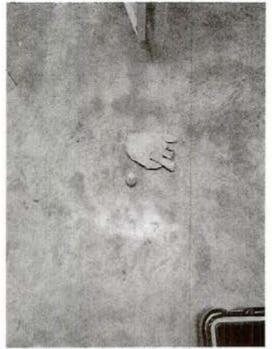
Photo 9: Lead wipe sample 052714-CST-W-05 collected from Building 6A vault floor.

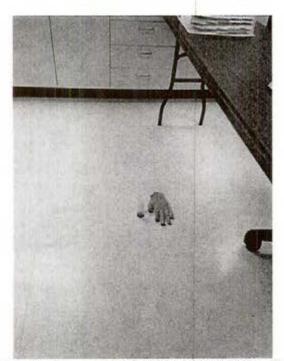
Photo 12: Lead wipe sample 052714-CST-W-08 collected from Building 6 medical laboratory floor.

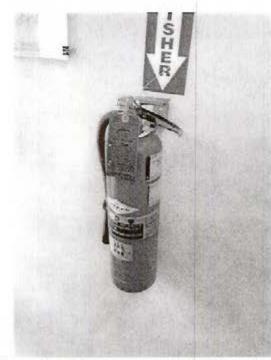
Photo 17: Fire extinguishers were present with expired monthly and annual inspections throughout the facility.

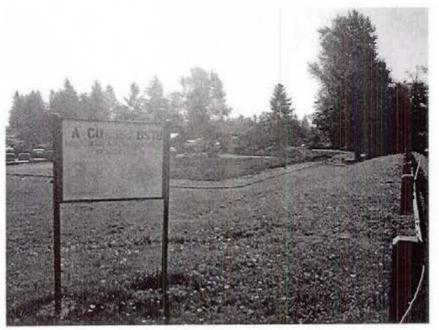
Photo 1: Vacant site with exposed dirt and concrete rubble pile where Kent Armory, Building 501 once stood; looking southeast.

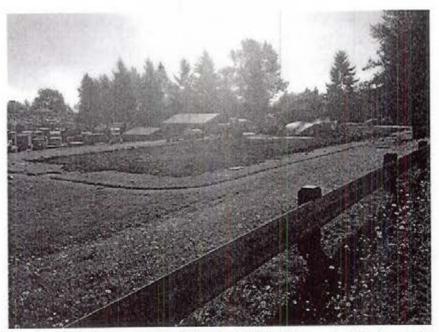
Photo 2: Demolition occurring during the IHSAV. Water actively being used to minimize dust accumulation while concrete rubble was being removed; looking southeast.

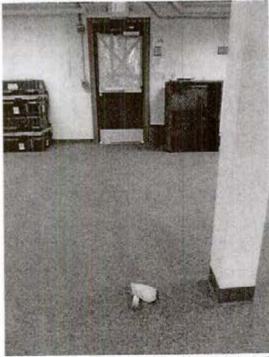
Photo 8: Building 500, Lead wipe sample (052114-B500-W-01) collected from the Redmond (simulator) room; floor.

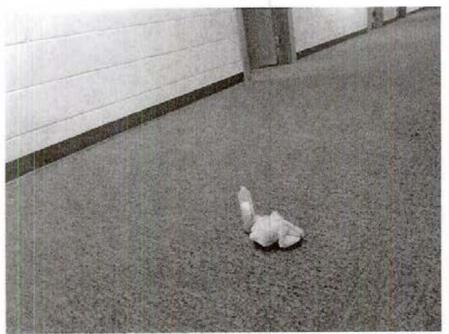
Photo 10: Lead wipe sample (052114-B500-W-03), collected from the south end of the hallway; floor.

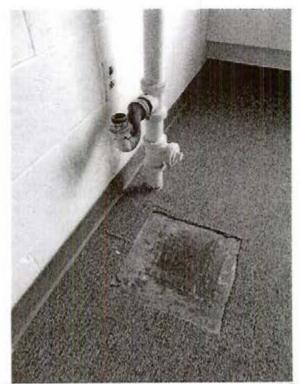
Photo 13: Opening in carpet, showing 9"x9" vinyl floor tile.

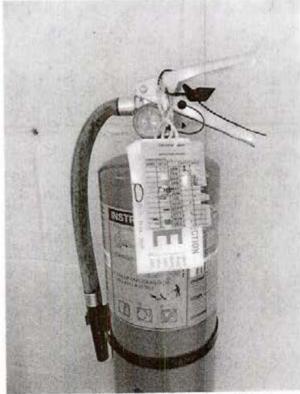
Photo 2: Fire extinguisher past due for monthly inspection and annual servicing.

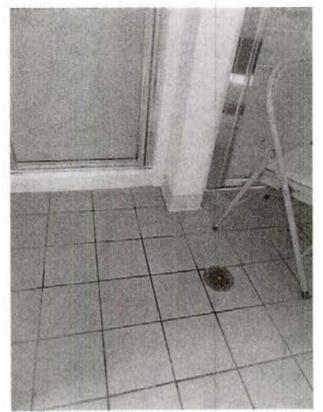
Photo 3: Floor drain in Men's Restroom releasing gas odor.

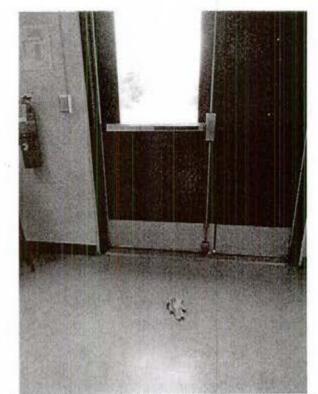
Photo 7: Lead wipe sample (052114-RA501-W-01) Dinning Hall; floor.

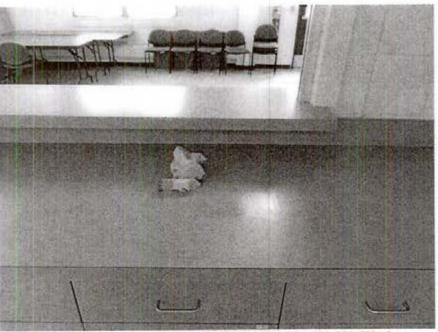
Photo 8: Lead wipe sample (052114-RA501-W-02) Kitchen; countertop.

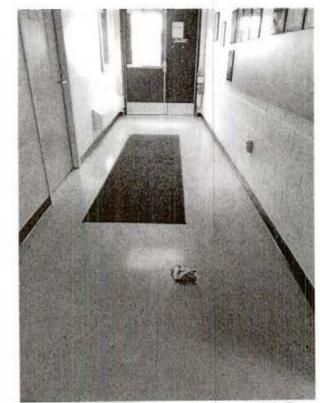
Photo 9: Lead wipe sample (052114-RA501-W-03) Entryway; floor.

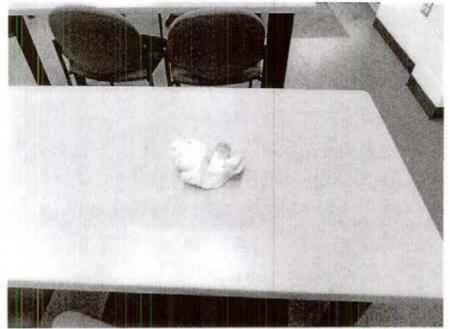
Photo 11: Lead wipe sample (052114-RA501-W-05) Classroom 101; desktop.

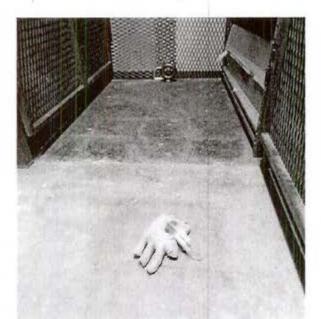
Photo 12: Lead wipe sample (052114-RA501-W-06) Supply room vault; floor.

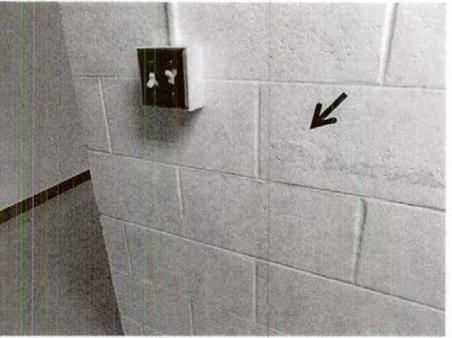
Photo 14: Bulk paint chip sample (RA-501-Bulk-01) collected in the main hallway; outside Room 122A.

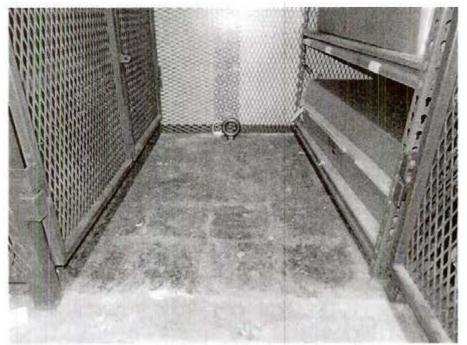
Photo 19: Mastic residue in supply vault.

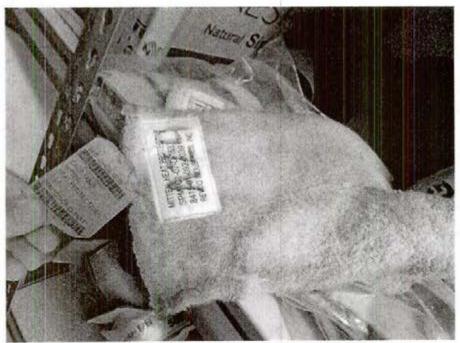
Photo 20: Thermal gloves in Supply room.

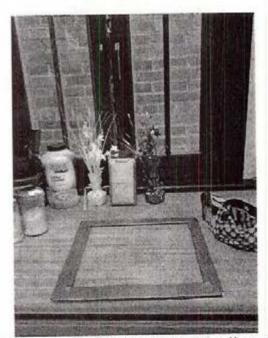
Photo 8: Lead wipe sample 120612-WWA-06 collected from Kitchen counter.
